AGENDA OF THE AD HOC FACILITIES COMMITTEE

- I. Consideration with possible action the review of the Facilities Assessment Updates for City Hall, Municipal Court, Police Station, and Fire Station #1.

An assessment of City Hall was conducted in 2015 by Berners Schober which reviewed the condition of the building's architectural, structural, mechanical, plumbing and electrical elements. This report, done in the summer of 2022, is an update to the previous assessment. Each building was re-surveyed by trade and the reports updated. Below are brief summaries of the changes to the building in the intervening 7 years.

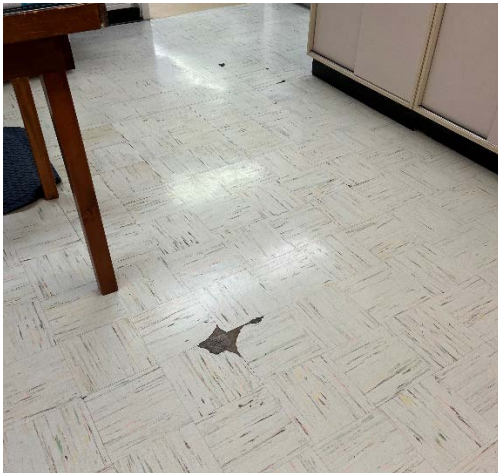
Chipped floor tile

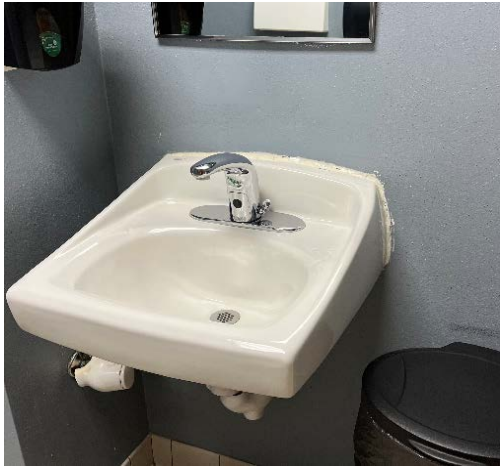
Excessive sealant at lavatory

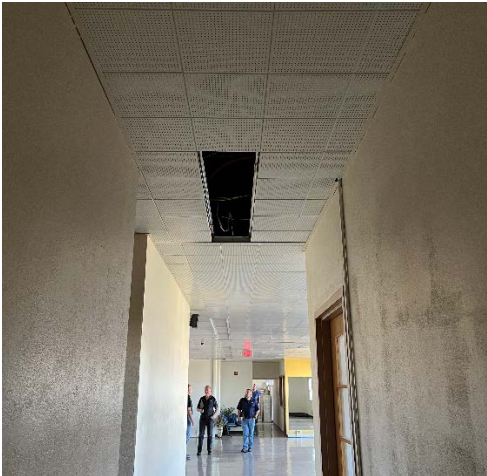
Missing light fixture

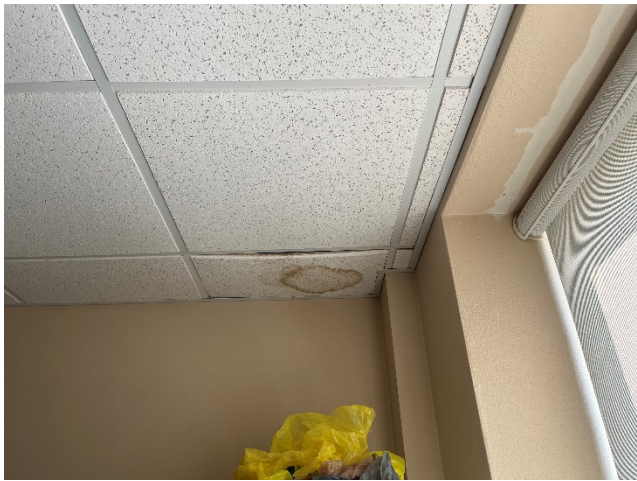
Damaged ceiling tile – adjacent to IT room

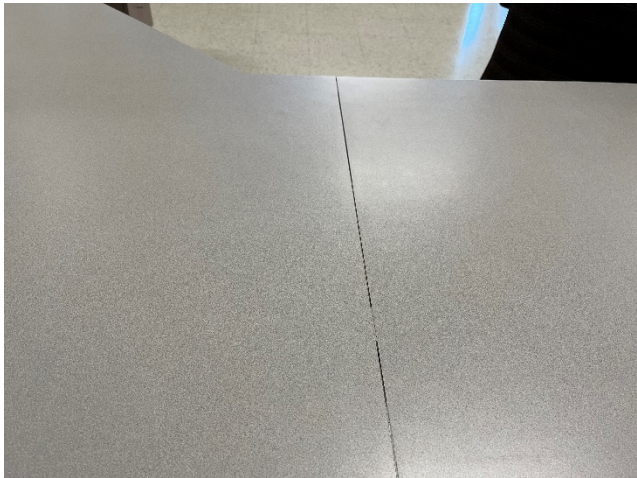
Plastic laminate gap

- A12.** Provide clear sealant at gap in plastic laminate. Recommend replacing cracked and de-laminated surface. If matching laminate is available, installer may be able to remove just damaged portion.

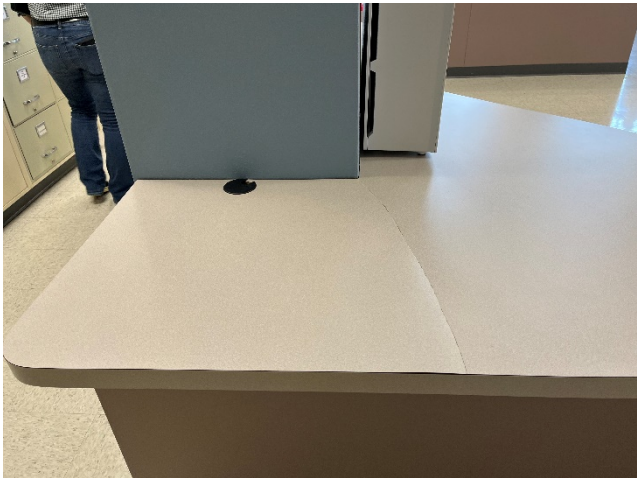
Cracked, damaged plastic laminate

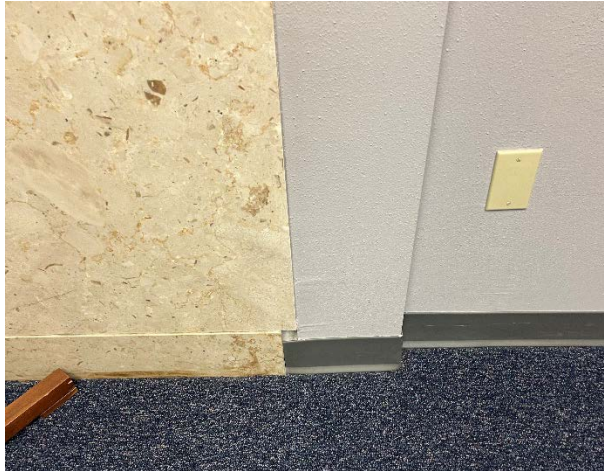
Fill gap in wall

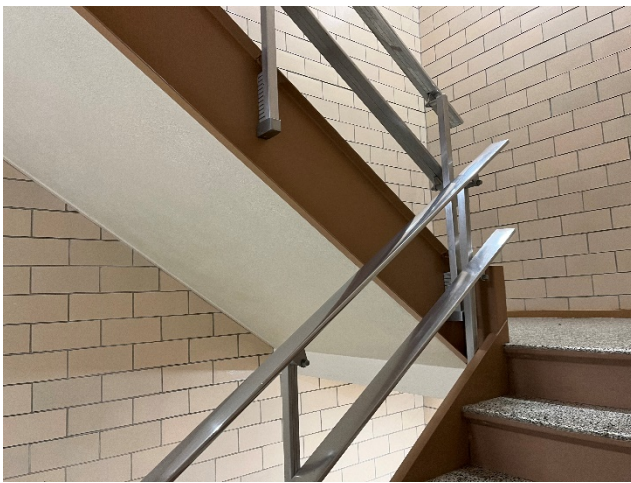
Large openings in open side of stair rails

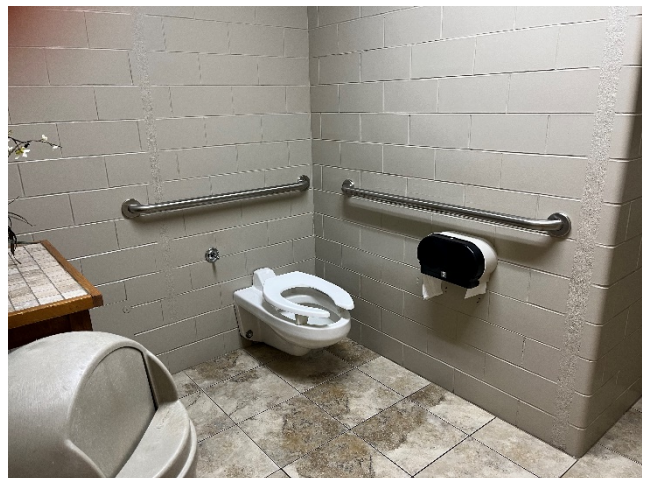
5th floor: Typical missing vertical grab bar

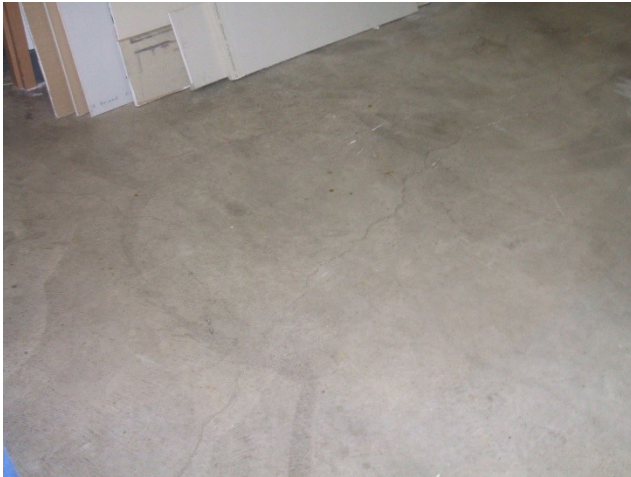
- S1.** There is minor shrinkage cracking in the concrete slab on grade in the basement at various locations. The cracking is not a cause for structural concern at this time.
- S2.** There is some minor settlement cracking in the glazed tile walls near the corners of the stairwells. However, the tile is non-load bearing, and no remedial action is recommended at this time.
- S3.** In addition to the recommended masonry repairs identified in the Architectural section, there is some expansion cracking in the face brick near the outside corners of the penthouse. It is not impairing the structural function of the walls, so no remedial action is immediately necessary. However, these cracks should be routed and sealed whenever the recommended repairs are performed.

**Shrinkage cracks in basement slab
(Note S1)**

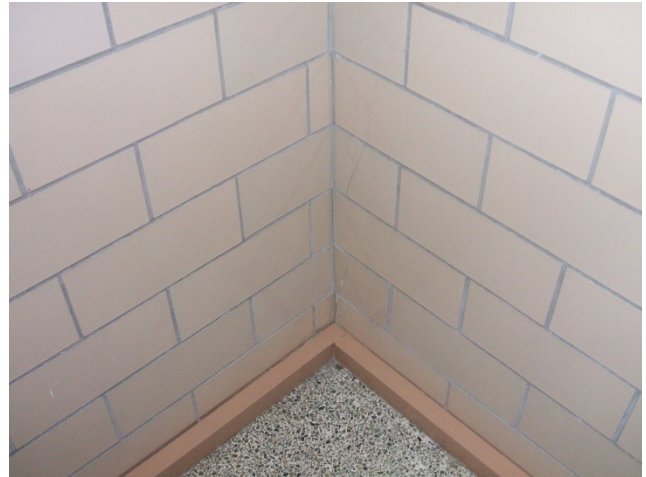
**Settlement cracks in glazed tile walls of stairs
(Note S2)**

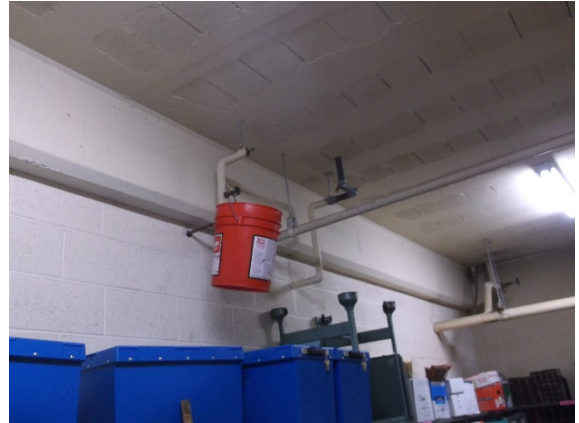
Leaking valve(s)

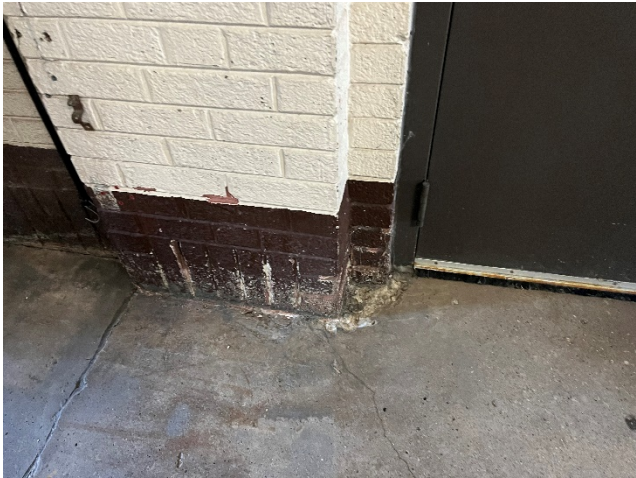
Spalling brick due to moisture exposure

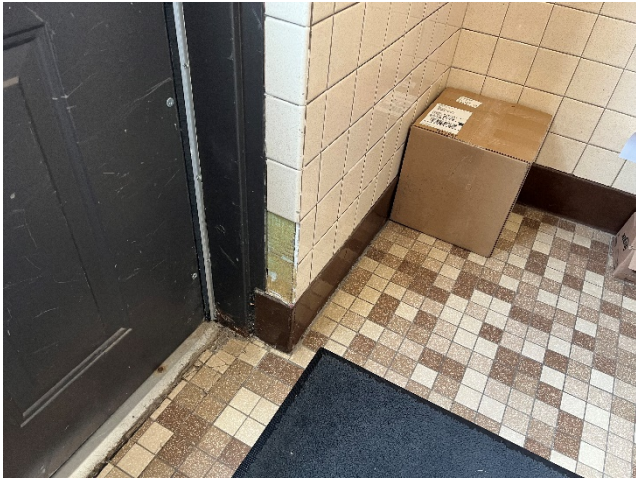
Missing wall tile

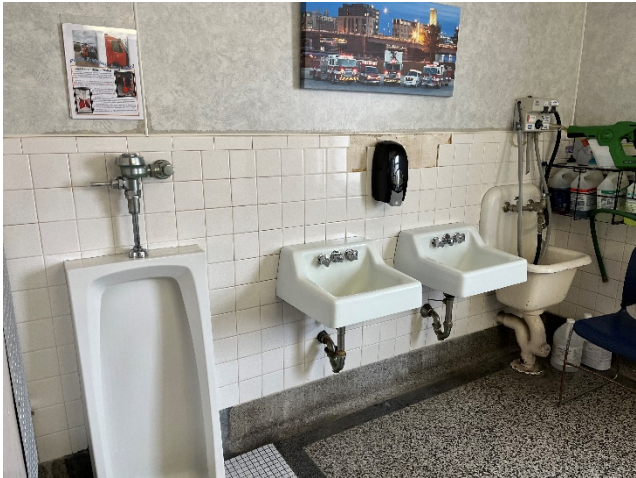
Missing wall tile at plumbing wall

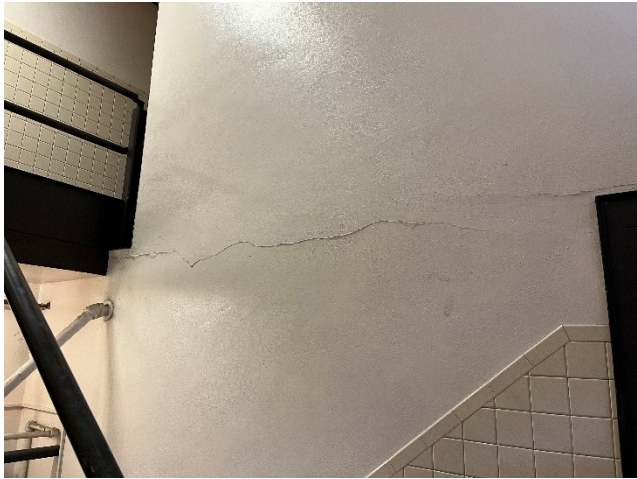
Cracked plaster at stair

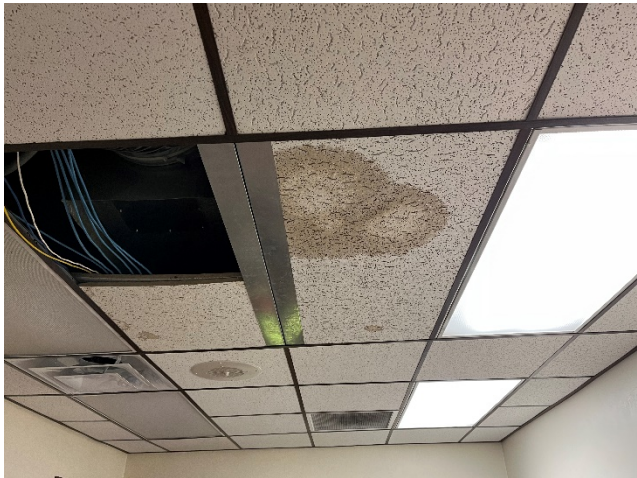
Missing and stained ceiling tile

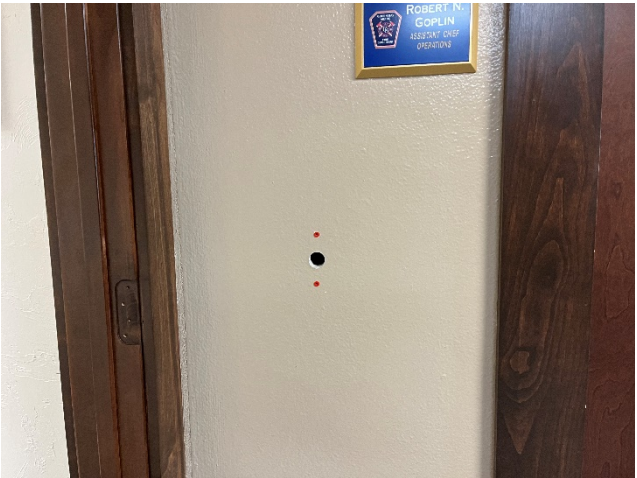
Patch hole in wall

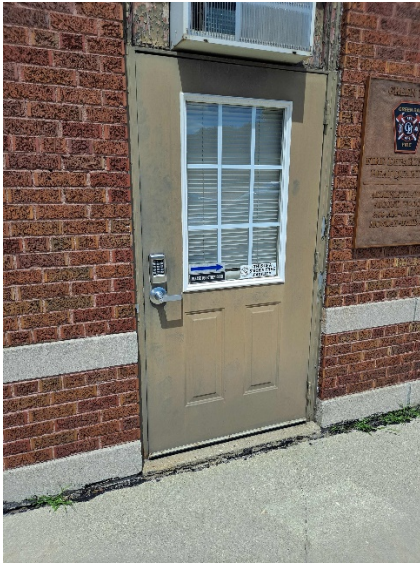
Recommend threshold at entry

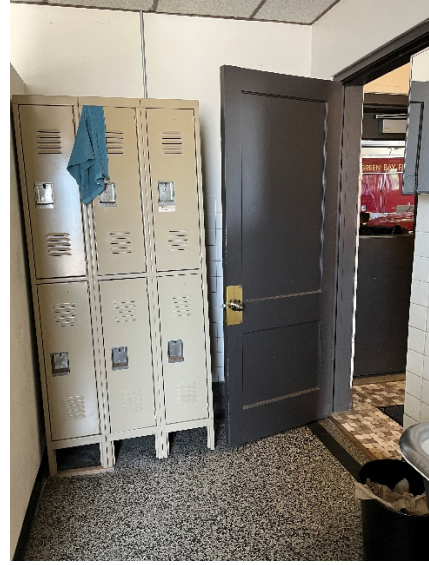
Recommend lever door hardware

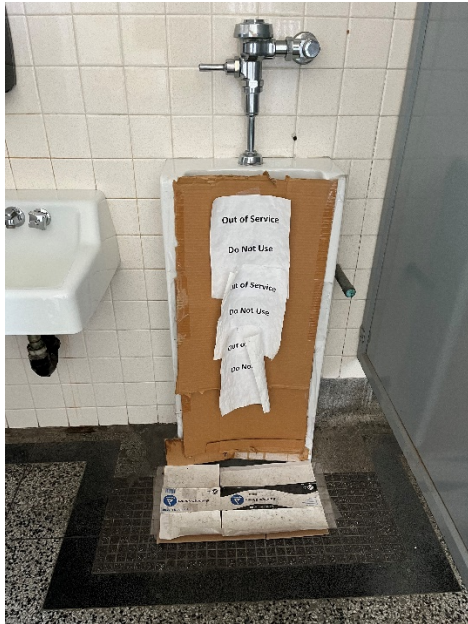
Remove unused fixture

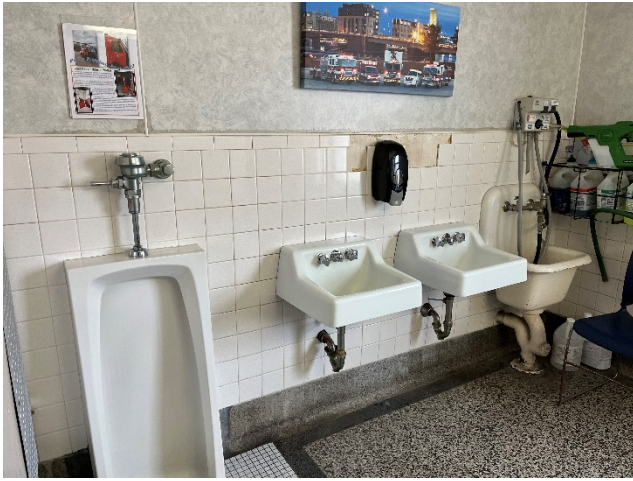
Recommend lever faucet handles

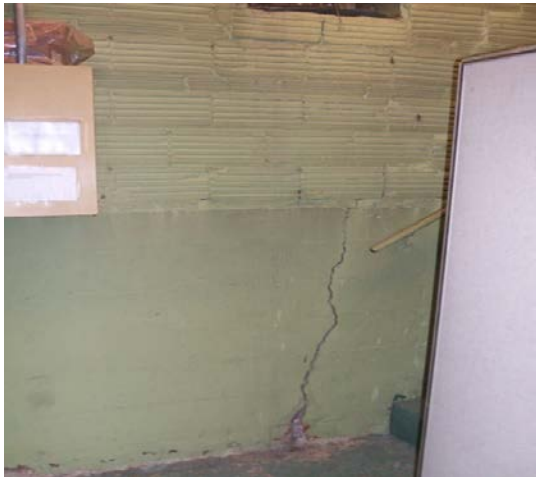
**Cracked foundation wall in generator room
(Note S1)**

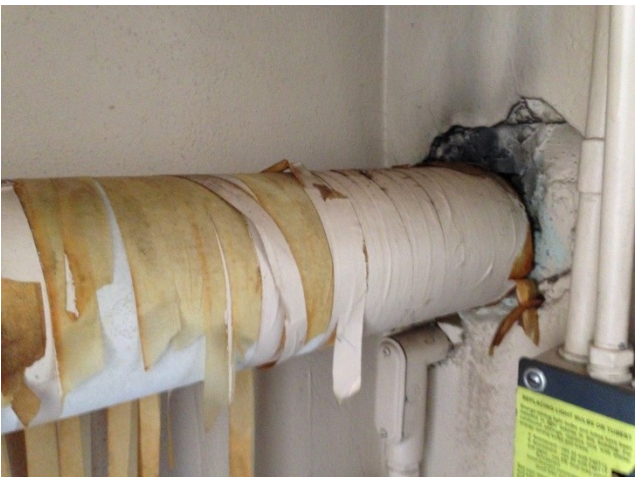
Poor insulation condition

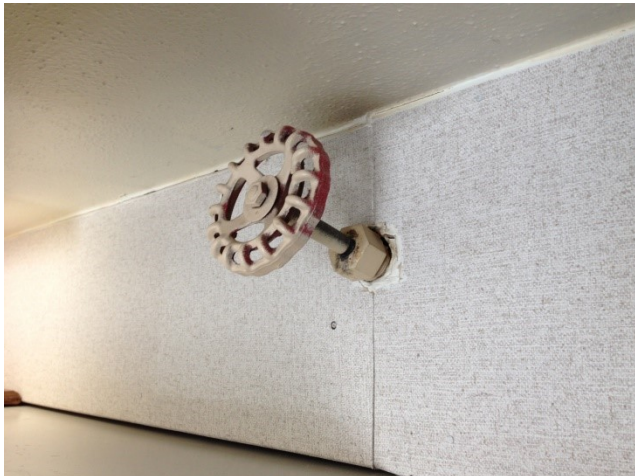
Wall built over valve

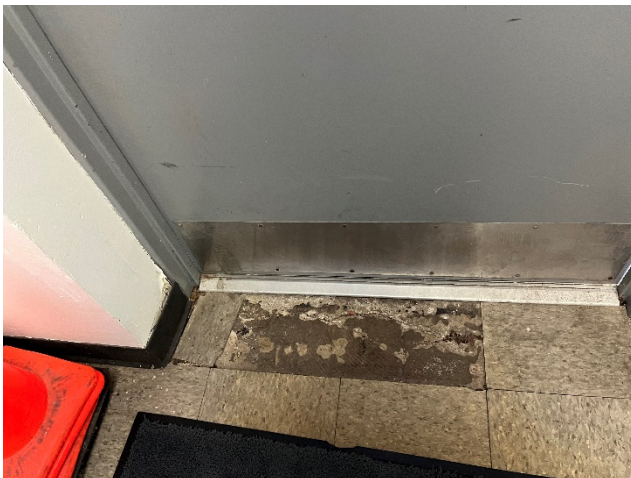
Missing vinyl tile at back door

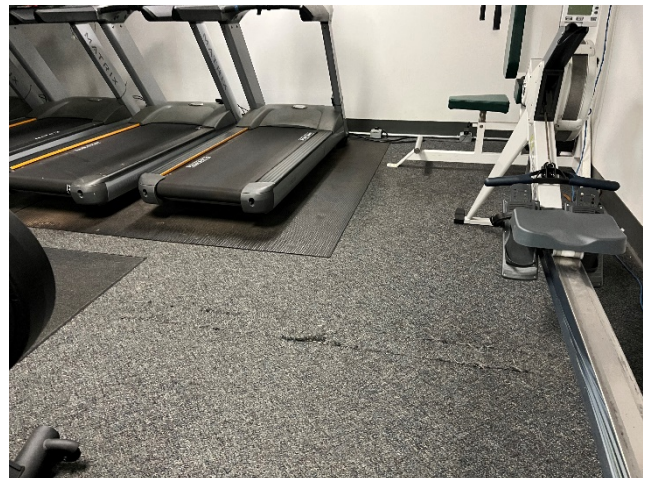
Ripped carpet at cardio room

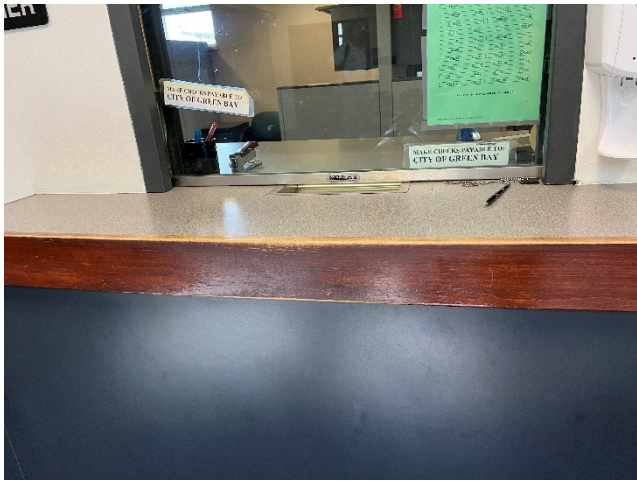
Worn finish at reception counter

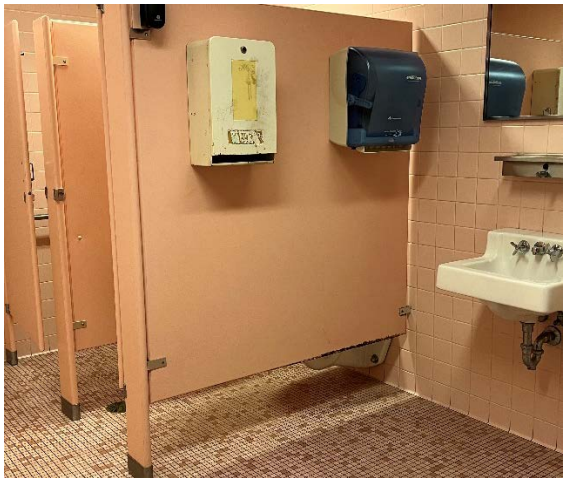
Rusted bottom of women's toilet partitions

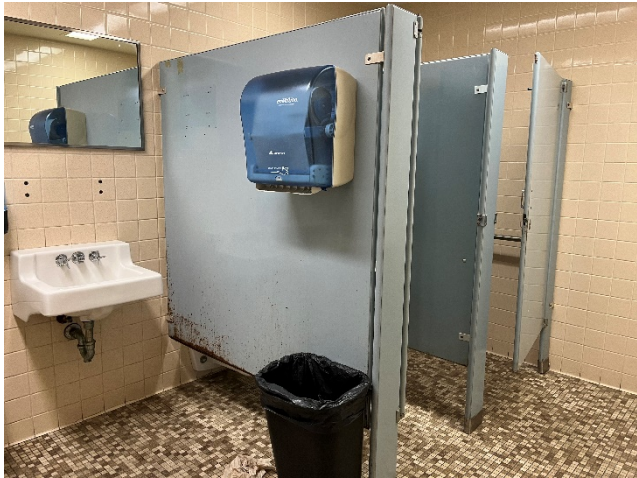
Rusted bottom of men's toilet partitions

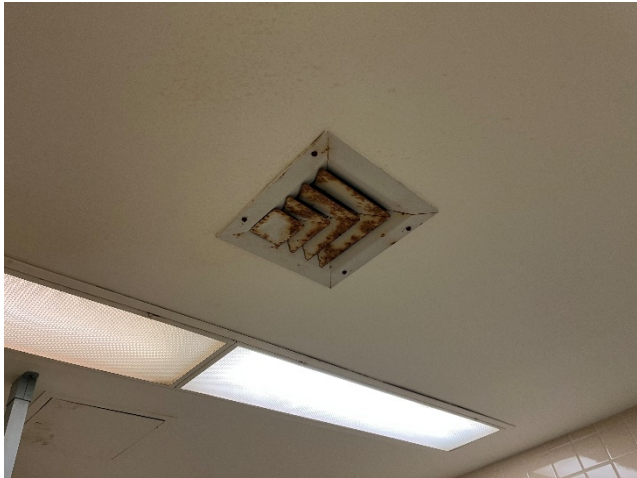
Rusted ceiling diffuser at basement toilet room

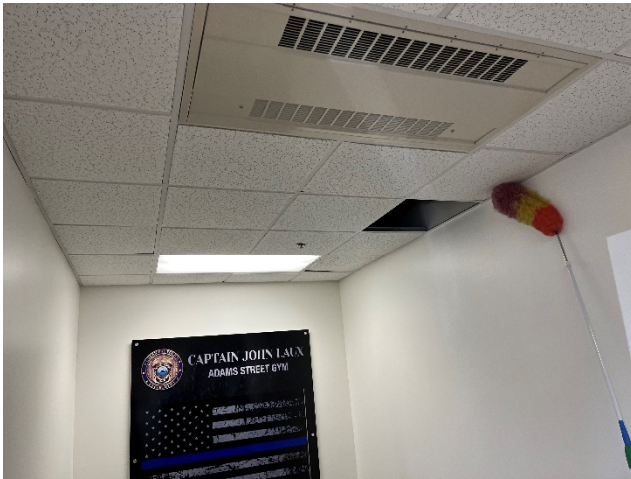
Missing ceiling tile at back stair shaft

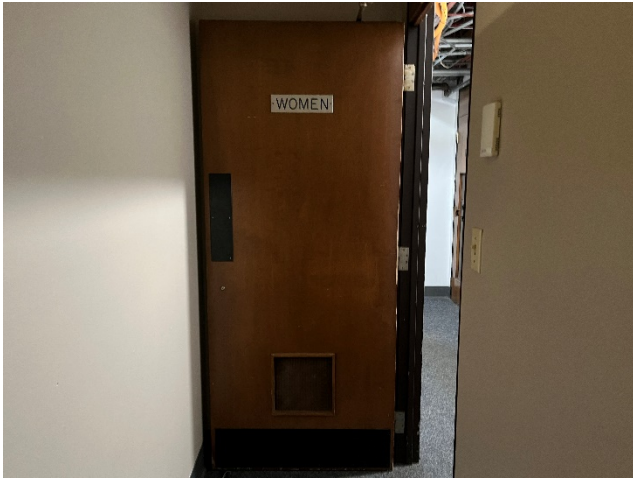
- CA1.** Route into basement Women’s room is not accessible due to width of passageway.
- CA2.** If a judge is in need of accessibility to the judge’s platform, provide ramp access and appropriate handrails.
- CA3.** If front stair shaft is modified, provide handrail extensions per code.
- CA4.** Recommend replacing knob door hardware with lever handles.
- CA5.** Provide workspace in breakrooms at accessible 34” height. Could be separate table.
- CA6.** Add vertical grab bars to accessible toilet rooms.

Narrow entry to basement Women's room

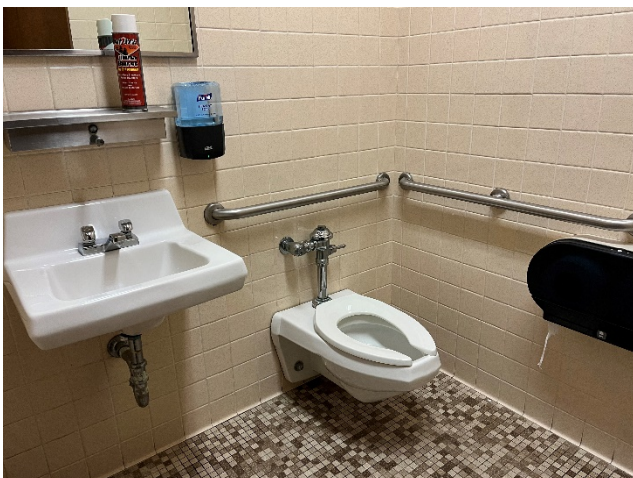
1st floor unisex toilet room – missing vertical grab bar

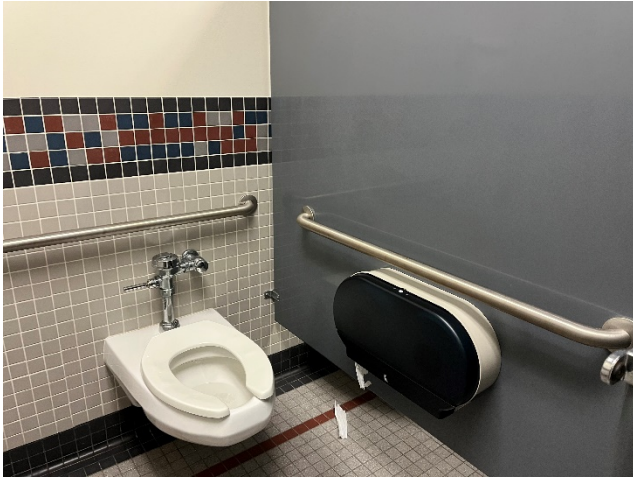
1st floor Women's – missing vertical grab bar

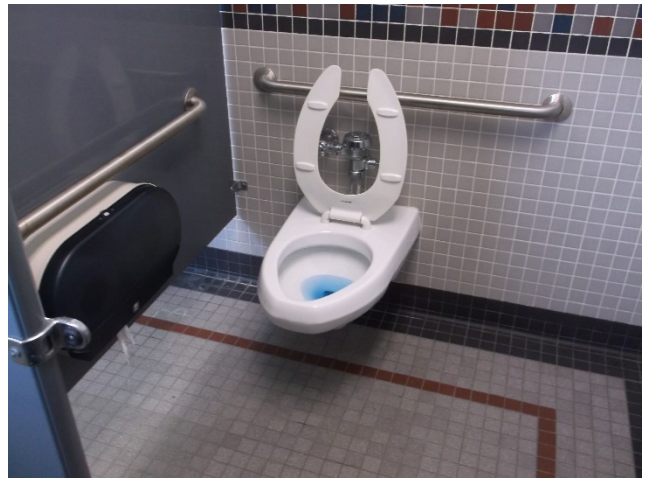
1st floor Men's – missing vertical grab bar

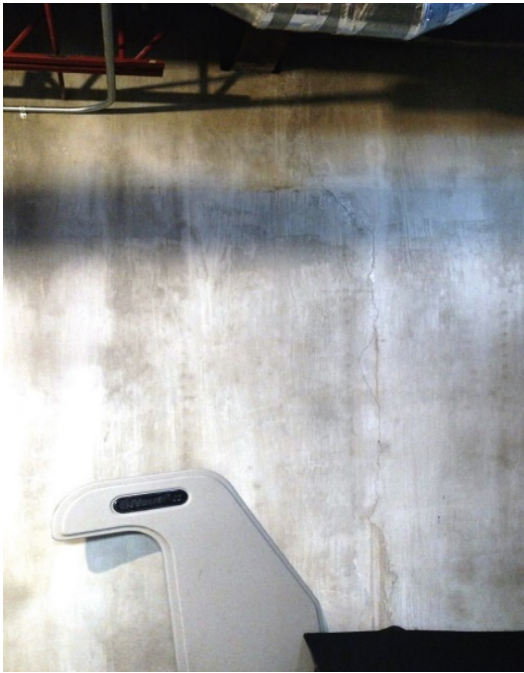
- S1. There is a minor vertically oriented shrinkage crack below the steel beam bearing location in the east foundation wall of the basement storage room. The crack shows no evidence of movement or water infiltration and is not a cause for structural concern. No remedial action is recommended at this time.

Concrete shrinkage crack in basement storage room (Note S1)

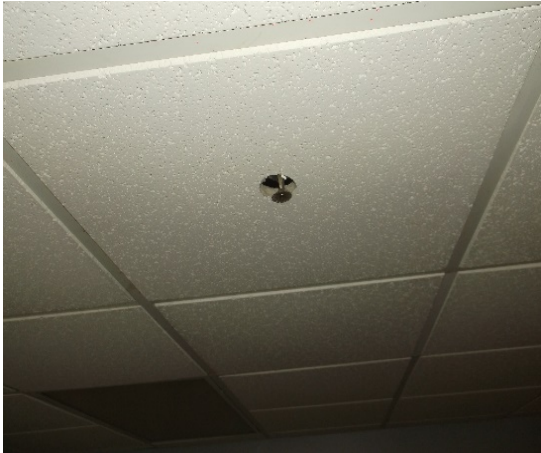
Sprinkler head – missing escutcheon

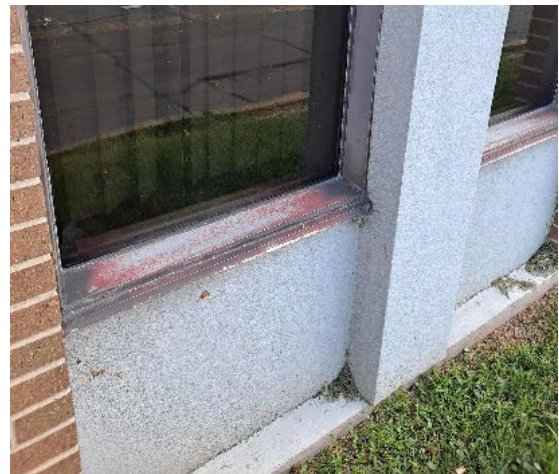
Faded metal window trim

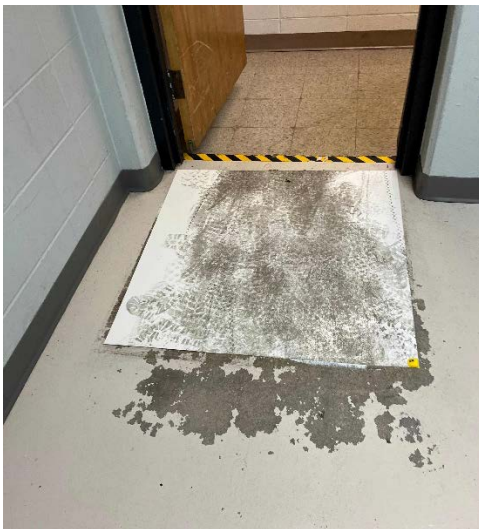
Chipped paint at shooting gallery entry

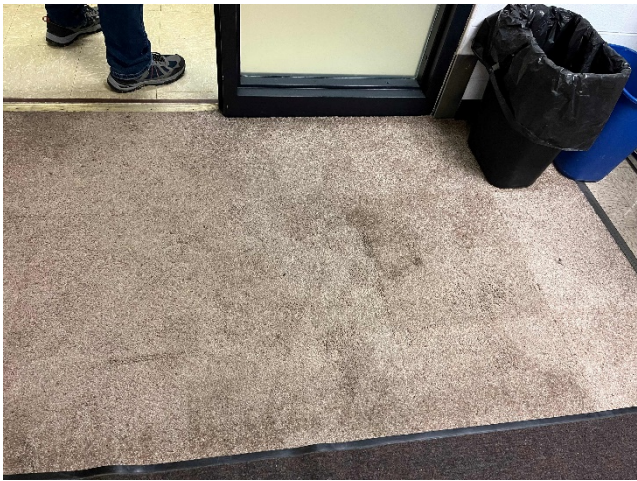
Worn, stained cut-pile carpet

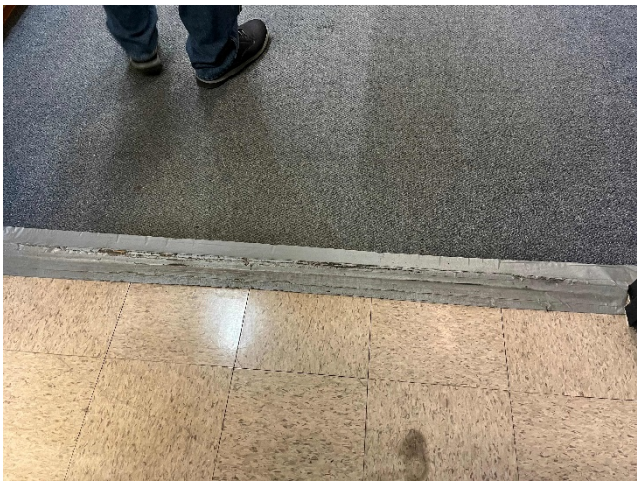
Duct tape at transition from carpet to VCT

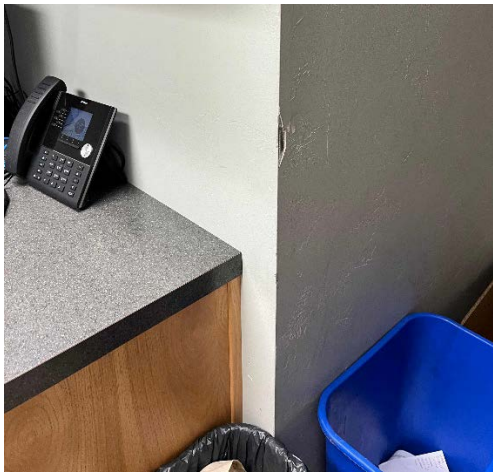
Damaged corner – Range

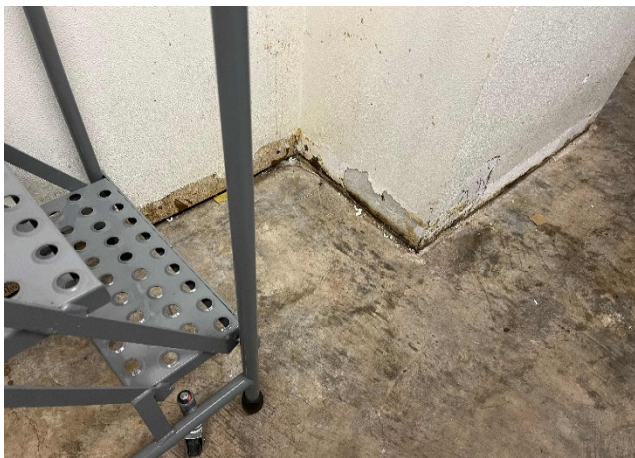
Deteriorated base at high-density storage

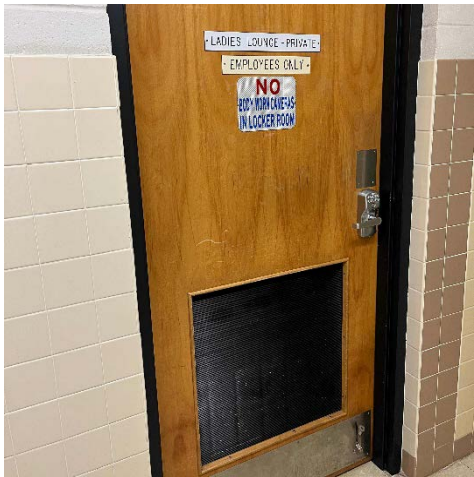
Scratched wood veneer

- A7. Refinish or replace doors with scratched and damaged veneer finish. Install minimum of 12" high kick plates. Estimated 4 doors; those in worst condition are in basement. See Code section of this report for recommended update of door hardware.

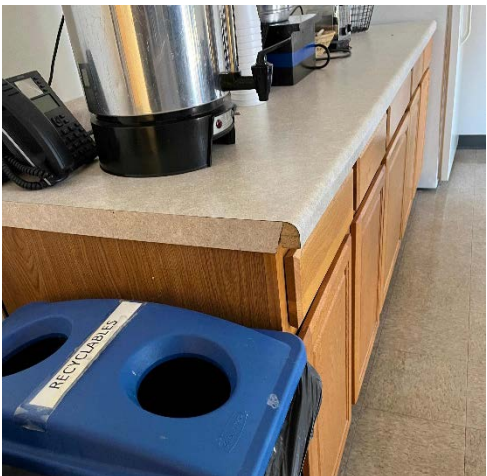
Chipped plastic laminate

- A8. Repair chips and delamination in plastic laminate countertops: Evidence Lost & Found, 2nd floor break area.
- A9. Replace missing and stained ceiling panels.

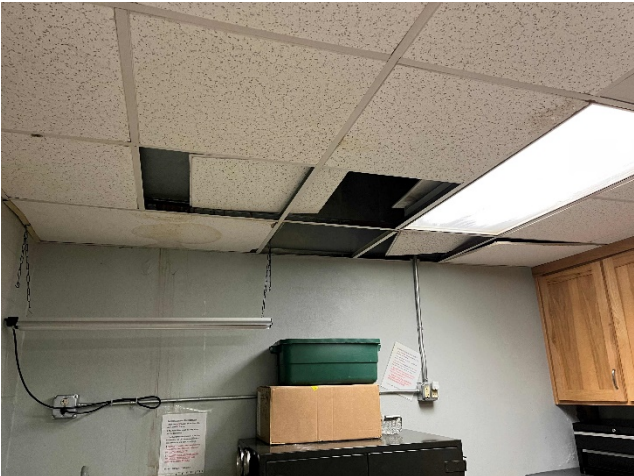
Missing and misplaced ceiling tiles

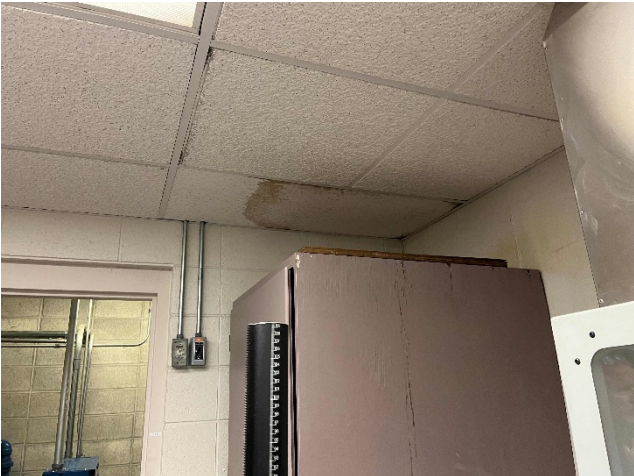
Typical stained ceiling tile

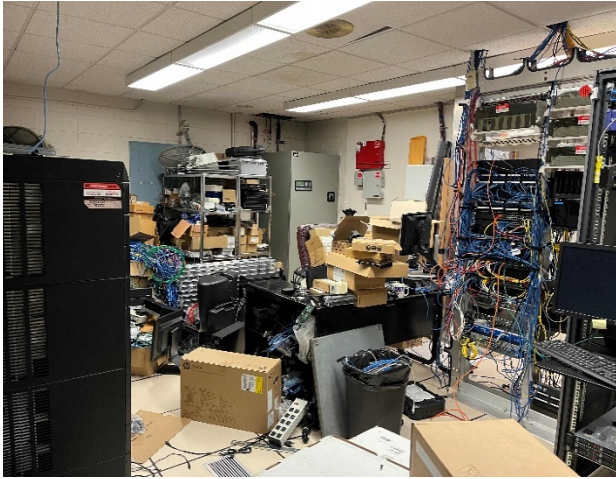
Basement IT room – needs egress route

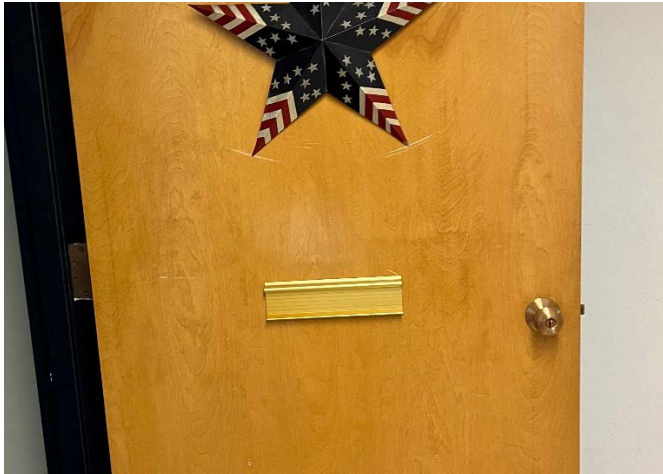
Knob hardware – not accessible

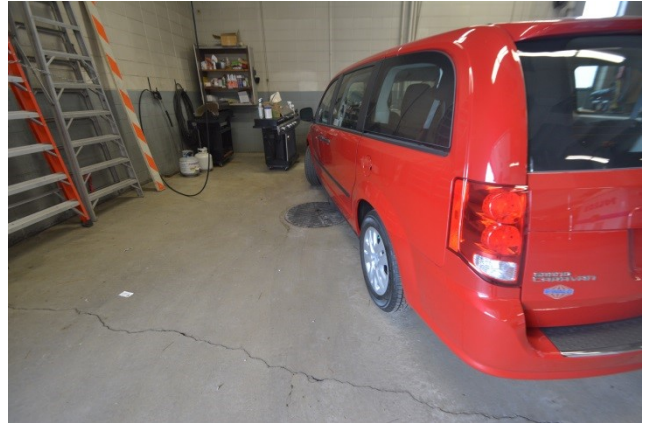
- S1. There is minor shrinkage cracking in the slab on grade in the garage area. The cracking is not as cause for structural concern and no remedial action is recommended at this time.

Cracked slab at garage (Note S1)

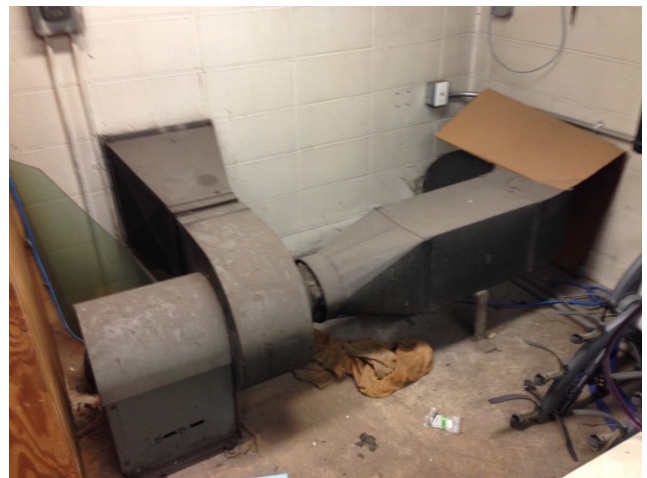
Garage storage exhaust fan (old)
