# **AGENDA OF THE FINANCE COMMITTEE**

**TUESDAY, NOVEMBER 29, 2022, 4:30 PM**

**F. Report of the Ad Hoc Facilities Committee (November 15, 2022).**

1. To direct Finance Staff to work with BSA on the total cost of the deficient and critical needs listed in the report in response to the review of the Facilities Assessment Updates for City Hall, Municipal Court, Police Station, and Fire Station #1.

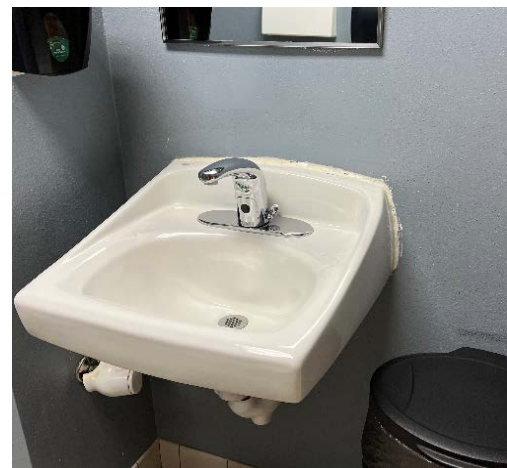
**Excessive sealant at lavatory**

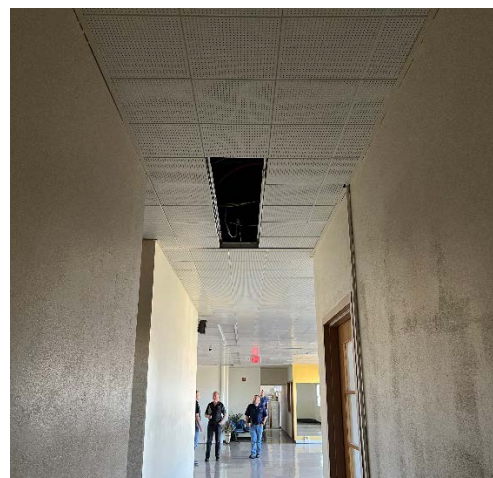
**Missing light fixture**

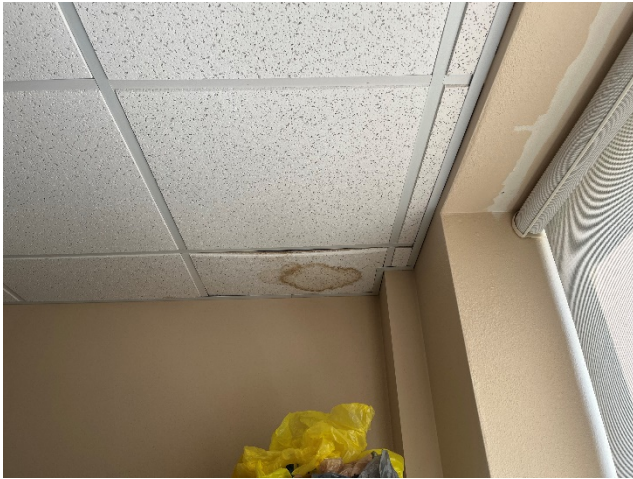
**Damaged ceiling tile – adjacent to IT room**

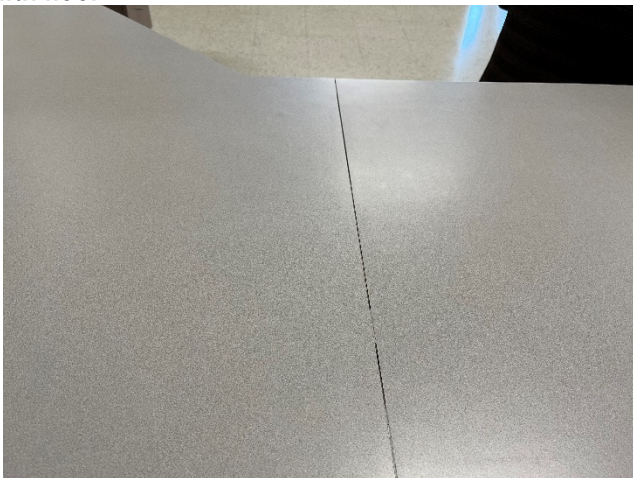
**Plastic laminate gap**

- A12.** Provide clear sealant at gap in plastic laminate. Recommend replacing cracked and de-laminated surface. If matching laminate is available, installer may be able to remove just damaged portion.

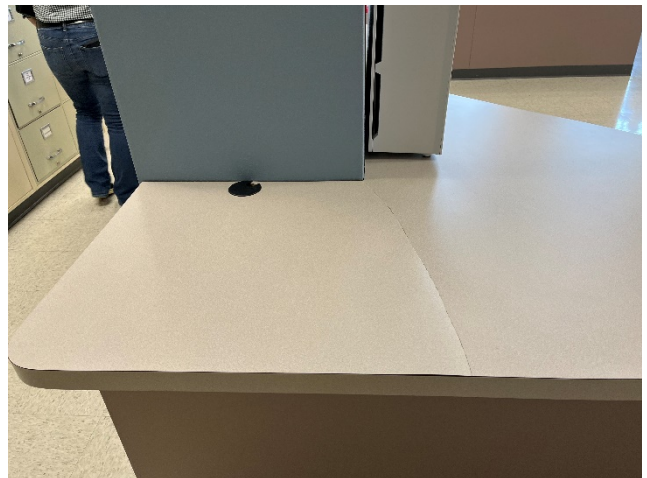
**Cracked, damaged plastic laminate**

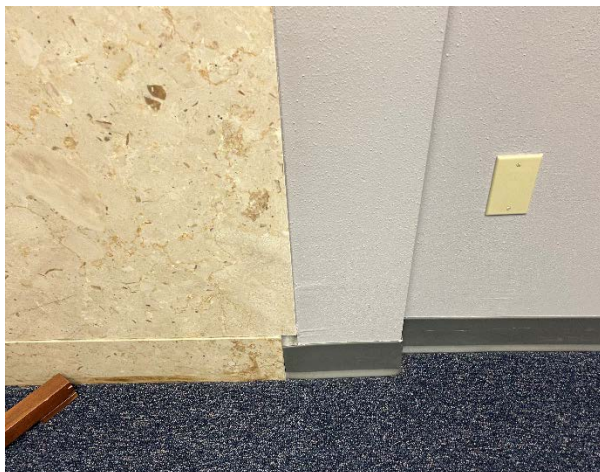
**Fill gap in wall**

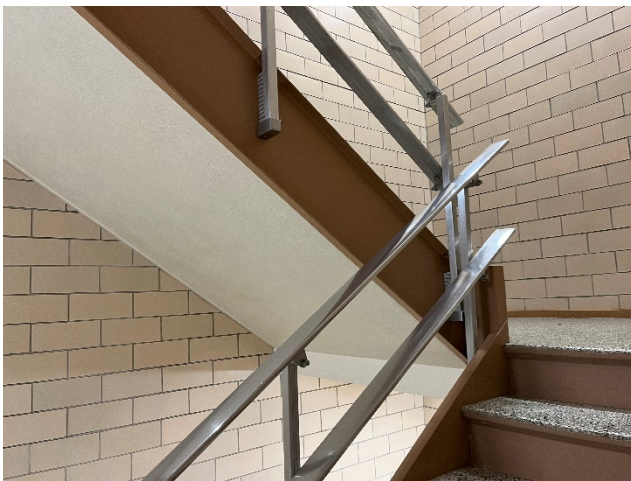
Large openings in open side of stair rails

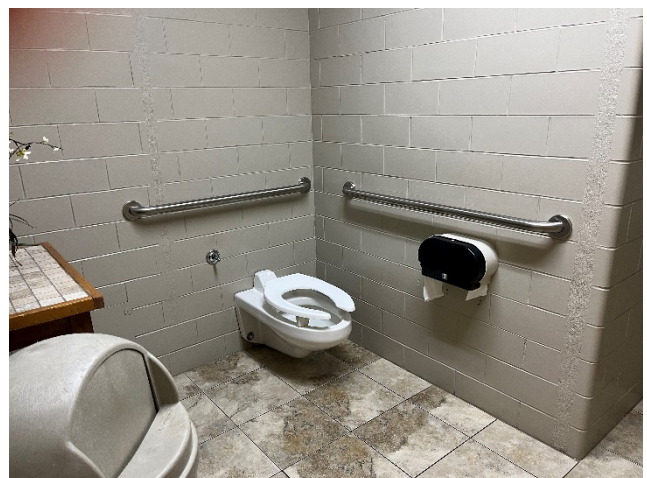
**5<sup>th</sup> floor: Typical missing vertical grab bar**

- CA4.** Relocate table in fifth floor accessible toilet room if persons with accessibility needs work on this floor.
- CA5.** As part of continuing maintenance program, continue to replace knob handles with lever handles.
- CA6.** Provide pipe protection. See Plumbing section of report for additional information.
- CA7.** Begin program to replace toilets in accessible toilet rooms to provide fixtures that meet seat height requirements. See Plumbing section of report for additional recommendations.
- CA8.** Re-mount grab bar in fourth floor toilet room to compliant height.

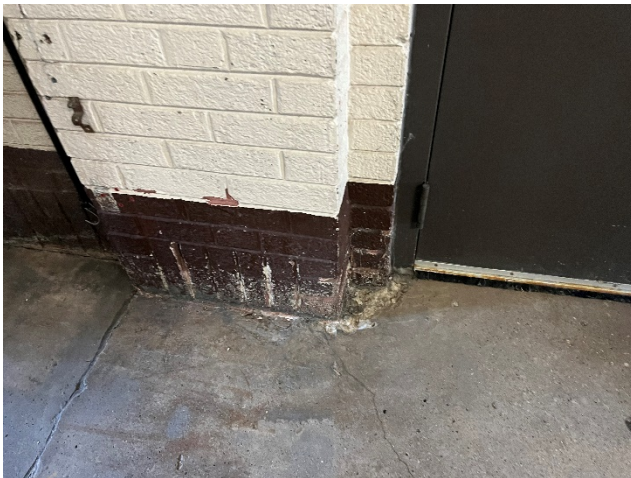
**Spalling brick due to moisture exposure**

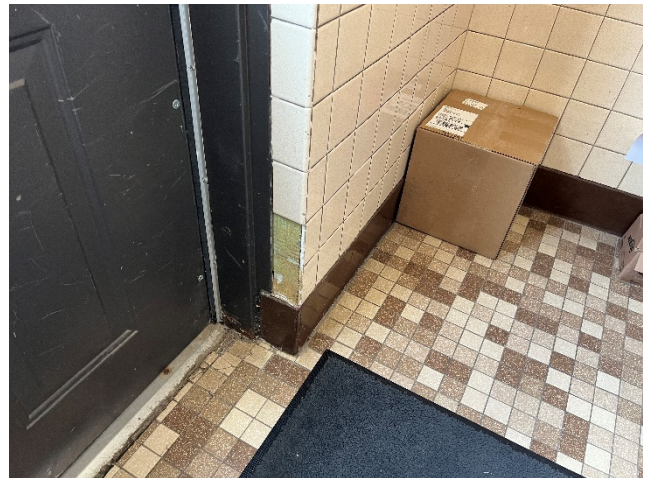
**Missing wall tile**

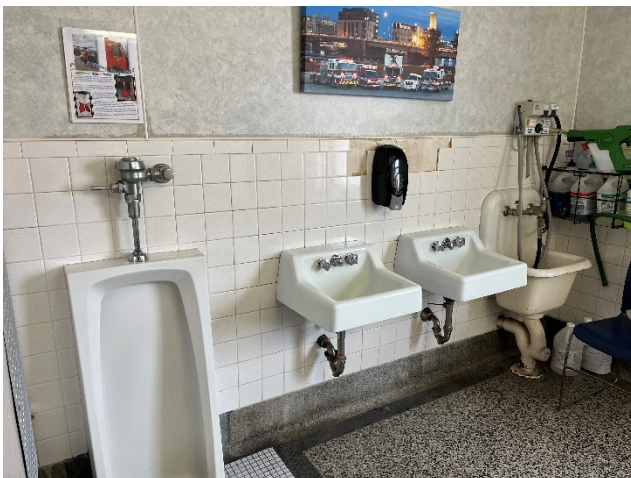
**Missing wall tile at plumbing wall**

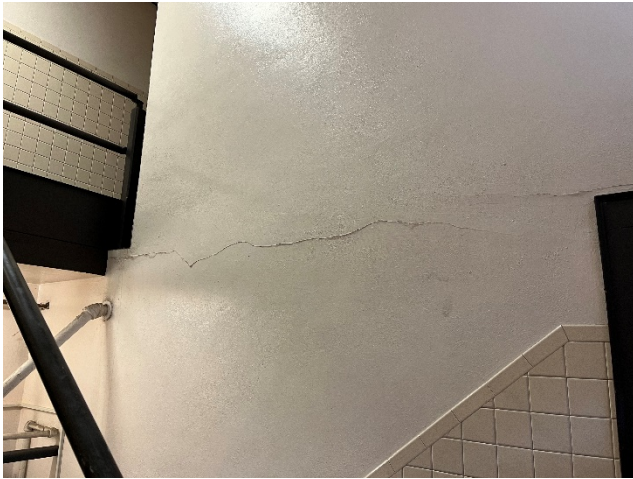
**Cracked plaster at stair**

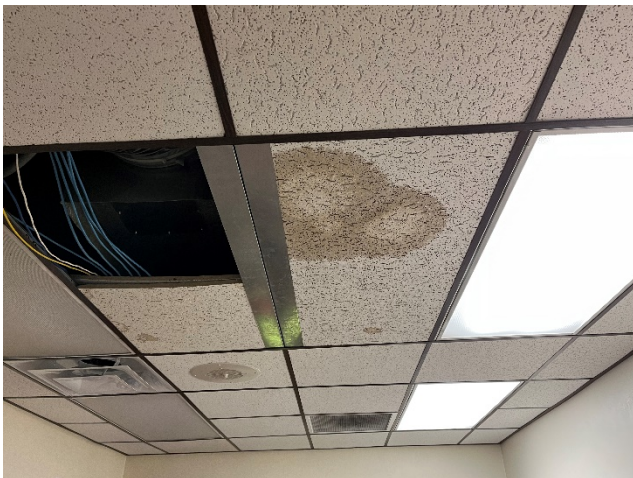
**Missing and stained ceiling tile**

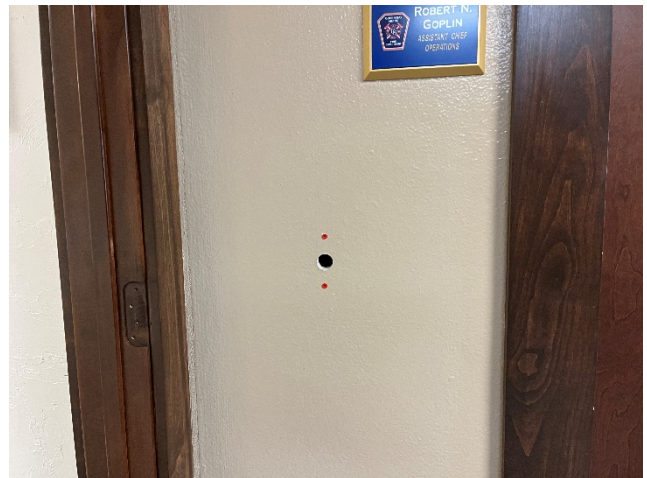
**Patch hole in wall**

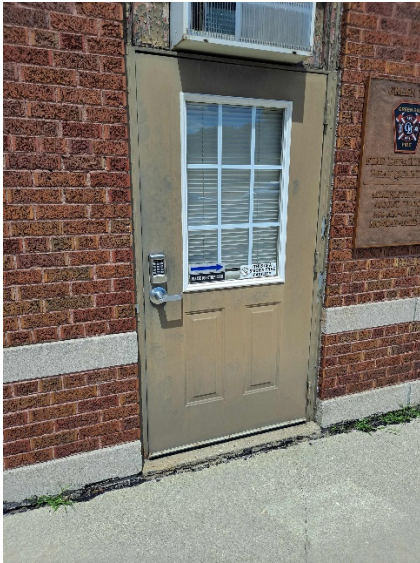
**Recommend threshold at entry**

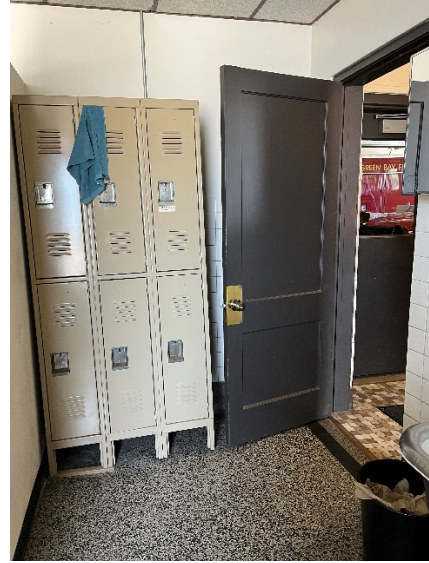
**Recommend lever door hardware**

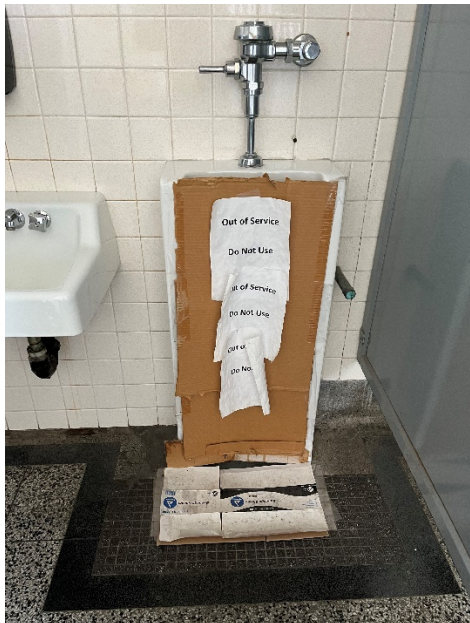
**Remove unused fixture**

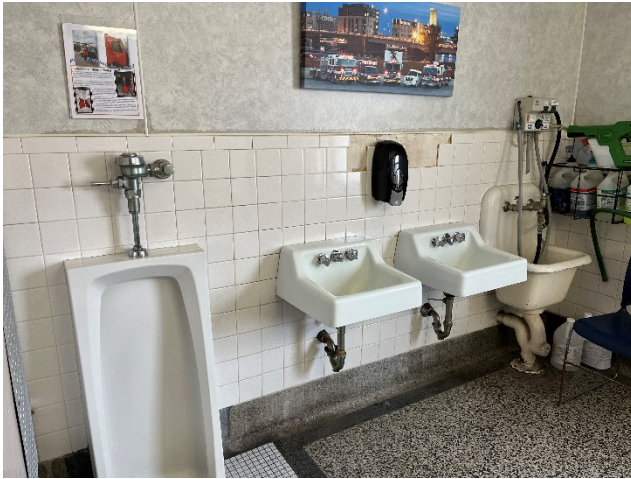
**Recommend lever faucet handles**

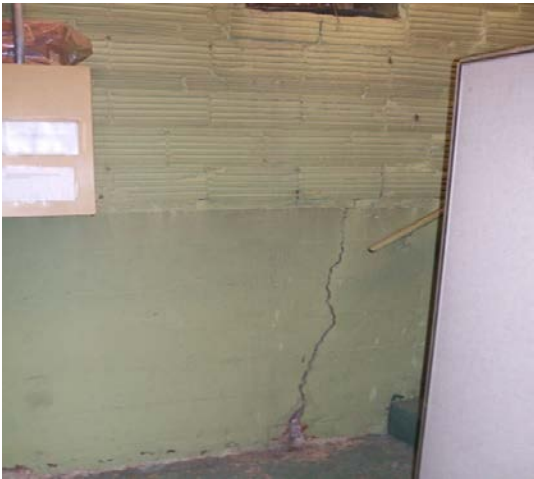
**Cracked foundation wall in generator room  
(Note S1)**

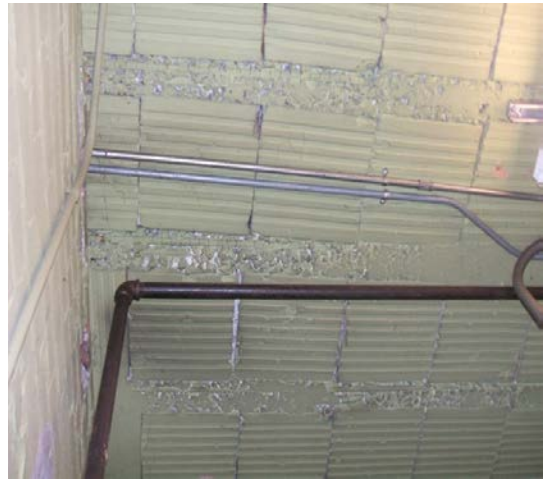
- S2.** There are five concrete joists above the generator room that have exposed reinforcing bars. Although this condition has been present since the original construction, reinforcing bars in joists require a minimum of 3/4" of concrete cover to maintain a 2-hour fire resistance for the slab assembly. Recommend application of cementitious repair mortar to develop required cover to steel reinforcing.

**Exposed reinforcing in joists above generator  
(Note S2)**

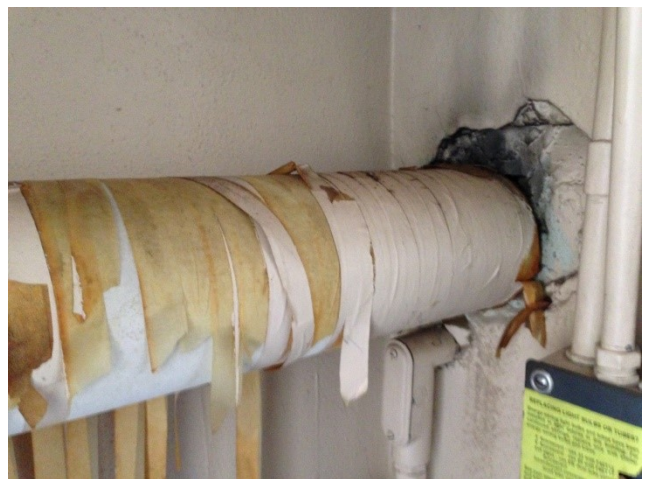
**Poor insulation condition**

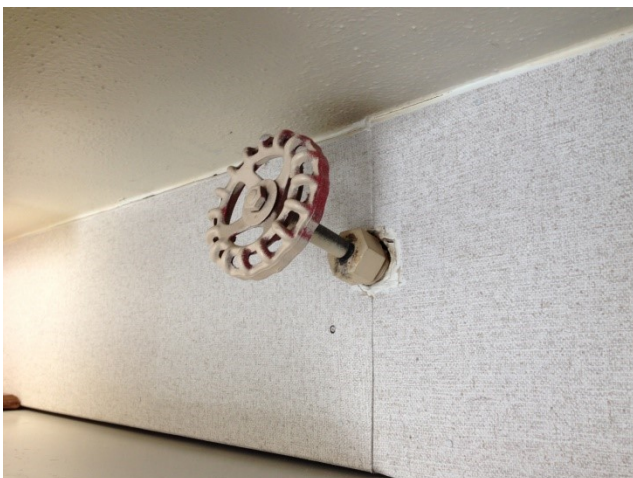
**Wall built over valve**

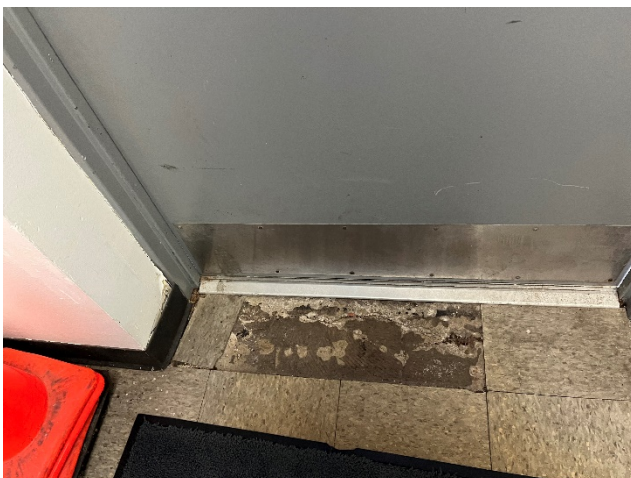
**Missing vinyl tile at back door**

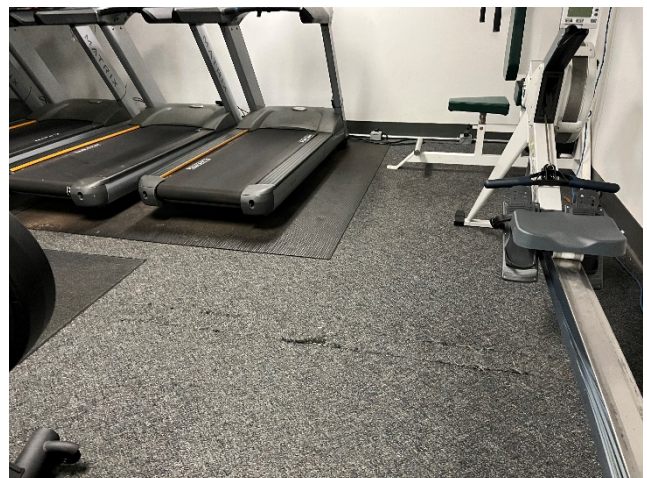
**Ripped carpet at cardio room**

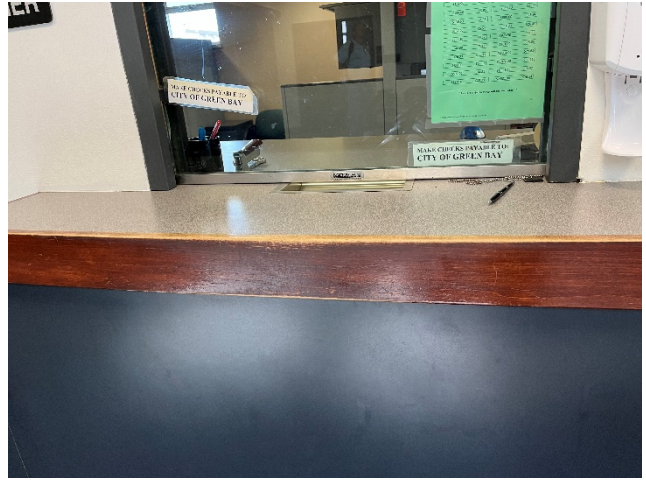
**Worn finish at reception counter**

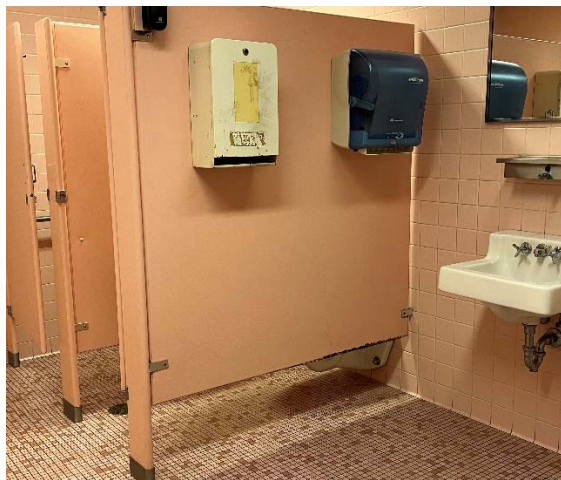
**Rusted bottom of women's toilet partitions**

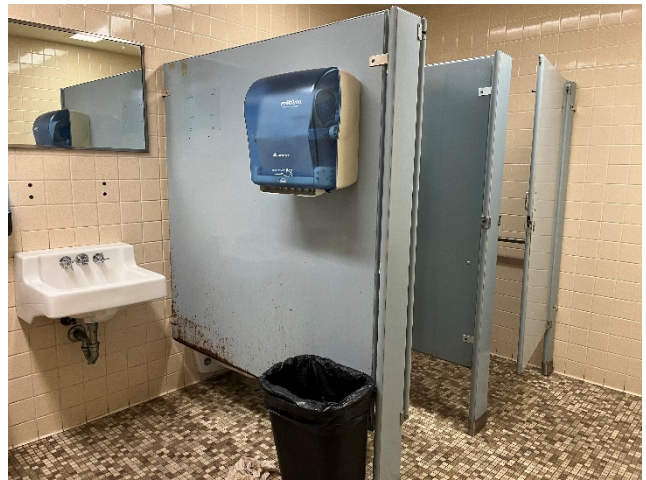
**Rusted bottom of men's toilet partitions**

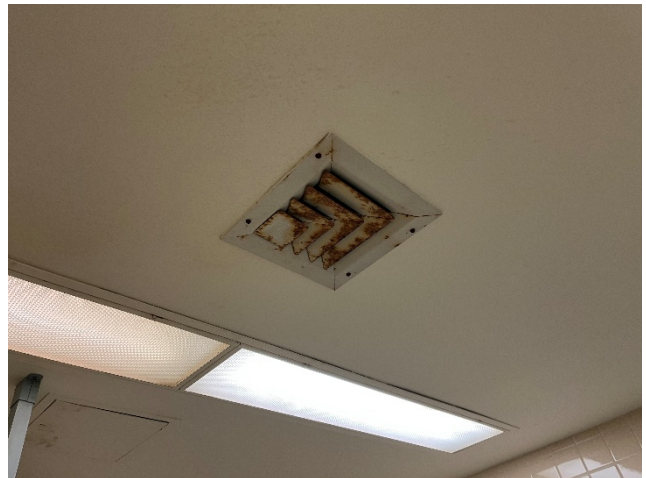
**Rusted ceiling diffuser at basement toilet room**

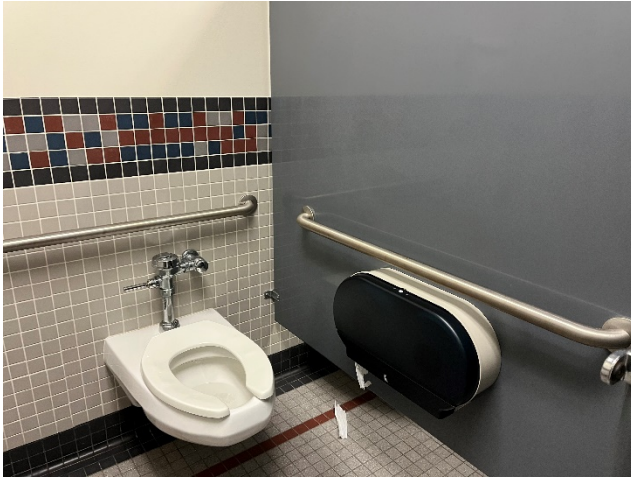
1<sup>st</sup> floor Women's – missing vertical grab bar

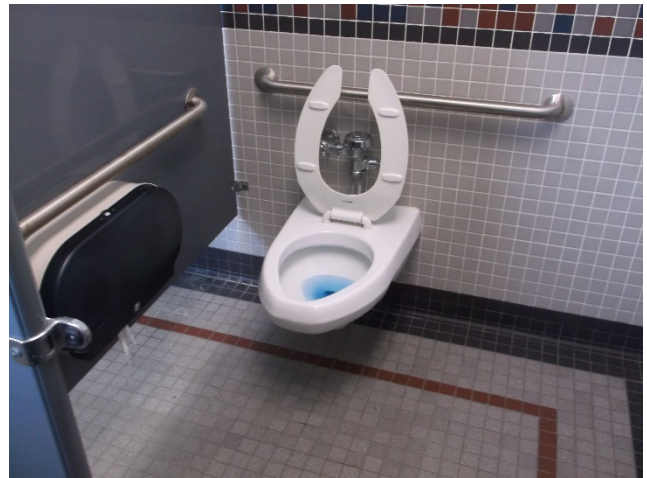
1<sup>st</sup> floor Men's – missing vertical grab bar

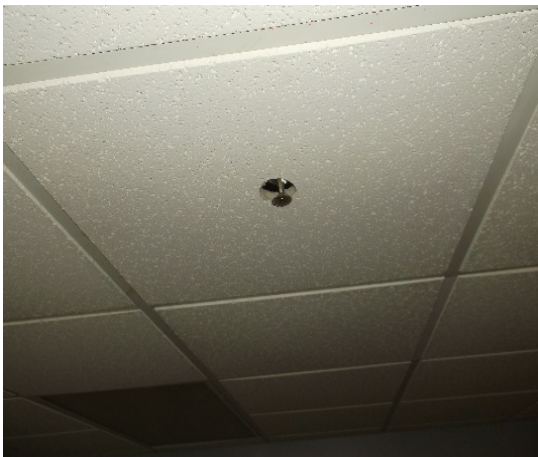
Sprinkler head – missing escutcheon

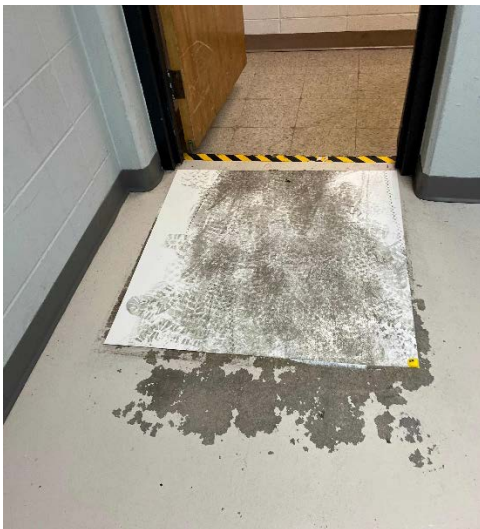
**Chipped paint at shooting gallery entry**

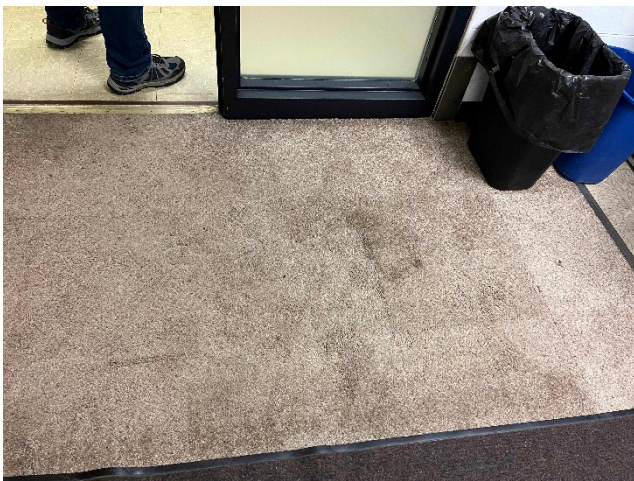
**Worn, stained cut-pile carpet**

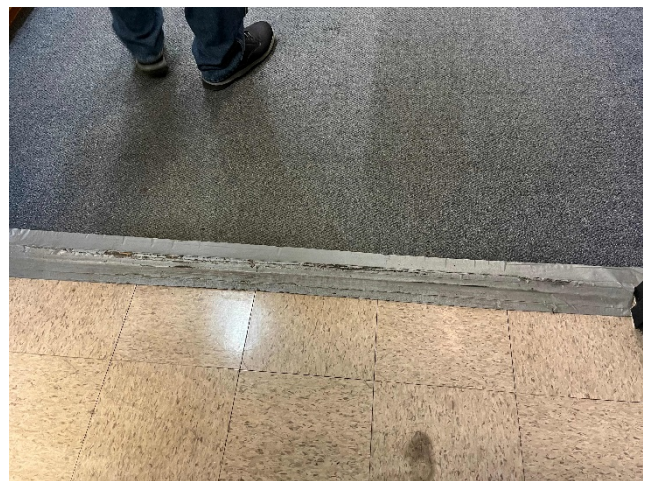
**Duct tape at transition from carpet to VCT**

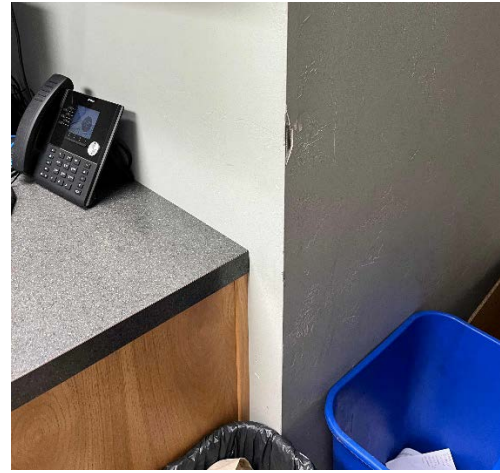
**Damaged corner – Range**

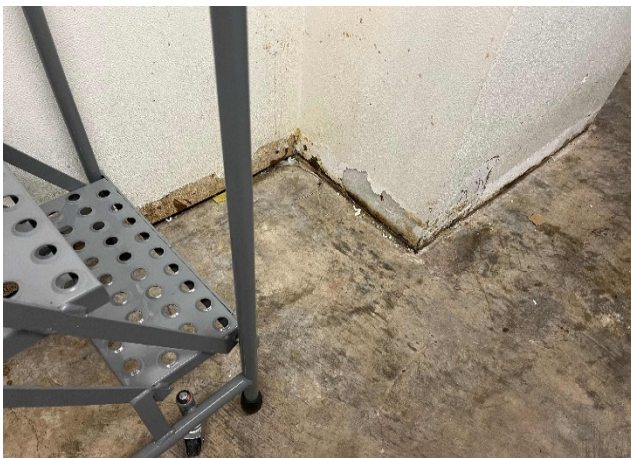
**Deteriorated base at high-density storage**

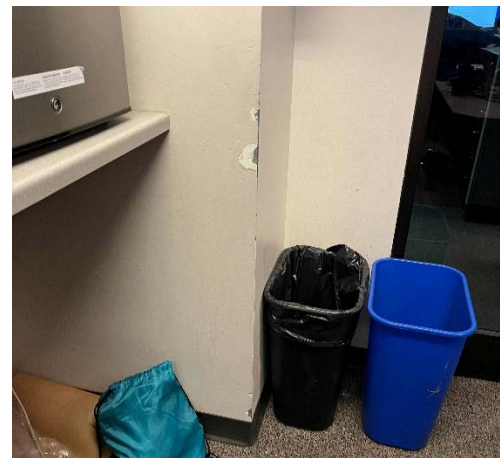
**Damaged corner – Shift Commander**

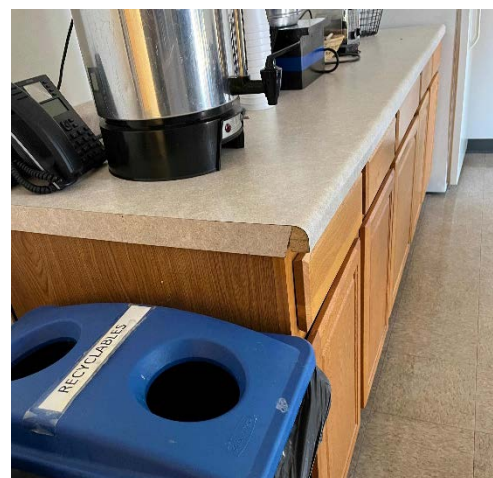
**Chipped plastic laminate**

- A8.** Repair chips and delamination in plastic laminate countertops: Evidence Lost & Found, 2<sup>nd</sup> floor break area.
- A9.** Replace missing and stained ceiling panels.

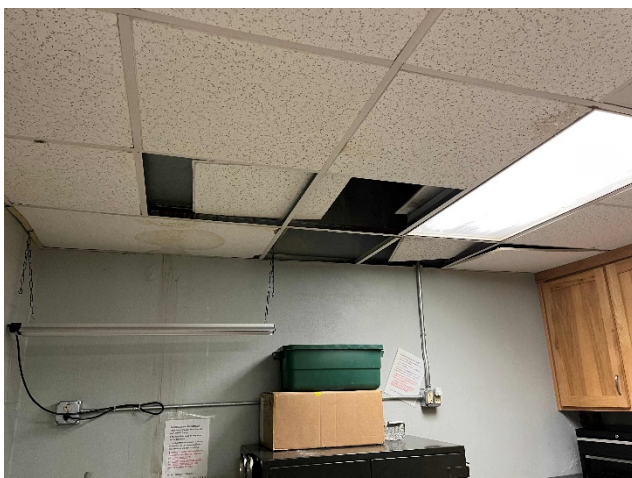
**Missing and misplaced ceiling tiles**

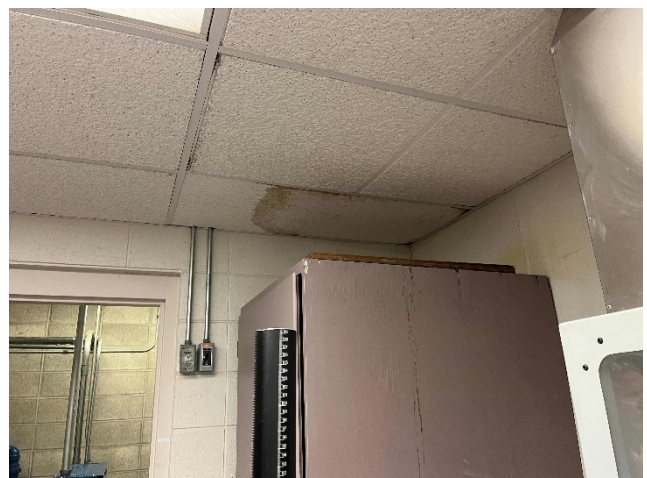
**Typical stained ceiling tile**

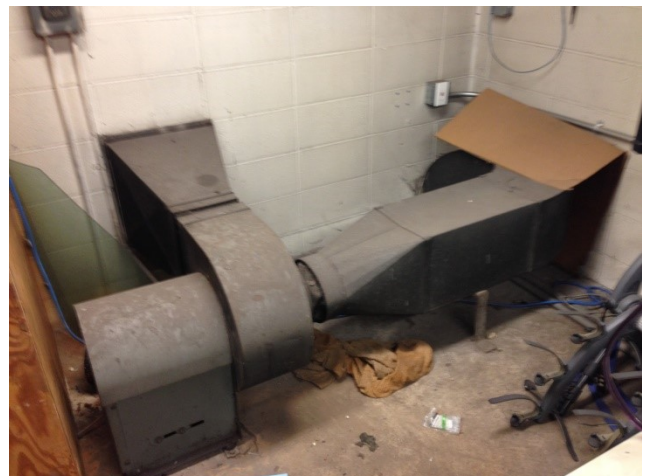
**Garage storage exhaust fan (old)**
