AGENDA OF THE AD HOC FACILITIES COMMITTEE

Report to the
Ad Hoc Facilities Committee
of the City of Green Bay

■ Existing Flow Analysis - City Hall | Green Bay, WI

Existing Flow Analysis - Police Department | Green Bay, WI

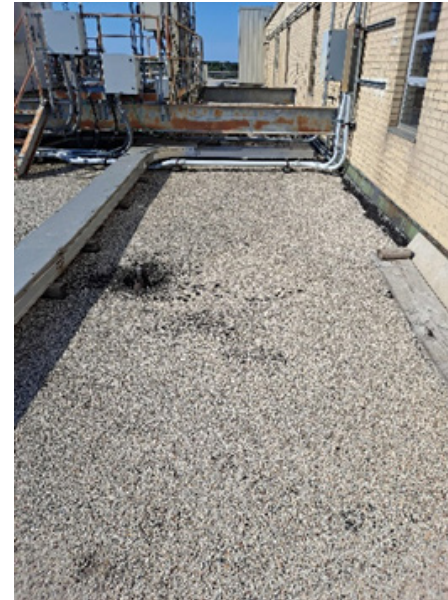
Existing roof - replace

The existing roof is a rubber membrane covered with a pea sized ballast system. It was recommended in our previous study in 2015 that the roof needed replacement in its entirety. This replacement work would also include the removal all of the copper flashings on the current roof. The roof of the existing mechanical penthouse should be replaced along with all damaged pre-cast concrete copings as these two roofs are the same age and condition. The existing roof is 11,170 sf with 500' of flashing and trim. The Mechanical Penthouse roof is 2,430 sf and has 250' of flashing that would be replaced.

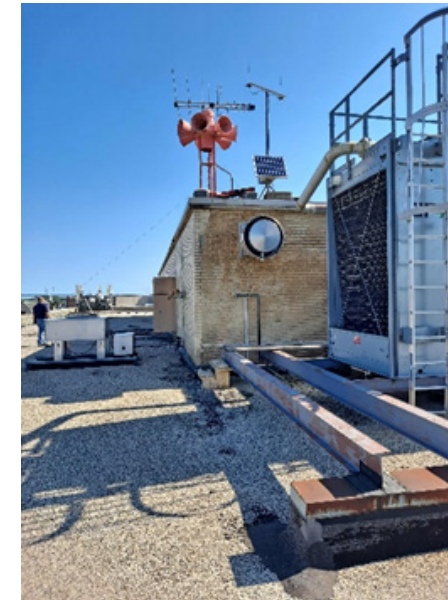
Existing roof - replace

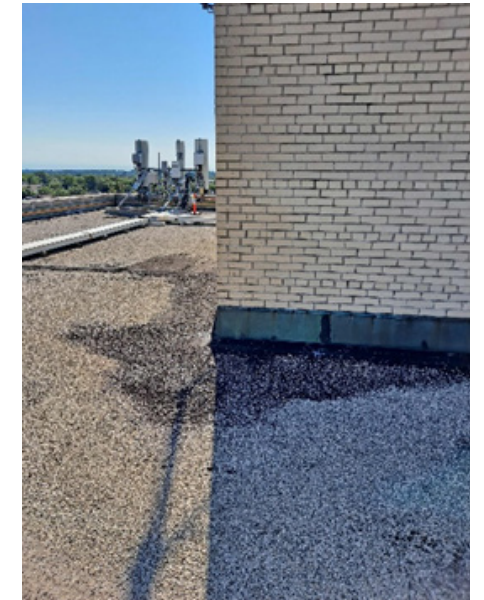
Mechanical penthouse - tuck pointing

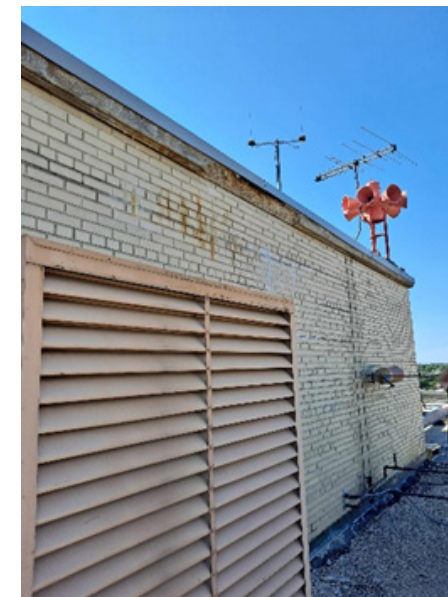
Penthouse pre-cast coping replacement

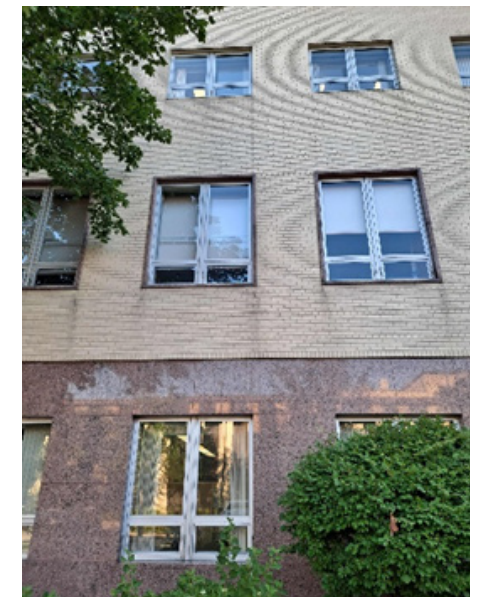
Replace exterior windows

The exterior windows are aluminum framed casement windows with single pane uninsulated glass panels. The interior of these windows has a secondary sliding, single-pane glass panel. These windows are not thermally broken, and the glass provides little or no insulation value to the building. In addition, there are numerous locations on the upper floors that are show signs of water damage at the jambs, which will get worse over time. It is highly recommended that all the windows should be replaced with a thermally broken frame with insulated low-E glass.

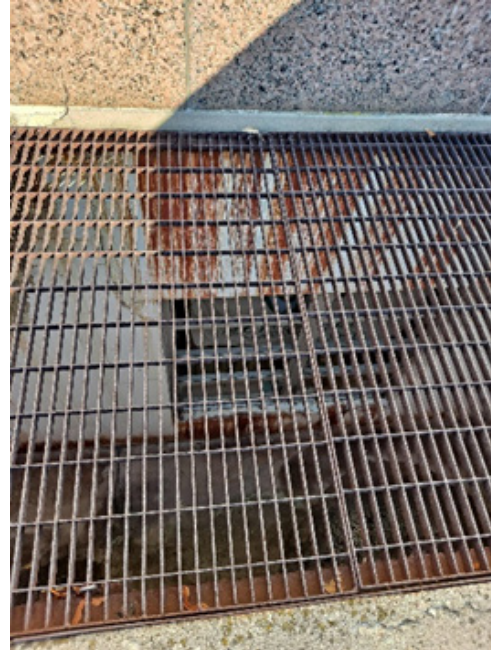
The window wells to the east have some rust staining below the grating and could be part of a maintenance cleaning program to maintain the exterior condition of the building.

Rust on window well walls

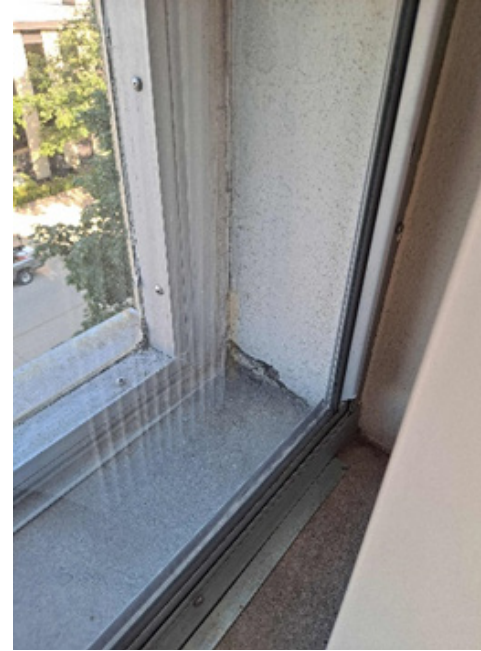
Rust on window well walls

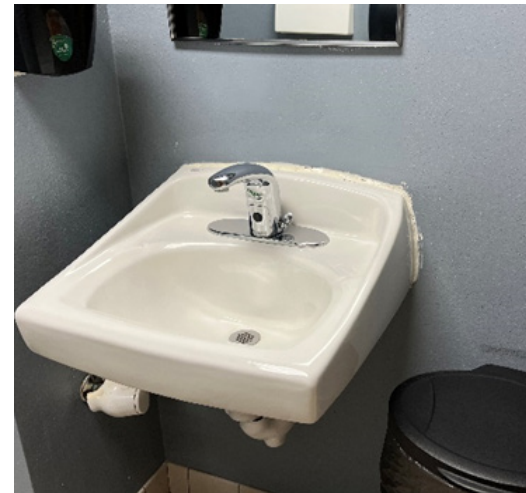
Excessive sealant at lavatory

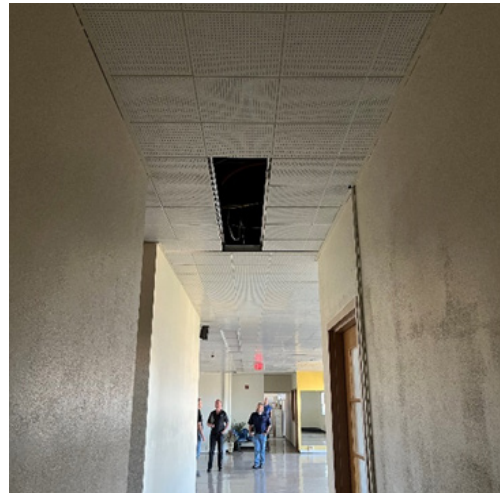
•Missing light fixture at internal corridor of unused space.
•Loose spline ceiling tiles at several areas of unused space.
•Water-stained ceiling panel at room outside of IT space. Adjacent window head has either unmatched paint or patched area.

Missing light fixture

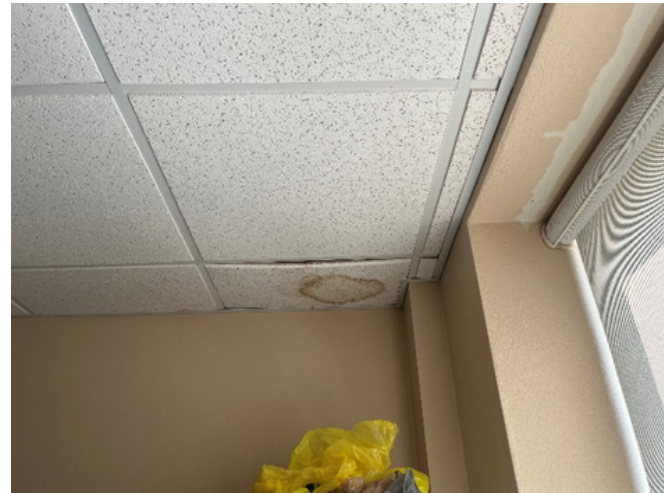
Damaged ceiling tile – adjacent to IT room

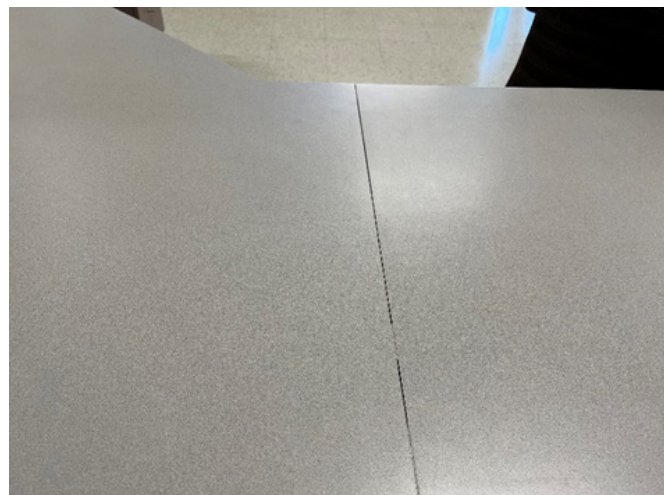
•Gap in plastic laminate countertop.
•Crack and de-laminated area of plastic laminate countertop at wall corner intersection.

Plastic laminate gap

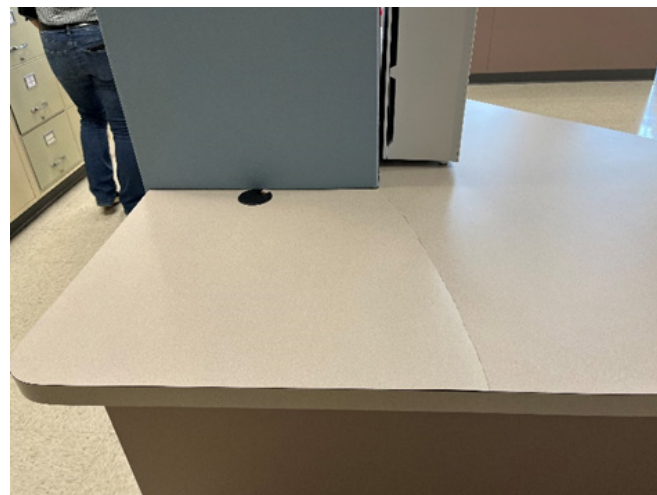
Cracked, damaged plastic laminate

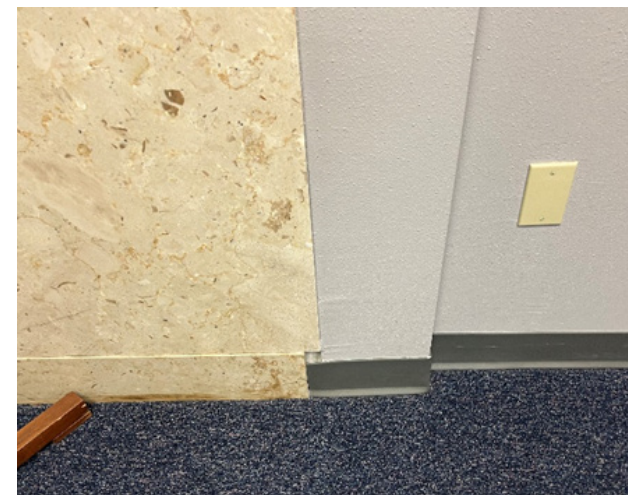
Fill gap in wall

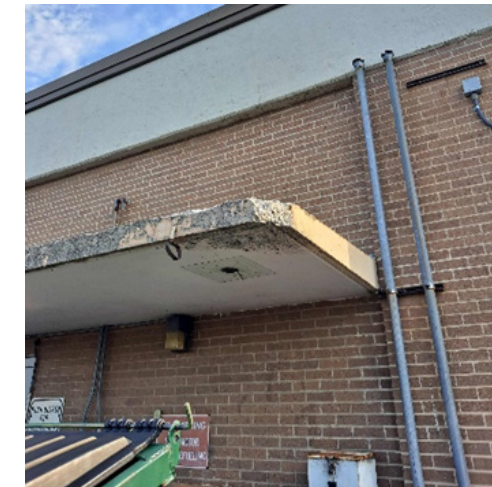
Damaged canopy

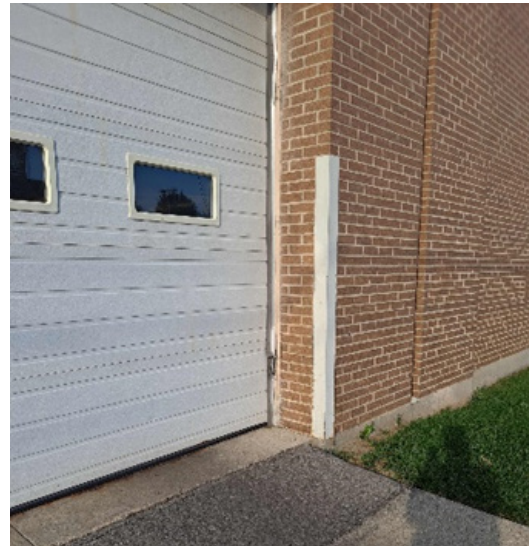
Damaged door jamb and door track

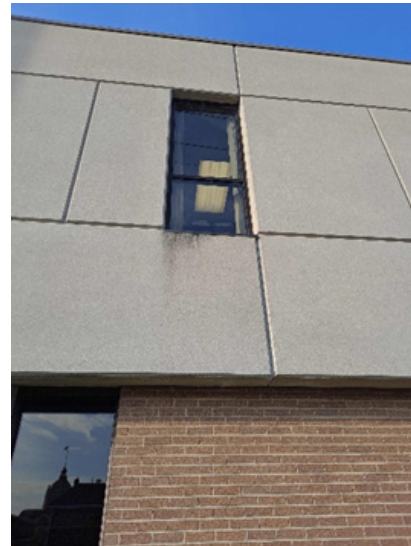
Streaking below windows

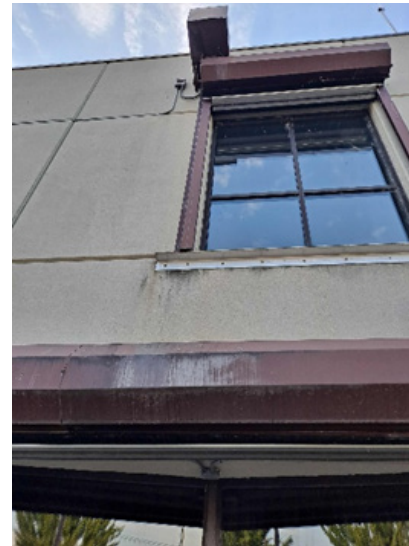
Window housing faded and rusting

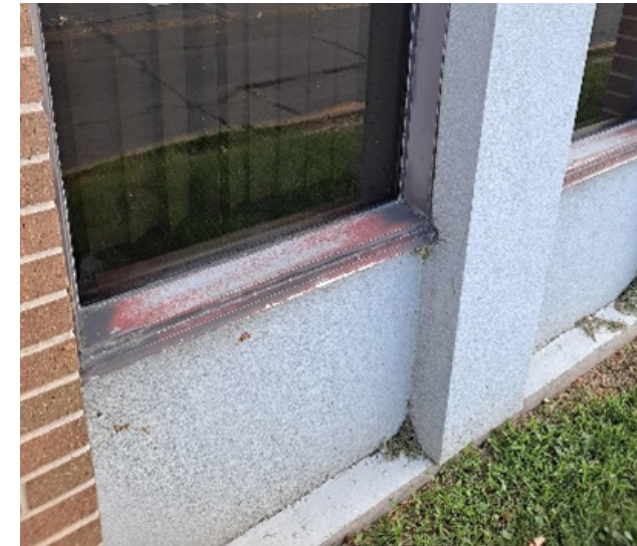
Faded metal window trim

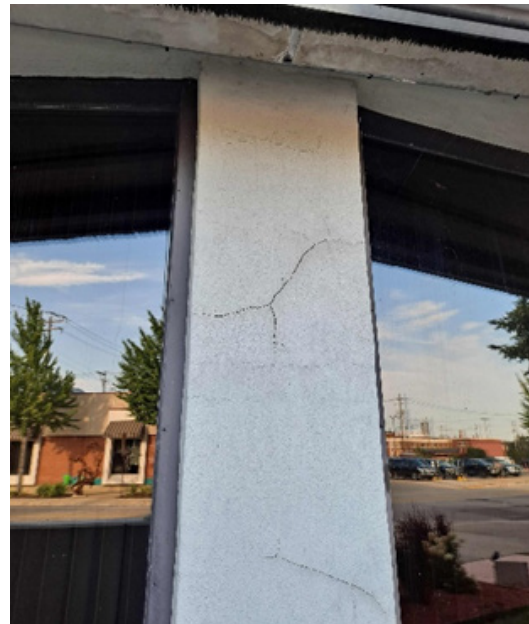
Cracked Concrete Between Windows - Cracks in the concrete between windows can allow moisture infiltration, leading to further damage and potentially affecting the building's structural integrity.

Cracked concrete between windows

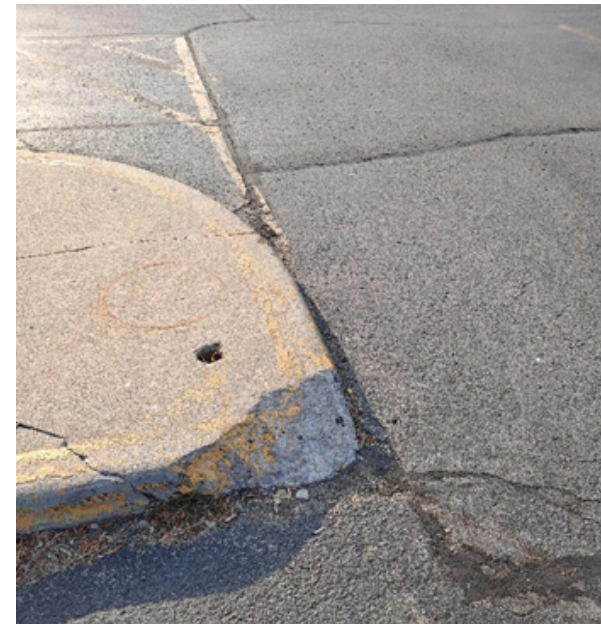
Damaged concrete curb

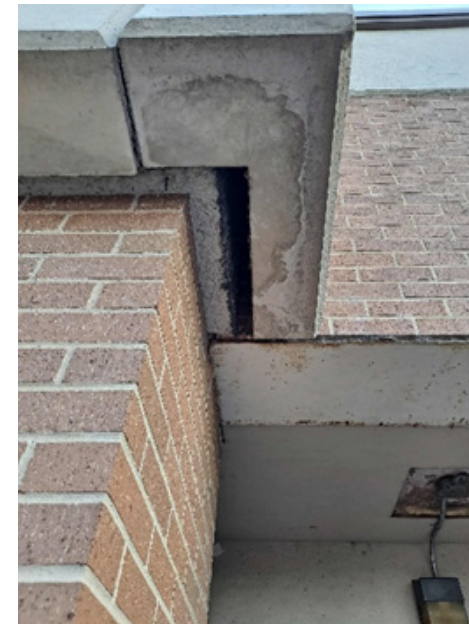
Gaps under precast concrete panels

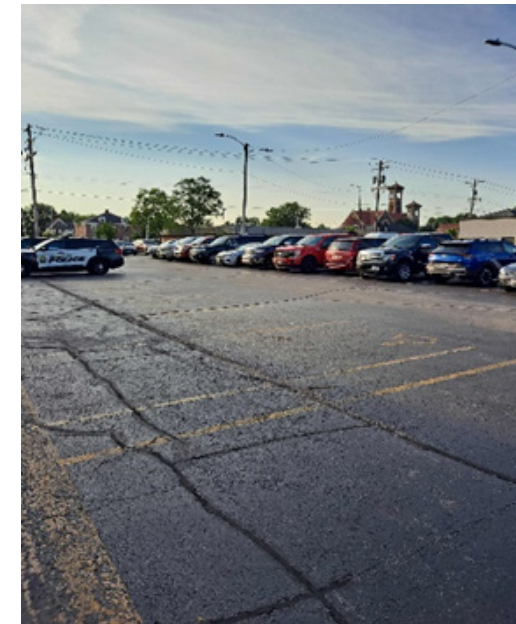
Previous sealing of asphalt cracks

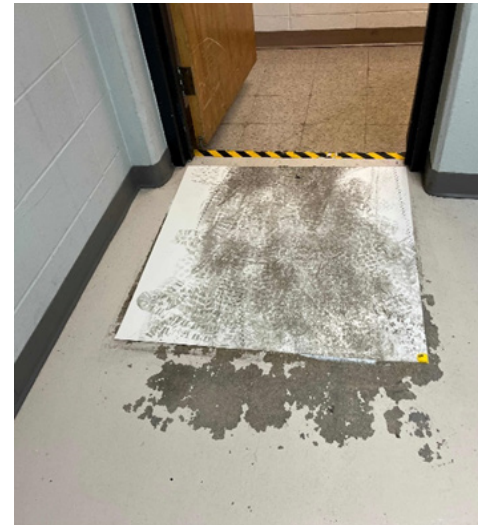
Chipped paint at shooting gallery entry

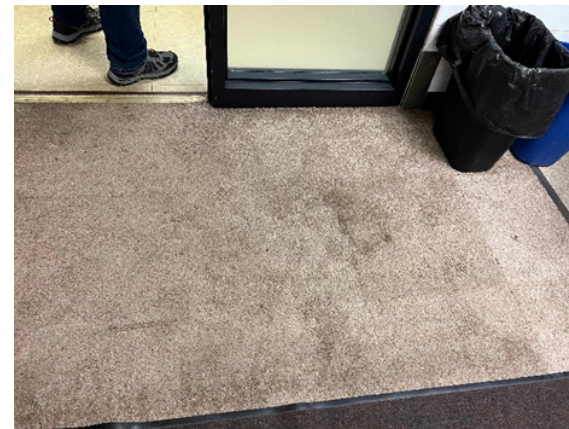
Worn, stained cut-pile carpet

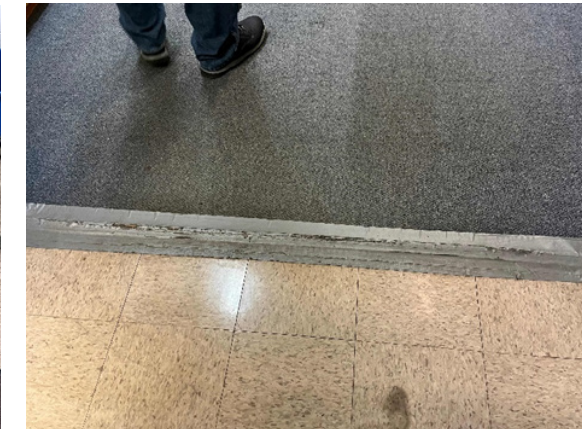
Duct tape at transition from carpet to VCT

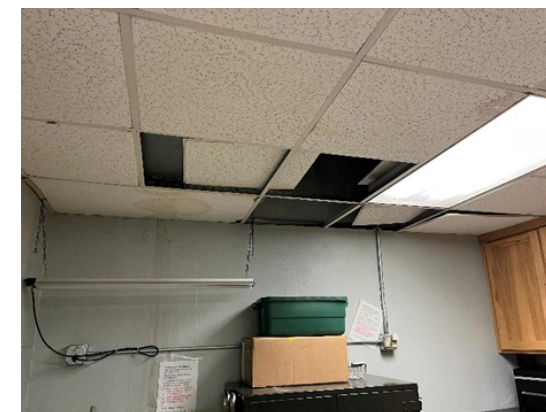
Missing and misplaced ceiling tiles

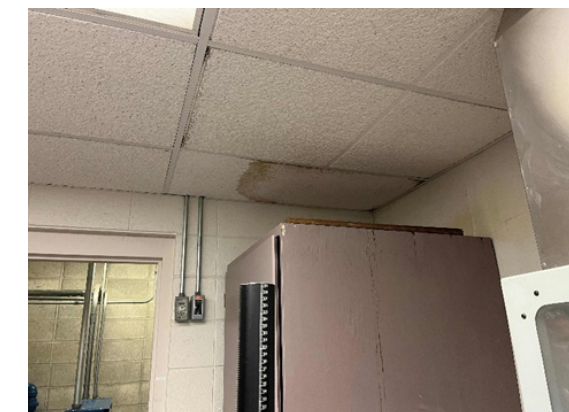
Many ceiling tiles are stained or missing, especially on the basement level.

Typical stained ceiling tile

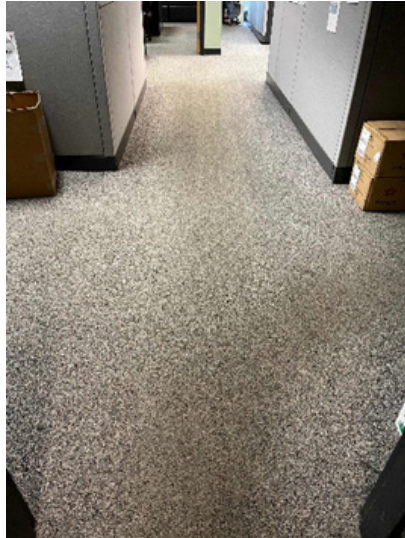
Worn carpet at office area

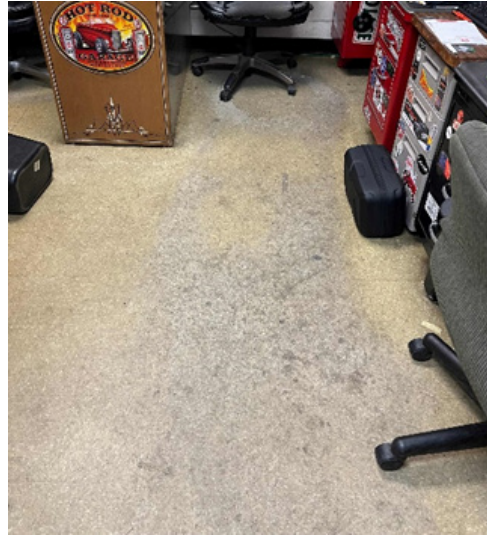
Worn VCT at shop office

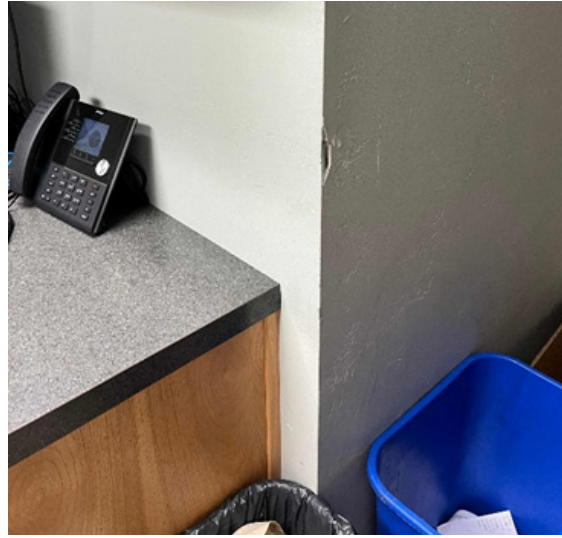
Damaged corner - Range

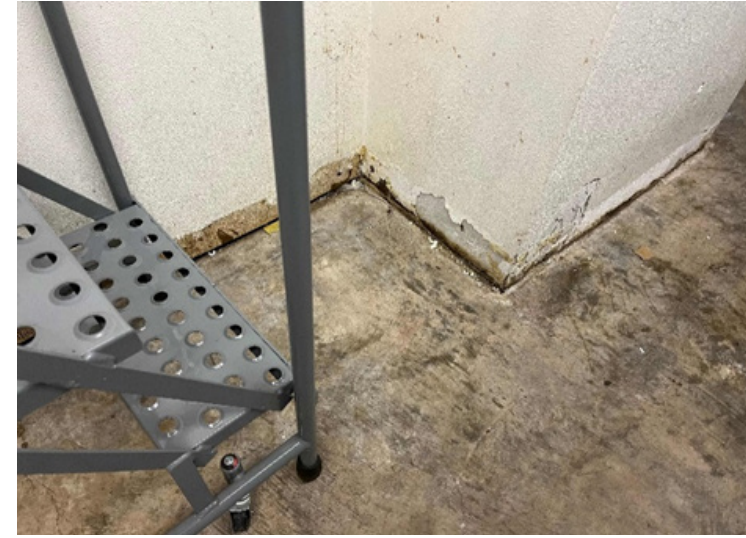
Deteriorated base at high-density storage

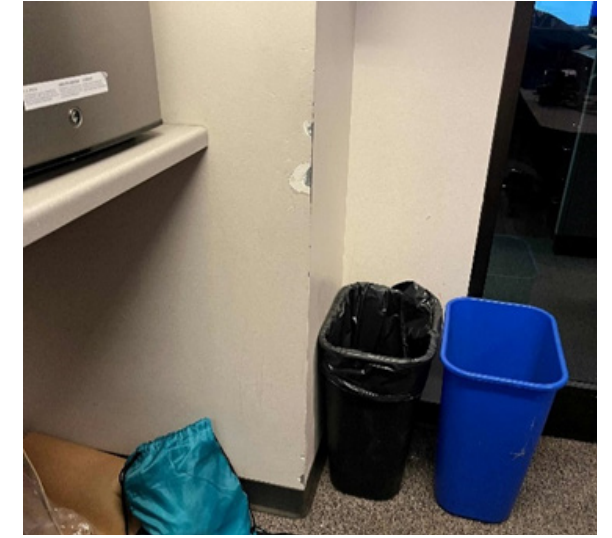
Damaged corner - Shift Commander

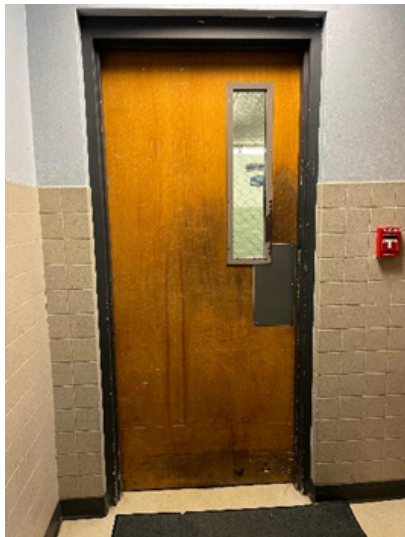
Chipped paint at lite and
damaged wood finish
Missing kick plate

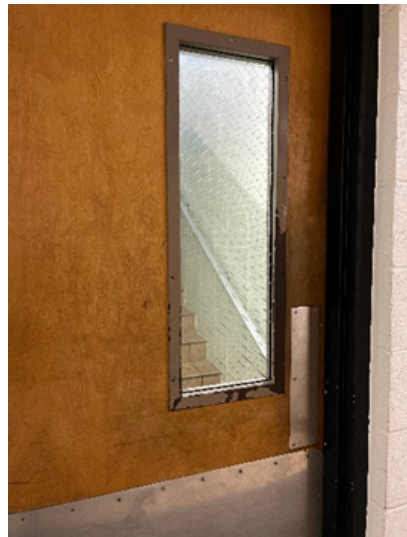
Chipped paint at lite and
damaged wood finish

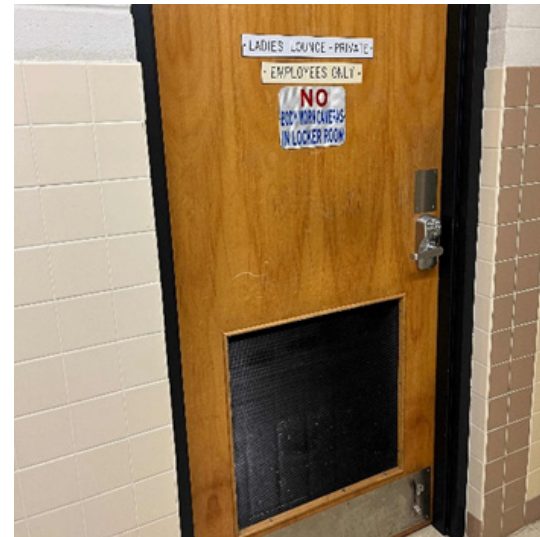
Scratched wood veneer

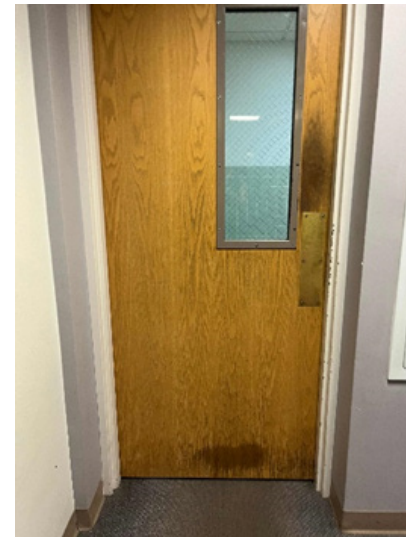
Damaged wood veneer &
missing kick plate

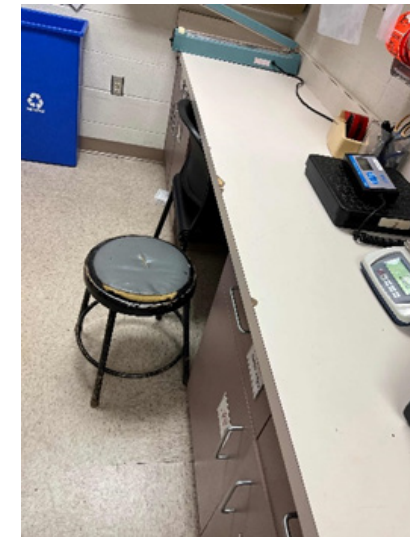
Plastic laminate casework
condition

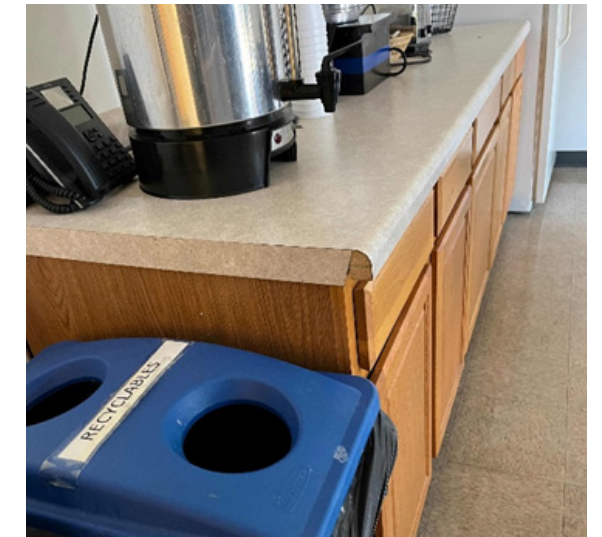
Chipped plastic laminate

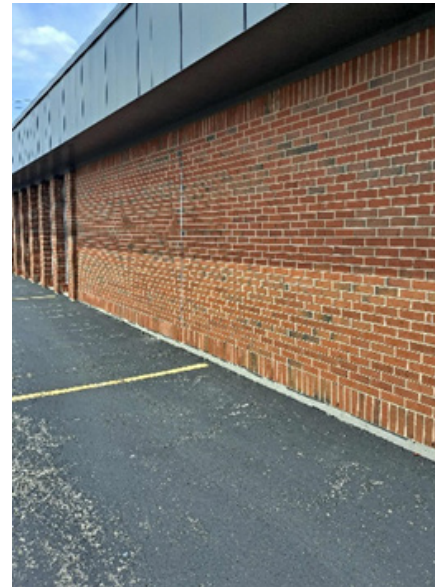
Exterior brick in good condition

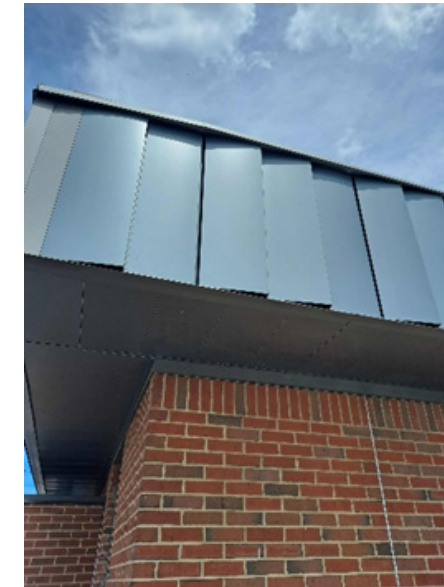
Aluminum fascia panels

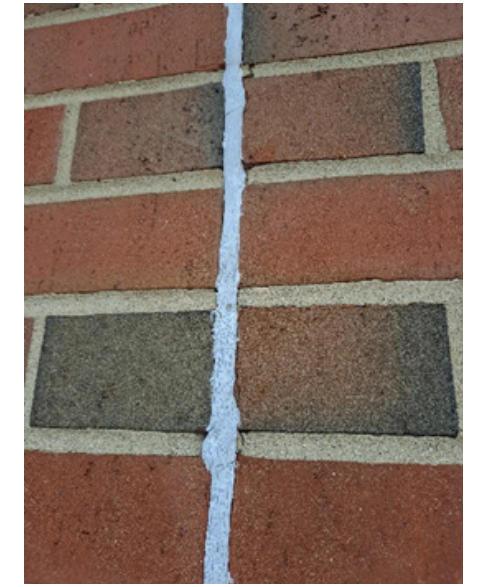
Dried and cracking expansion joint material

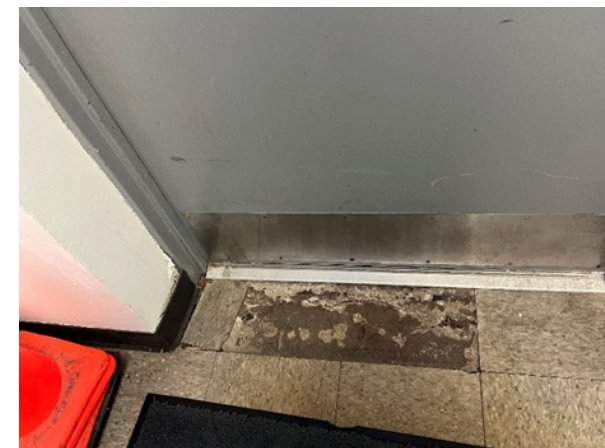
Missing vinyl tile at back door

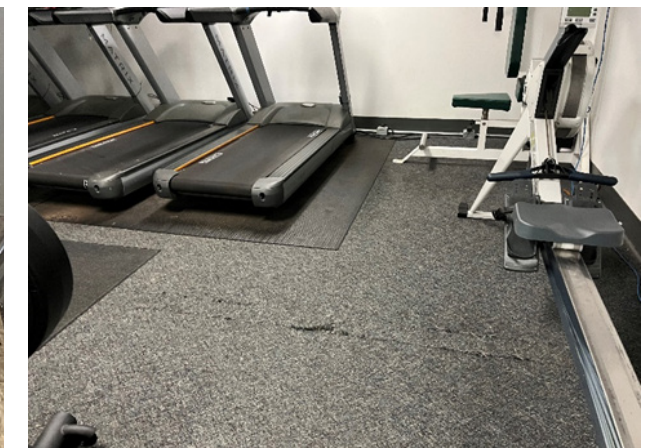
Ripped carpet at cardio room

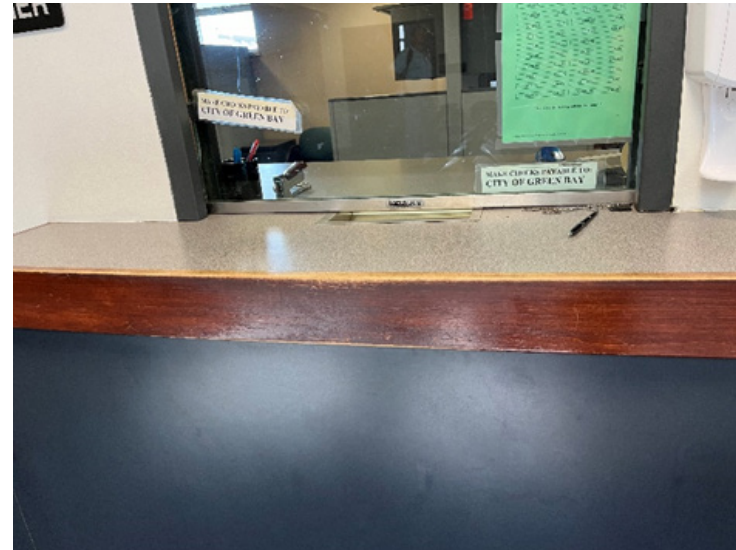
Toilet partitions in basement are rusting at the lower edges. Most casework is in good condition. The wood trim along the patron side of the reception desk has worn finish off the edges.

Worn finish at reception counter

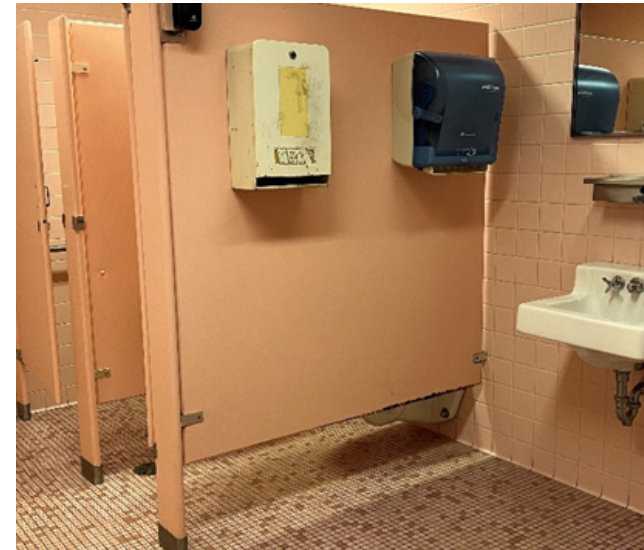
Rusted bottom of women's toilet partitions

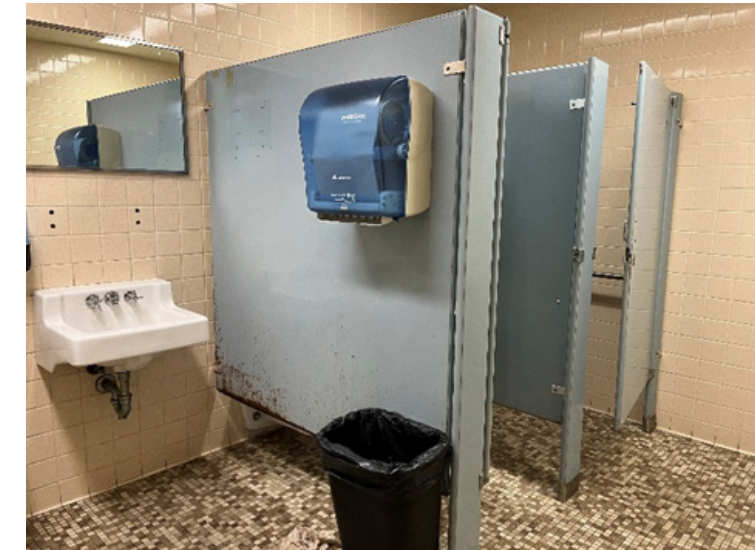
Rusted bottom of men's toilet partitions

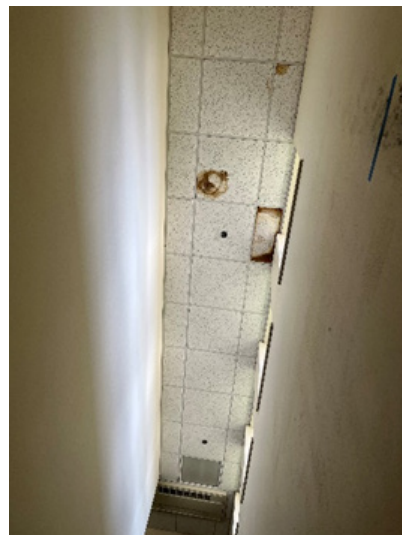
Ceiling at front stair shaft

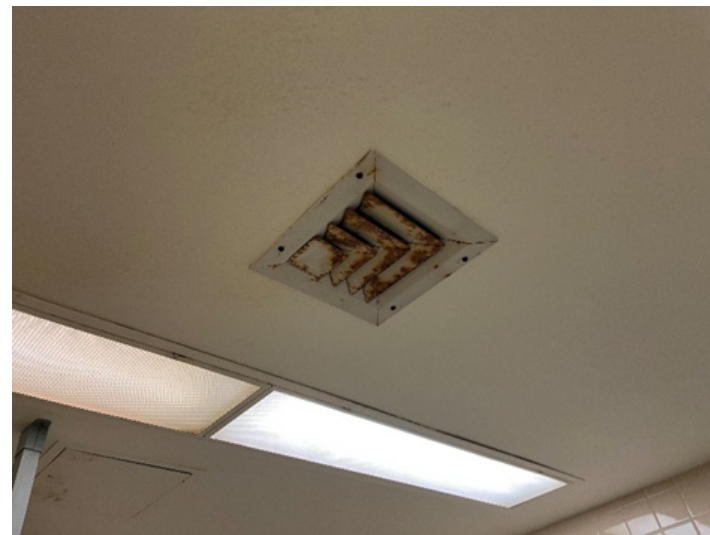
Rusted ceiling diffuser at basement toilet room

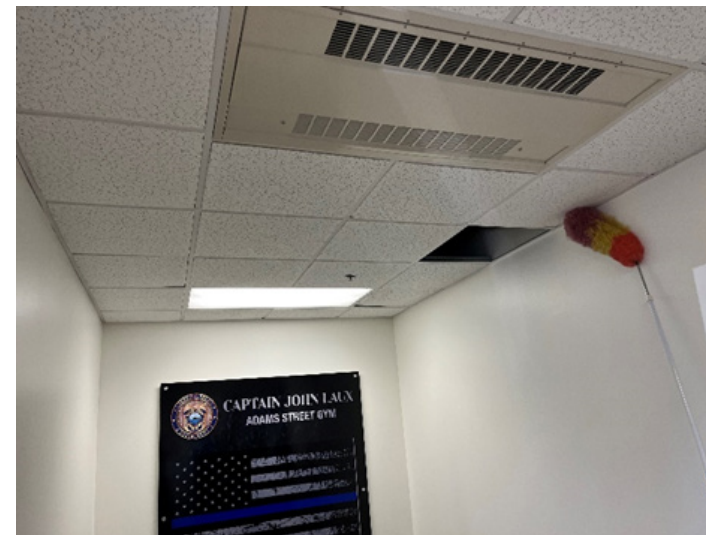
Missing ceiling tile at back stair shaft
