# AGENDA OF THE FINANCE COMMITTEE

**TUESDAY, NOVEMBER 28, 2023, 4:30 PM**

An assessment of City Hall was conducted in 2015 by Berners Schober with an update in 2022, which reviewed the condition of the building’s architectural, structural, mechanical, plumbing, and electrical elements. This report is a flow analysis, studying and noting the observed deficiencies.

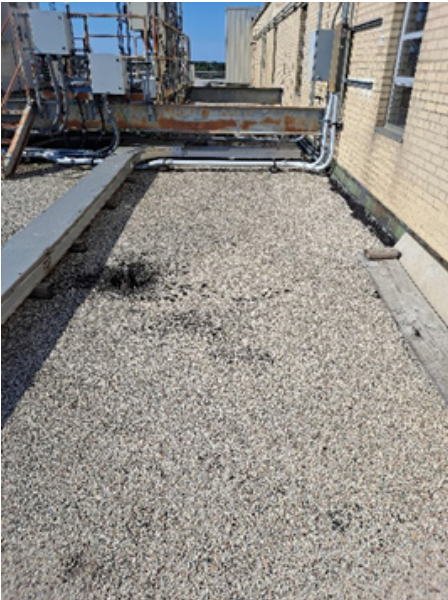
**roof**  
The existing roof is a rubber membrane covered with a pea sized ballast system. It was recommended in our previous study in 2015 that the roof needed replacement in its entirety. This replacement work would also include the removal all of the copper flashings on the current roof. The roof of the existing mechanical penthouse should be replaced along with all damaged pre-cast concrete copings as these two roofs are the same age and condition. The existing roof is 11,170 sf with 500’ of flashing and trim. The Mechanical Penthouse roof is 2,430 sf and has 250’ of flashing that would be replaced.

Existing roof - replace

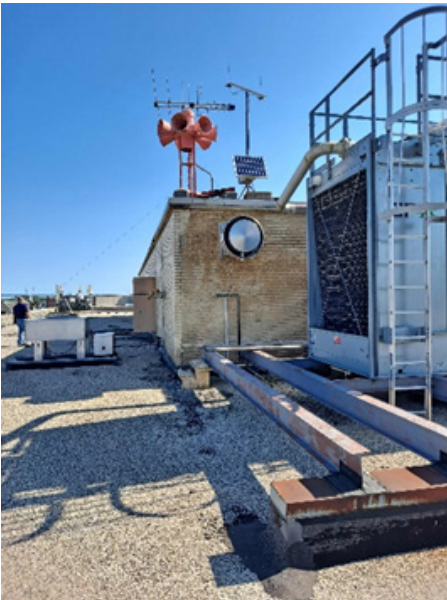
Existing roof - replace

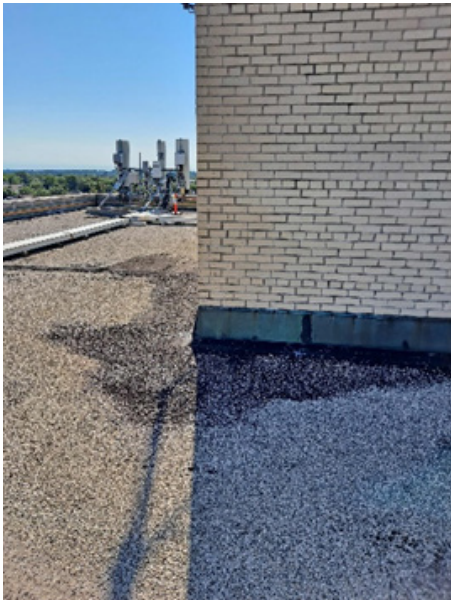
**exterior walls**  
The exterior of the building is clad on the first floor with granite panels. These panels are in very good condition for a building of this age. The upper five stories are clad with a cream-colored face brick. From observance at the ground level most of the brick appears to be in good condition. The building could be power washed to clean the streaking from window ledges above. There are more than likely a few areas in which tuck pointing might be required but were not visible from the ground.

Mechanical penthouse - tuck pointing

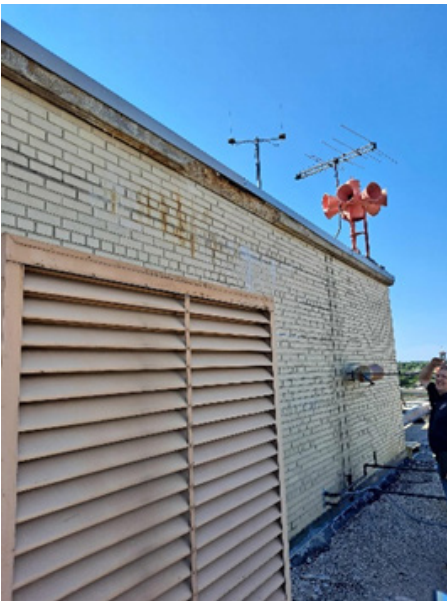
Penthouse pre-cast coping replacement

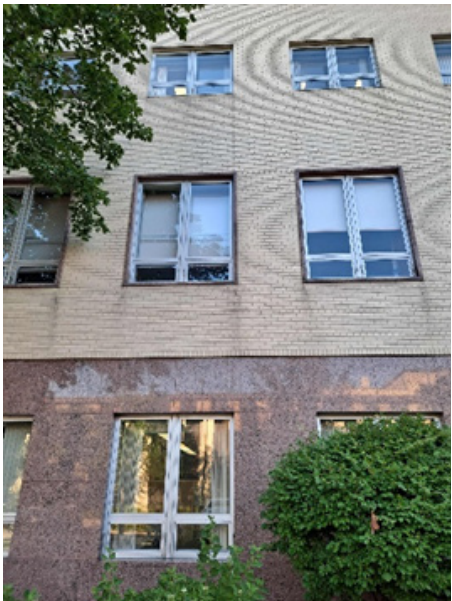
The exterior windows are aluminum framed casement windows with single pane uninsulated glass panels. The interior of these windows has a secondary sliding, single-pane glass panel. These windows are not thermally broken, and the glass provides little or no insulation value to the building. In addition, there are numerous locations on the upper floors that are show signs of water damage at the jambs, which will get worse over time. It is highly recommended that all the windows should be replaced with a thermally broken frame with insulated low-E glass.

Replace exterior windows

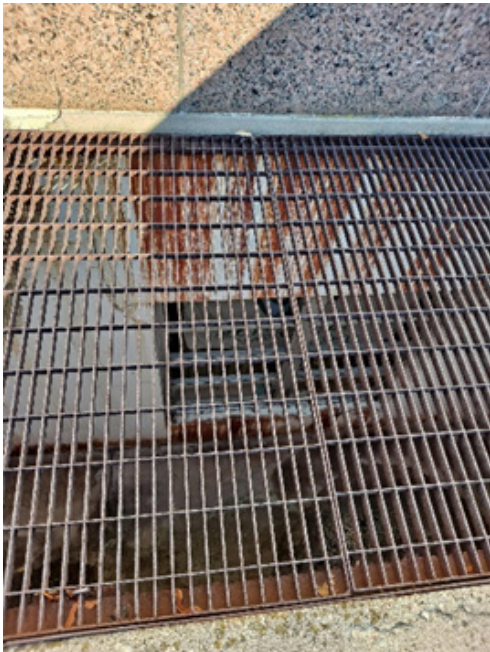
The window wells to the east have some rust staining below the grating and could be part of a maintenance cleaning program to maintain the exterior condition of the building.

Rust on window well walls

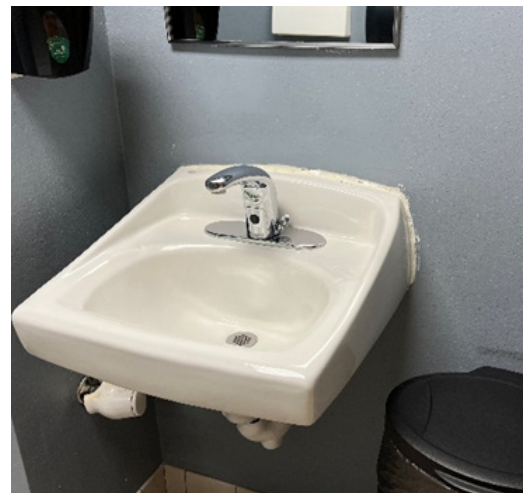
Excessive sealant at lavatory

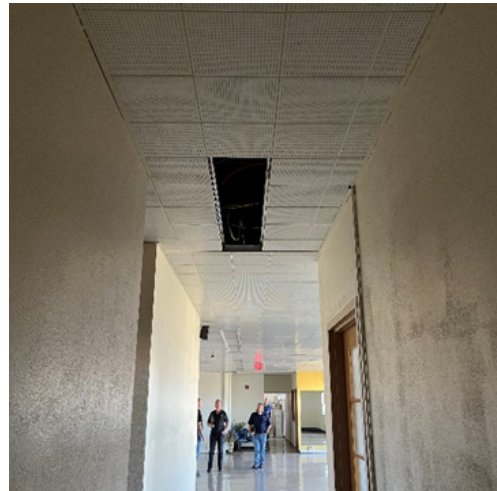
•Missing light fixture at internal corridor of unused space.  
•Loose spline ceiling tiles at several areas of unused space.  
•Water-stained ceiling panel at room outside of IT space. Adjacent window head has either unmatched paint or patched area.

Missing light fixture

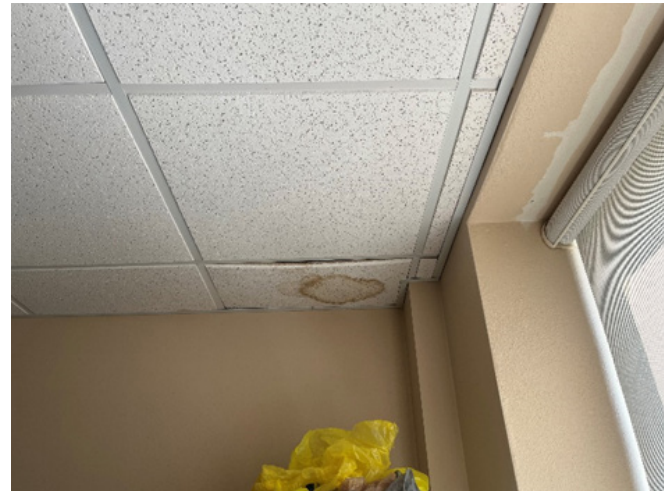
Damaged ceiling tile – adjacent to IT room

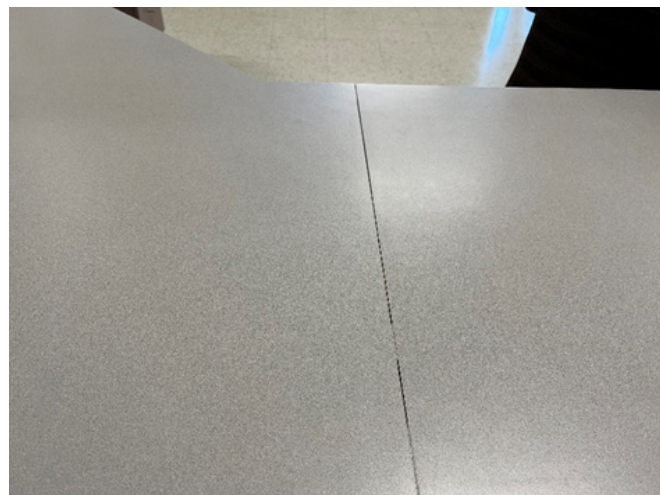
•Gap in plastic laminate countertop.  
•Crack and de-laminated area of plastic laminate countertop at wall corner intersection.

Plastic laminate gap

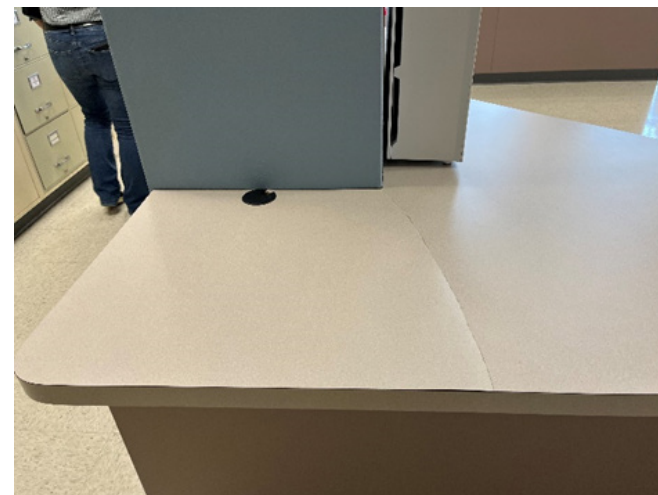
Cracked, damaged plastic laminate

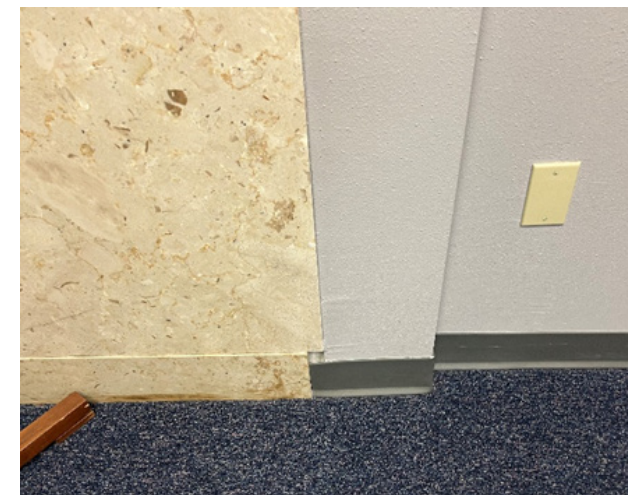
Fill gap in wall

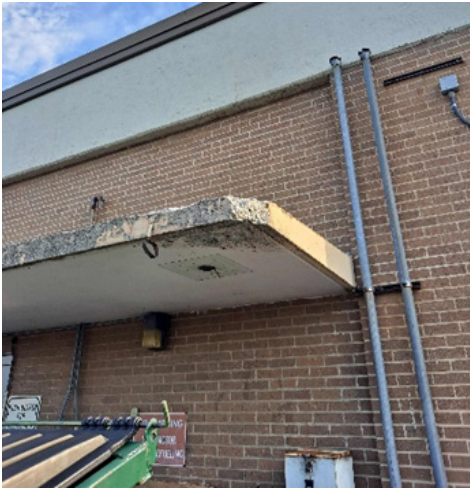
Damaged canopy

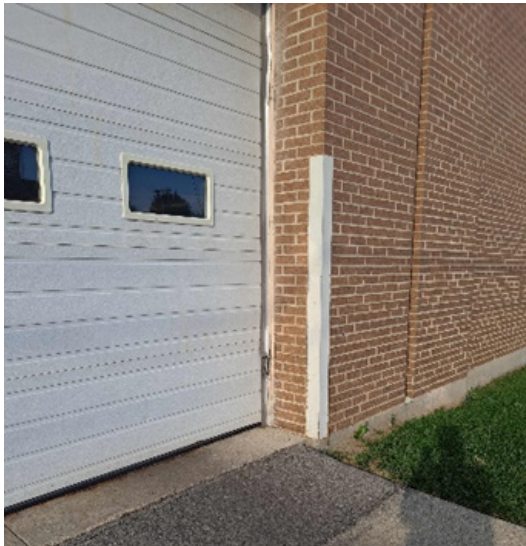
Damaged door jamb and door track

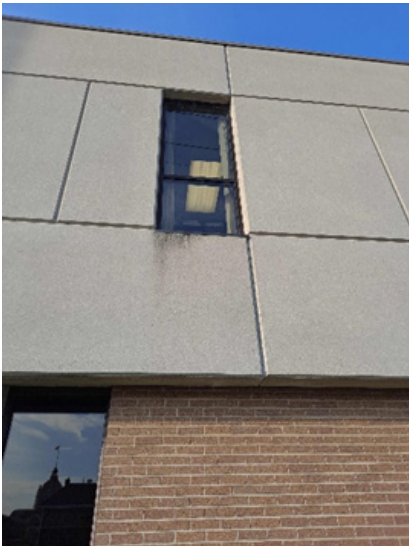
Streaking below windows

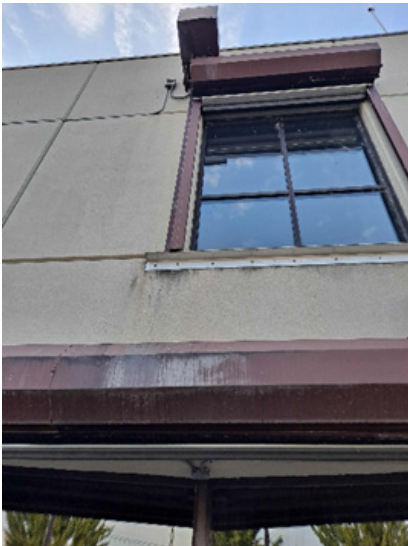
Window housing faded and rusting

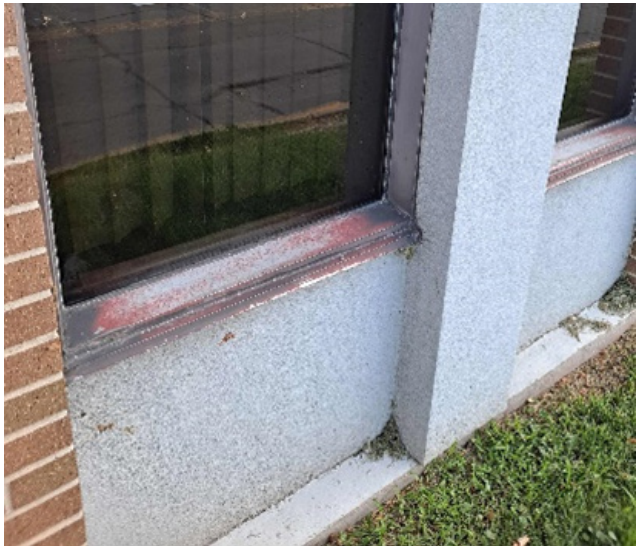
Faded metal window trim

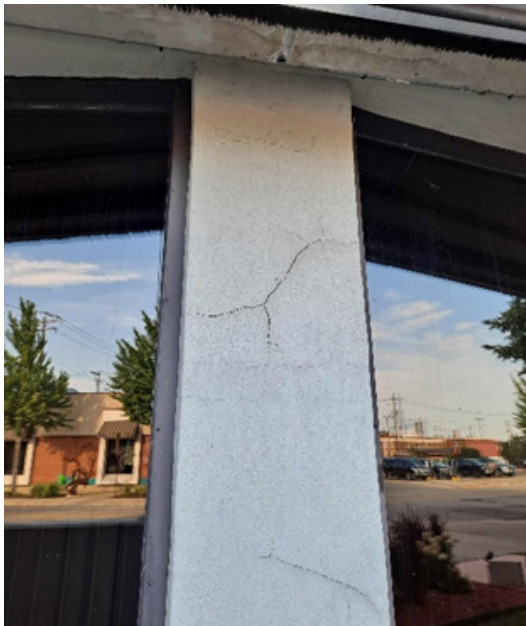
Cracked concrete between windows

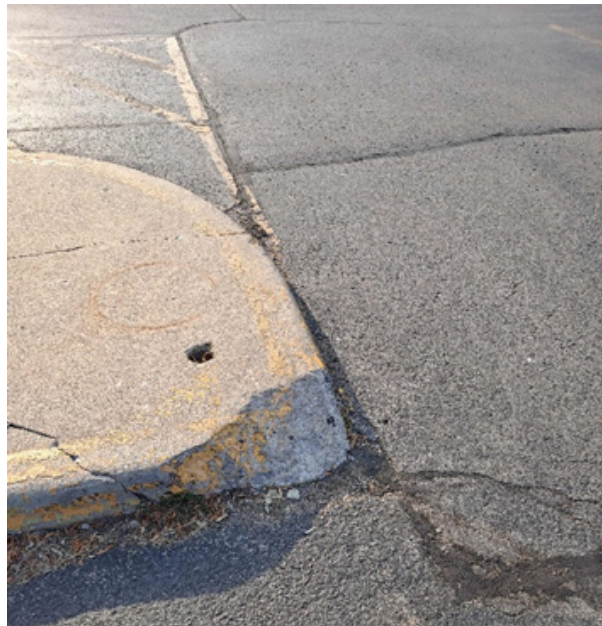
Damaged concrete curb

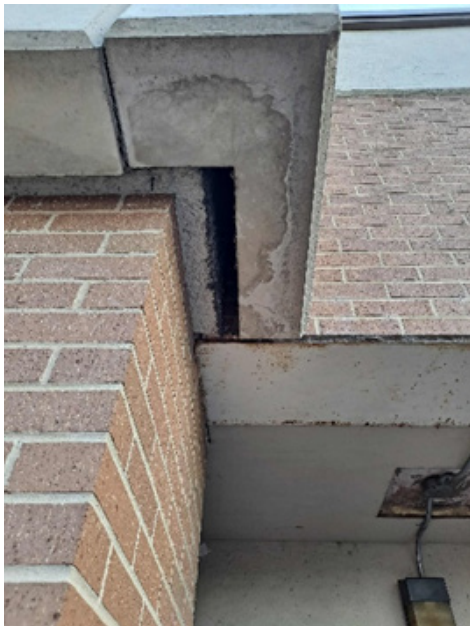
Gaps under precast concrete panels

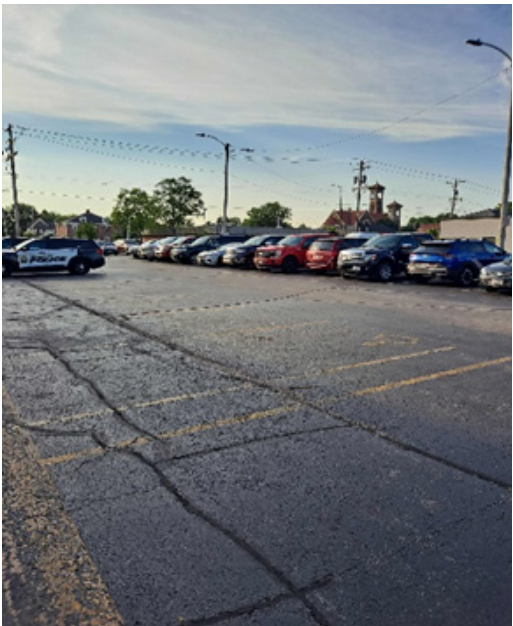
Previous sealing of asphalt cracks

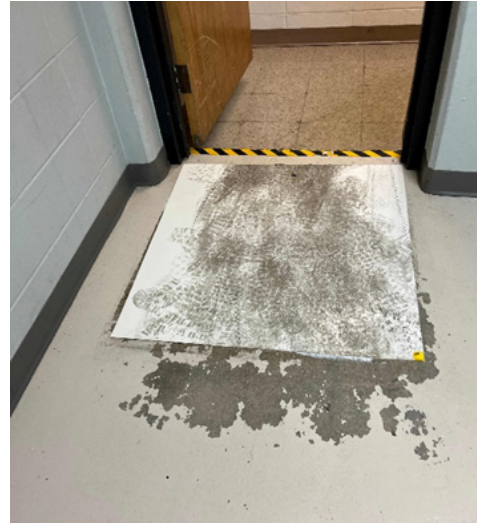
Chipped paint at shooting gallery entry

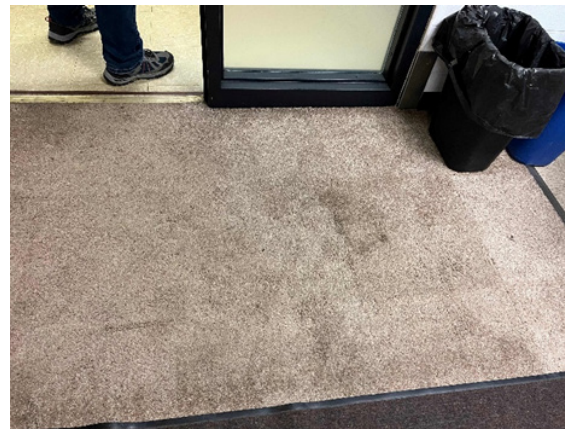
Worn, stained cut-pile carpet

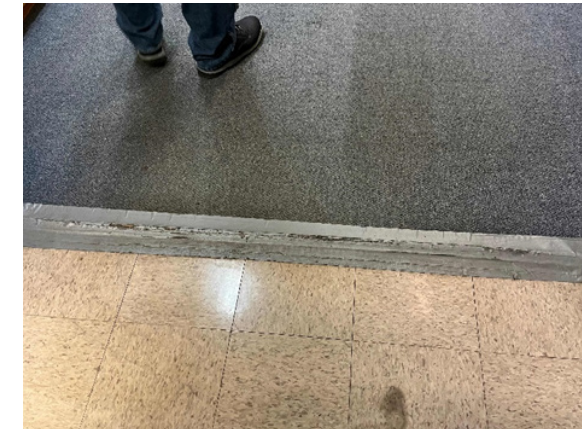
Duct tape at transition from carpet to VCT

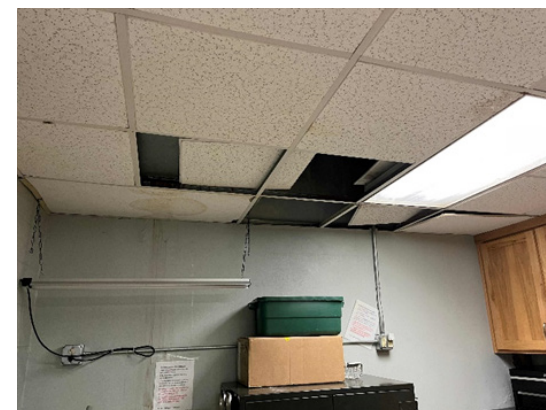
Many ceiling tiles are stained or missing, especially on the basement level.

Missing and misplaced ceiling tiles

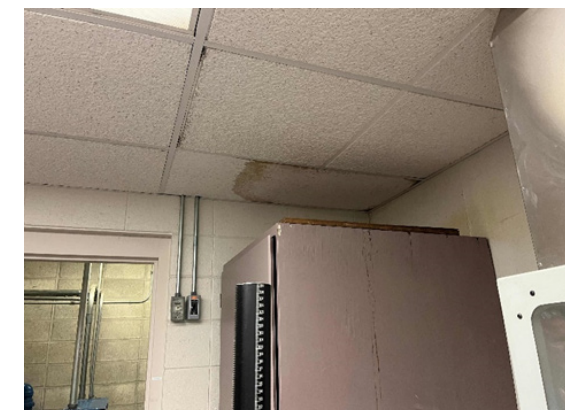
Typical stained ceiling tile

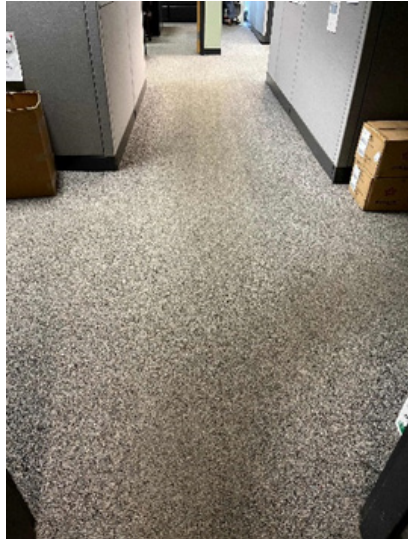
Worn carpet at office area

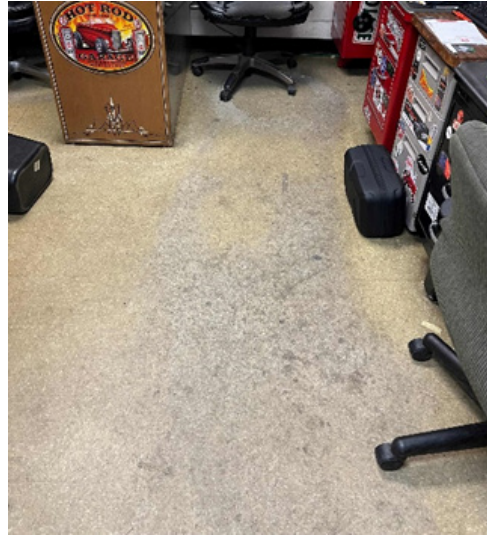
Worn VCT at shop office

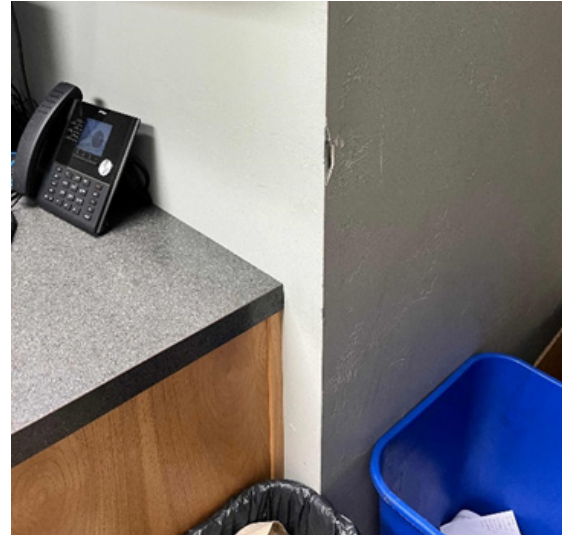
Damaged corner - Range

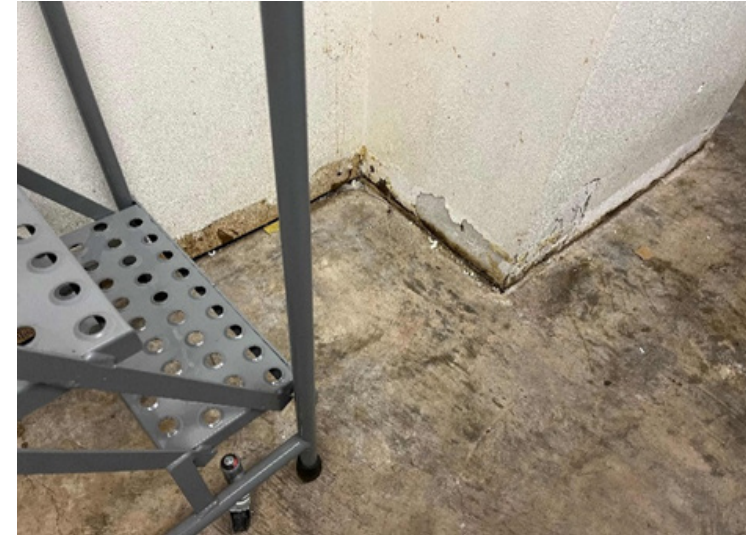
Deteriorated base at high-density storage

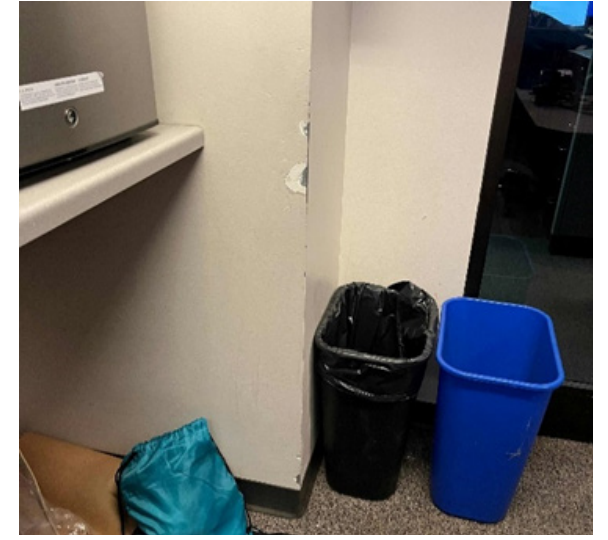
Damaged corner - Shift Commander

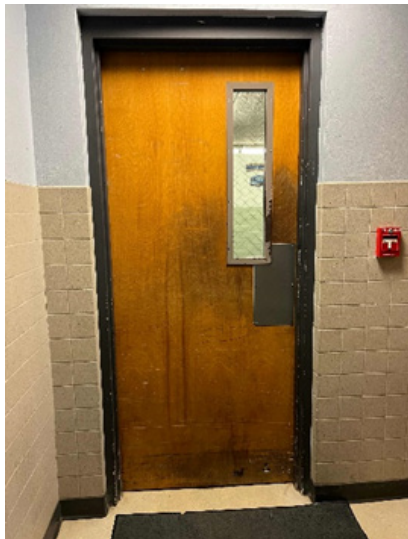
Chipped paint at lite and  
damaged wood finish  
Missing kick plate

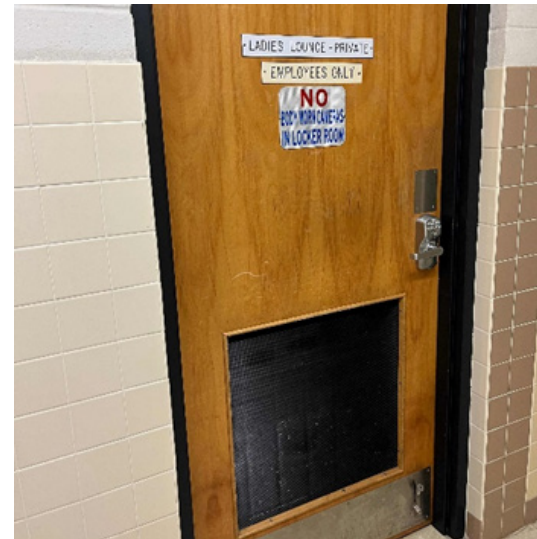
Scratched wood veneer

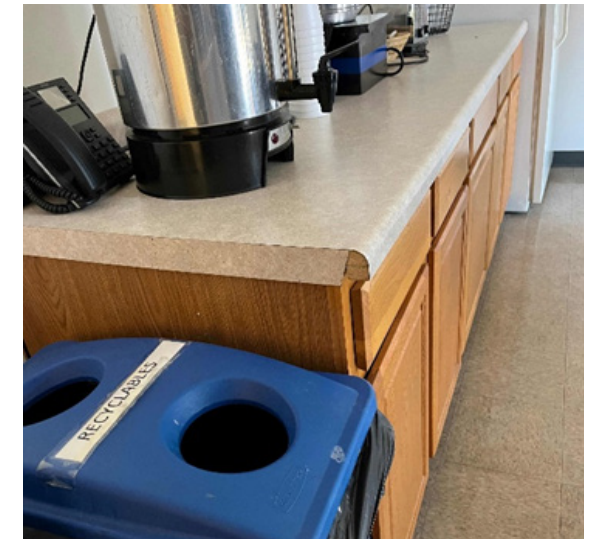
Chipped plastic laminate

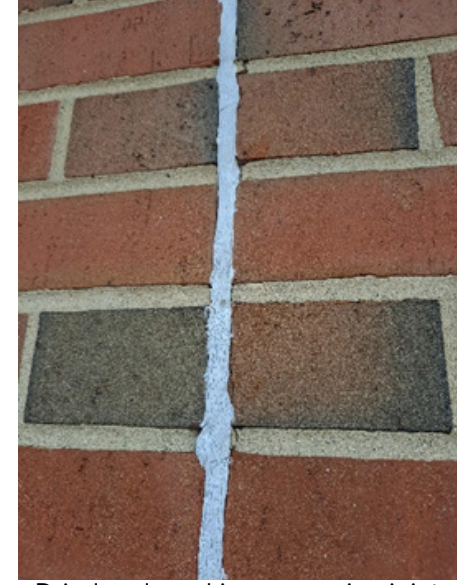
Dried and cracking expansion joint material

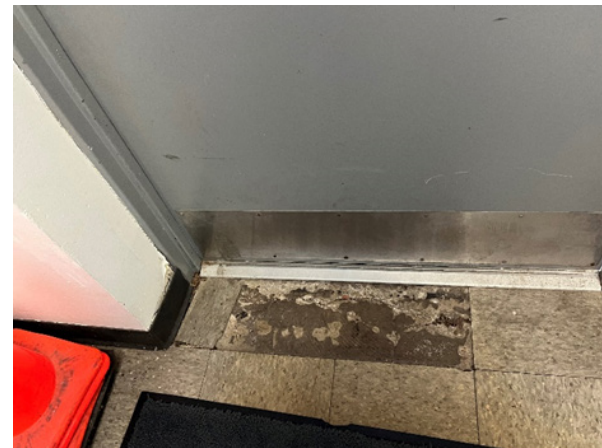
Missing vinyl tile at back door

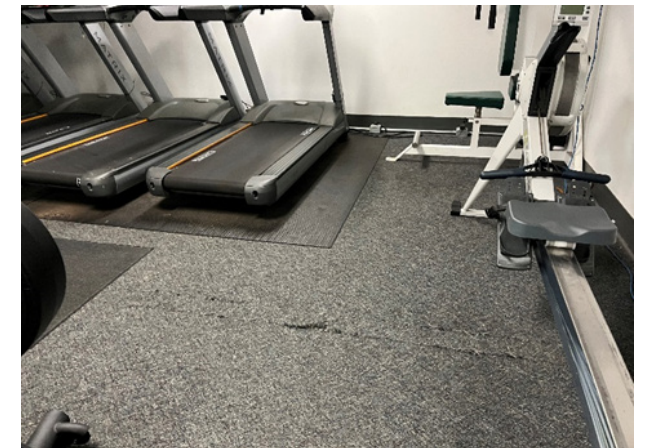
Ripped carpet at cardio room

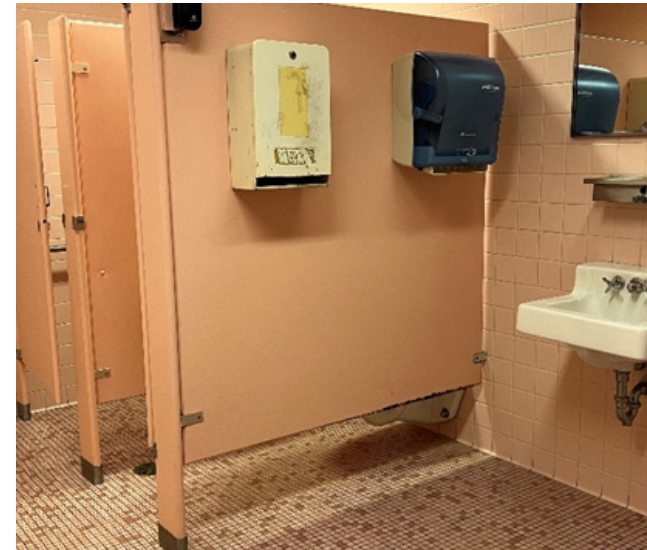
Toilet partitions in basement are rusting at the lower edges. Most casework is in good condition. The wood trim along the patron side of the reception desk has worn finish off the edges.

Rusted bottom of women's toilet partitions

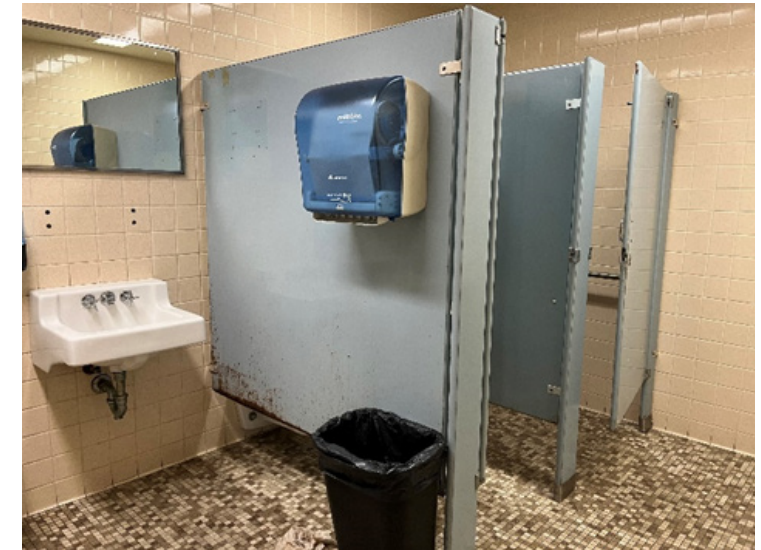
Rusted bottom of men's toilet partitions

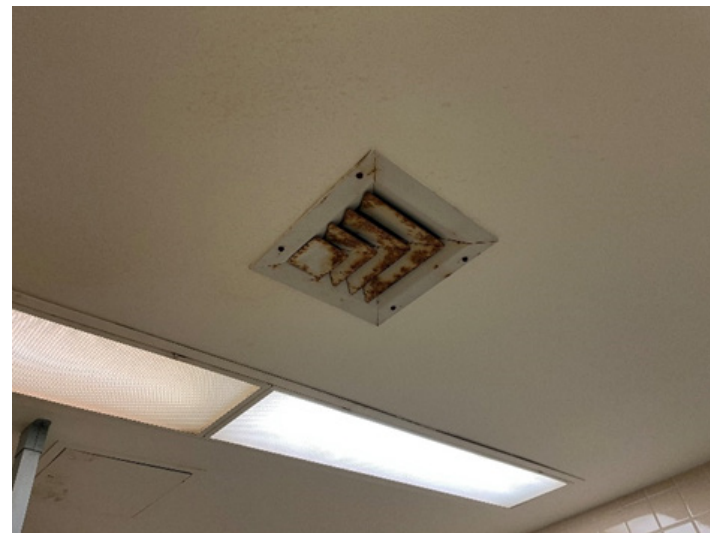
Rusted ceiling diffuser at basement toilet room

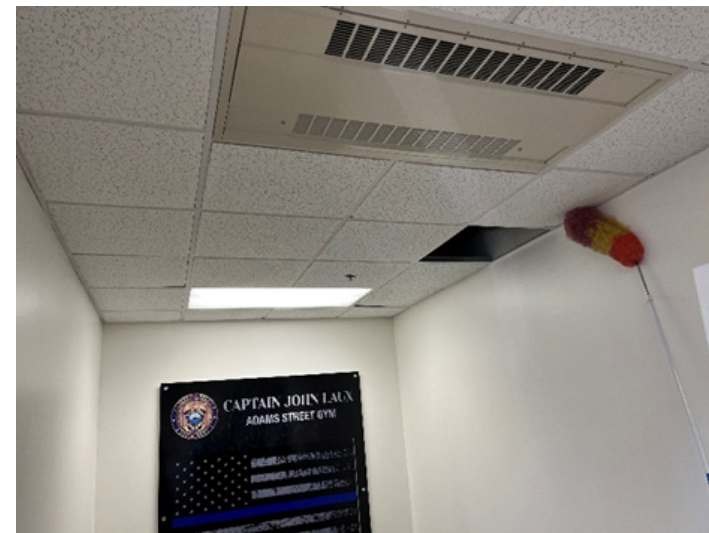
Missing ceiling tile at back stair shaft
