# **AGENDA OF THE LANDMARKS COMMISSION**

# **MINUTES OF THE LANDMARKS COMMISSION**

## (COA 19-11) Window Replacement, Roofing, & Addition at 1014 S Jackson Street

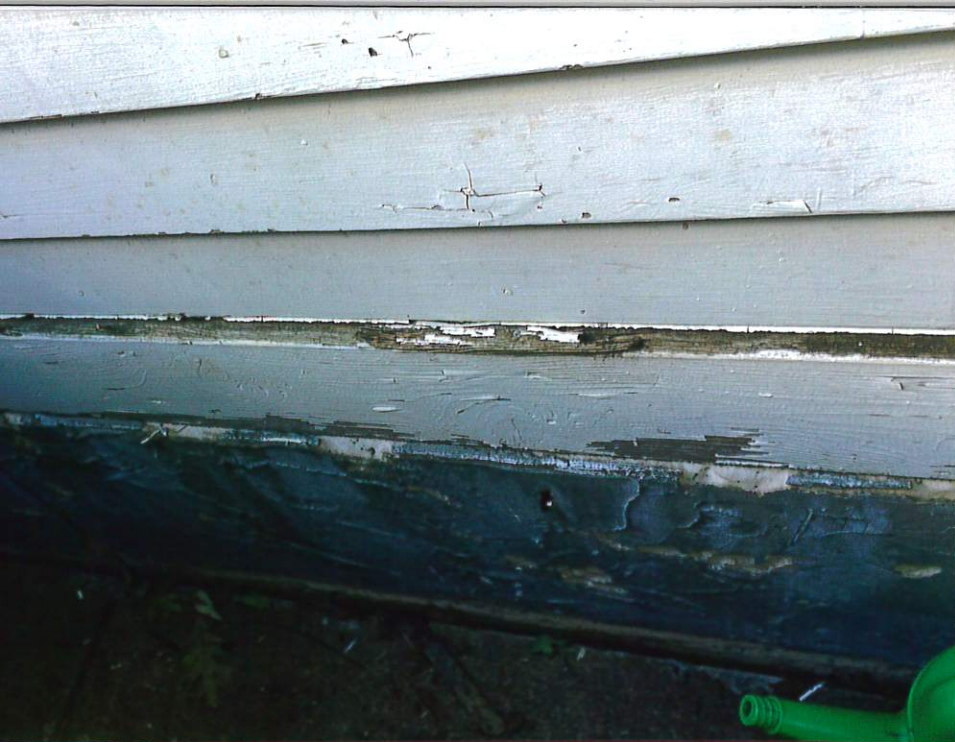
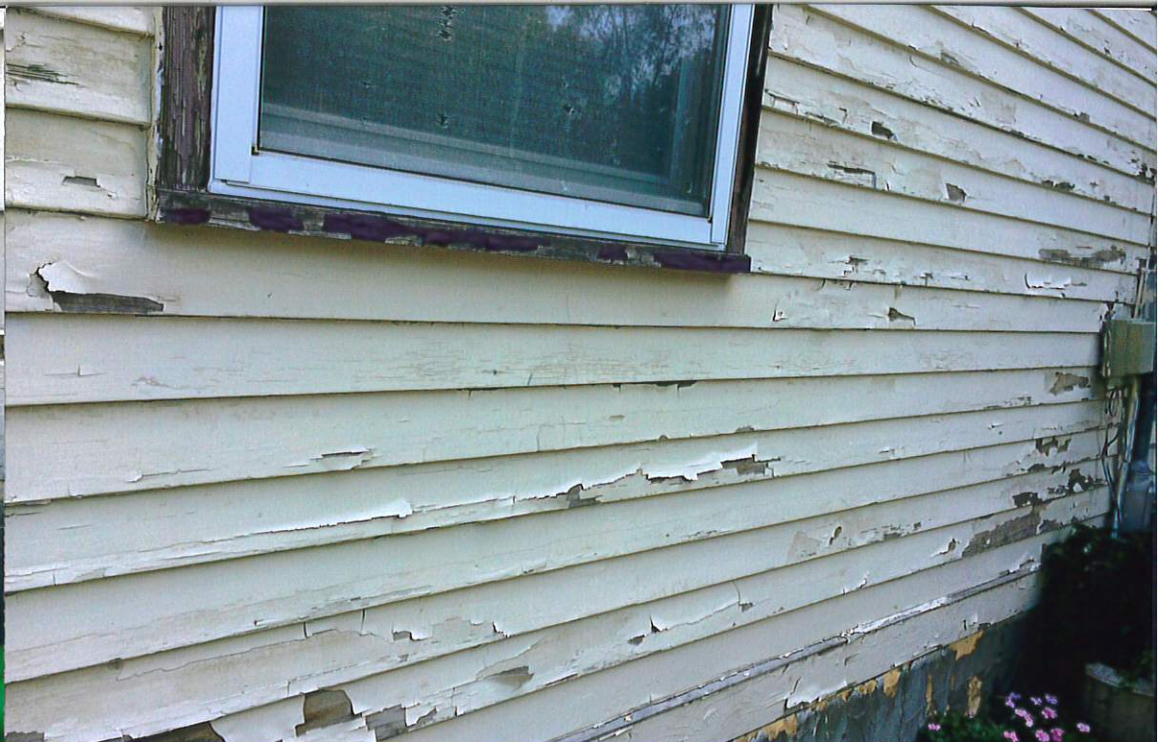
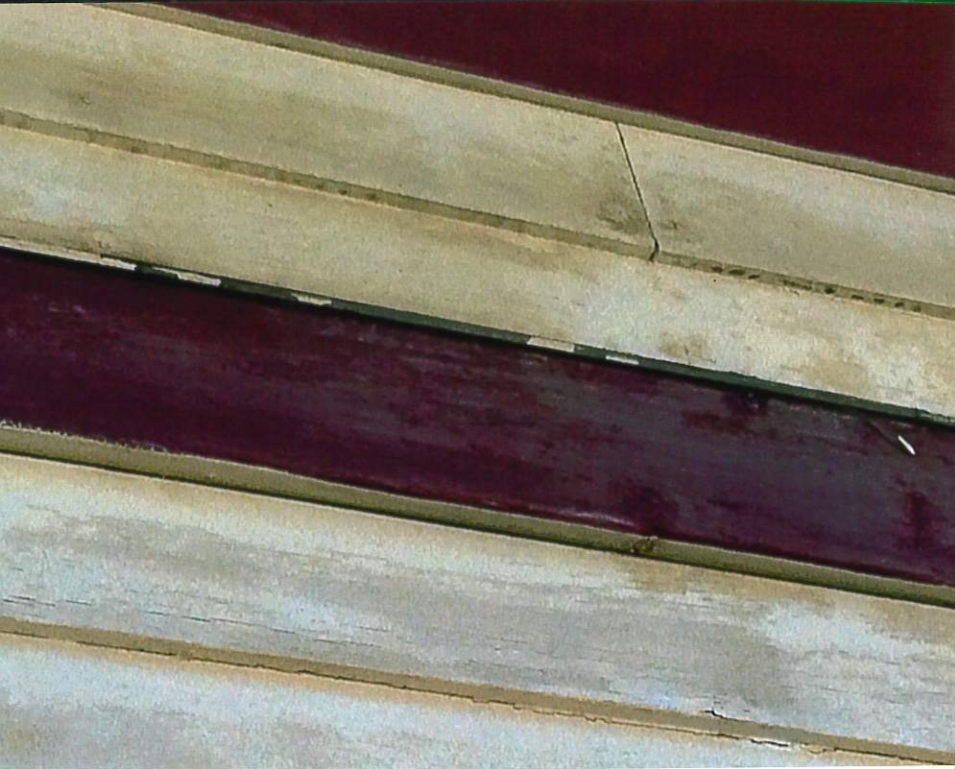
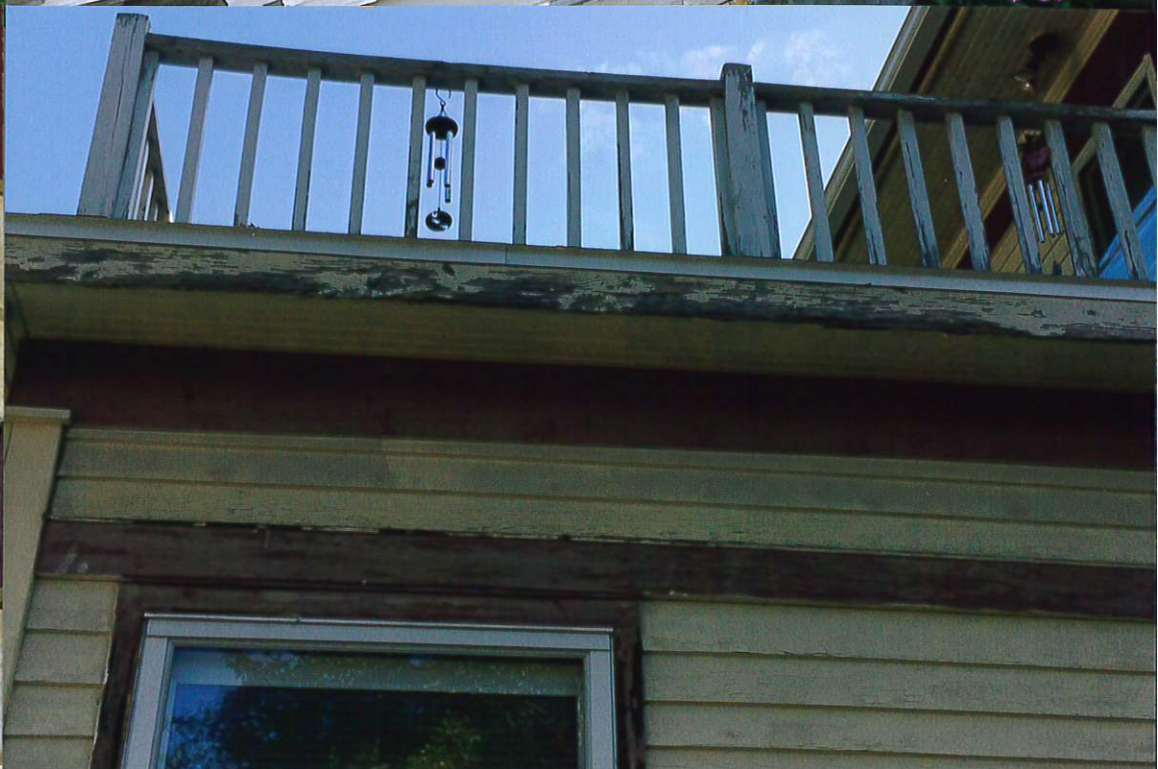
- Pictures A: There is substantial damage due to rotting wood on several sides of the house as these images show, the entire home will need to be resided.
- Pictures B: I have one wall that needs to be completely repaired due to rot. We have made some temporary patches where boards just fell off, but there are still more holes to repair. This same wall also has damage to the inside which will be repaired at the same time.
- Pictures C: rotten soffits in need of repair

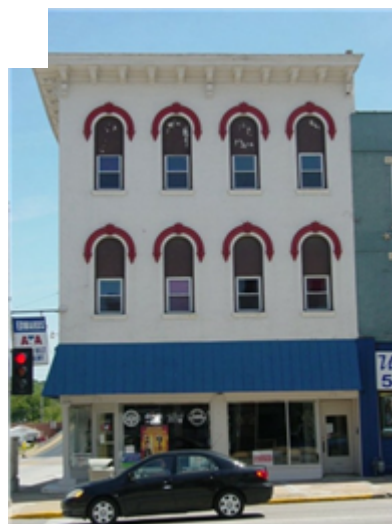
In this example, notice the replacement windows do not fit the masonry opening of

the original window. Instead the new window was reduced in size dramatically changing the historic appearance of this commercial building. Source: Bob Yapp

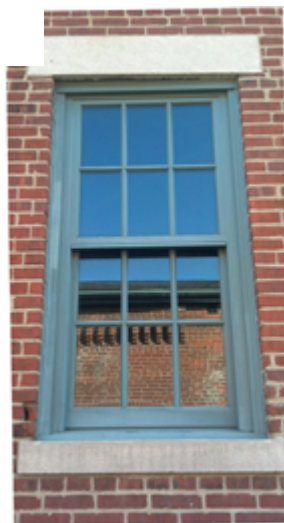
A replacement window should match the original in design, dimension and, where possible, materials. Here is an excellent example of a replacement window. Source: Bob Yapp

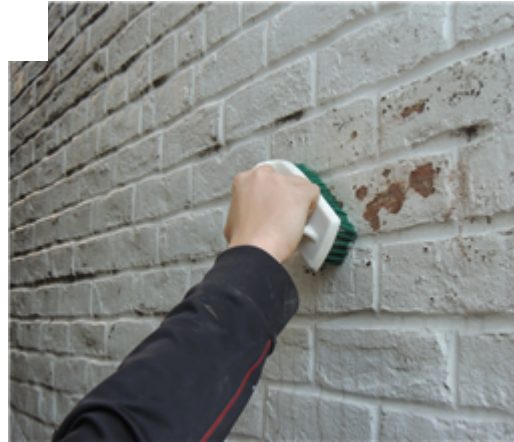
**Step 2**

You should use a mixture of synthetic TSP and water to hand-wash all bare masonry and solid paint that remains on your masonry surfaces. Use  $\frac{1}{4}$  cup of TSP for every gallon of water. Before you begin, tarp off the area where you are working to prevent the TSP from seeping into the ground. Be sure to wear eye protection and gloves. When you are done scrubbing, rinse the masonry surfaces with clear water from your garden hose.

Do not use high-pressure washing to clean a masonry surface. High-pressure washing can damage masonry surfaces. It is also a major cause of catastrophic paint failure. High-pressure washing will drive so much moisture deep into the masonry that it could take months to dry enough for painting.

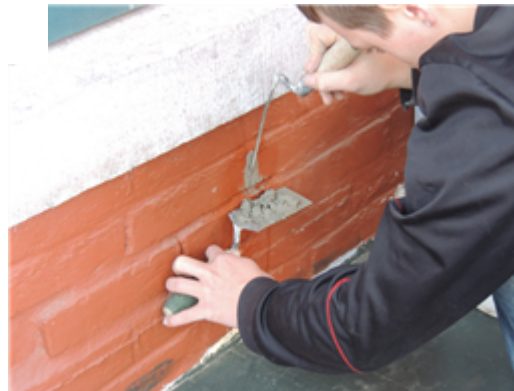
**Step 3**

## Step 3: Repair Damaged Components

Repair or replace any rotted or cracked brick moldings, eaves, or other wood components surrounding the masonry. Repair any failing mortar with mortar that is softer than your brick or stone. Allow the mortar to cure thoroughly before you prime, caulk or paint the masonry.

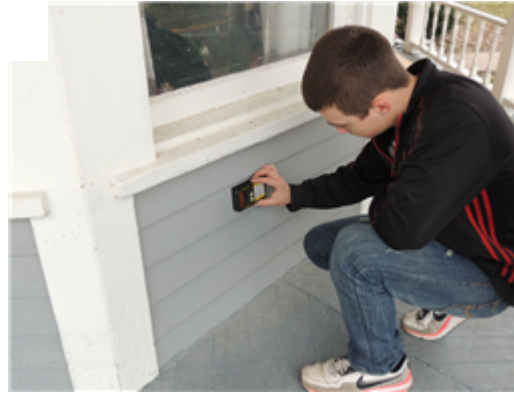
### Step 4

Before you apply any primer, paint or caulk, use a moisture meter to test the moisture content of the masonry. Paint will not adhere to any masonry surface with a moisture content that exceeds 15 percent. You can purchase a masonry grade moisture meter at masonry supply stores and sometimes lumberyards.

Note: while the photo shows a clapboard wall, the equipment and process is the same. Source: Bob Yapp

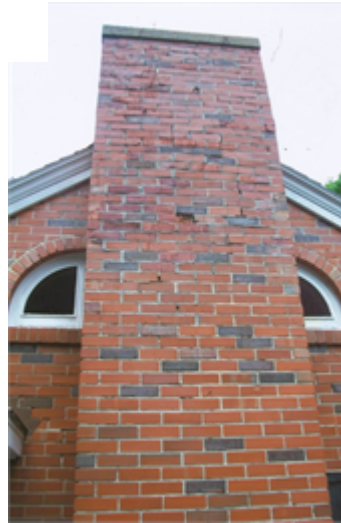
Dane County. The brick on this chimney has experienced severe deterioration - the brick has shifted, cracked and spalled. Source: WHS - Historic Preservation - Public History.

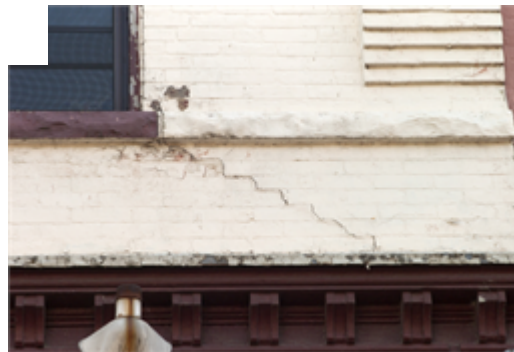
Madison, Wisconsin. Even though this is brick building has been painted, the joint cracking is evident. Source: Photographer Mark Fay.

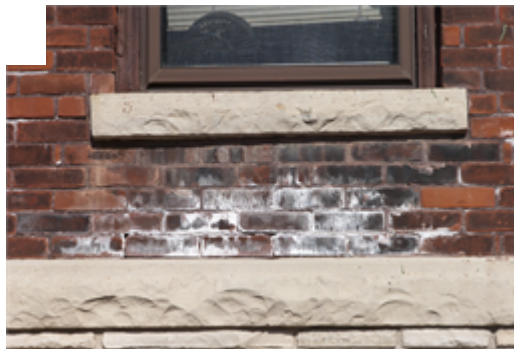
Madison, Wisconsin. Efflorescence can be found on all types of masonry walls - here the efflorescence is evident on the brick surface below the window. Source: Photographer Mark Fay.

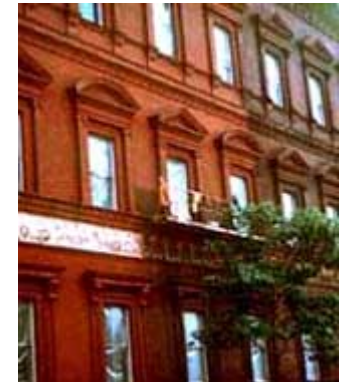
Appropriate cleaning of historic masonry. Photo: NPS files.

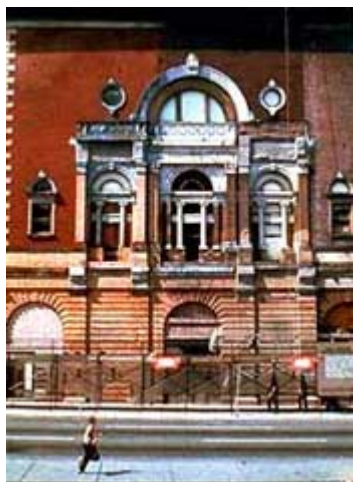
Ninety years of accumulated dirt and pollutants are being removed from this historic theater using an appropriate chemical cleaner, applied in stages. Photo: Richard Wagner, AIA.

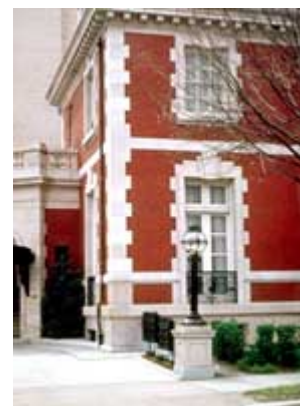
The decorative trim on this brick building is architectural terra-cotta intended to simulate the limestone foundation. Photo: NPS files.

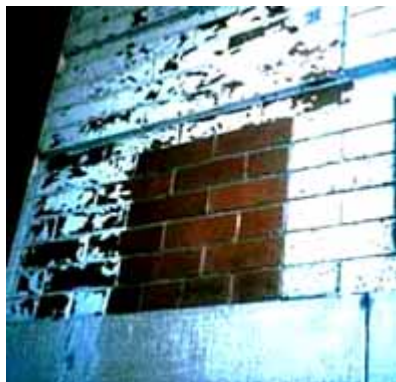
Any cleaning method should be tested before using it on historic masonry. Photo: NPS files.

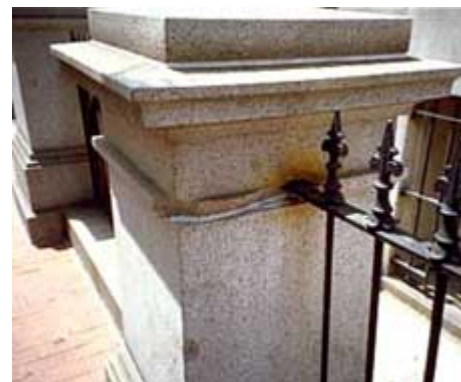
The iron stain on this granite post may be removed by applying a commercial rust-removal product in a poultice. Photo: NPS files

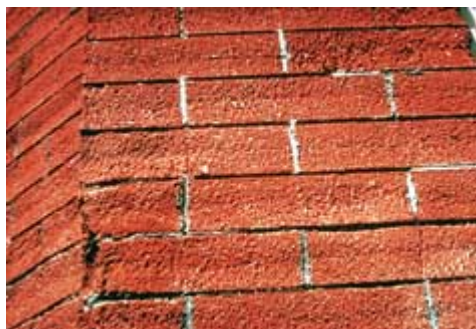
Sandblasting has permanently damaged this brick wall. Photo: NPS files

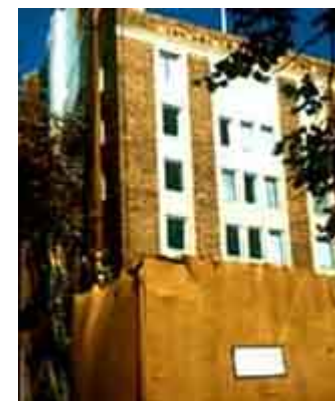
The lower floors of this historic brick and architectural terra-cotta building have been covered during chemical cleaning to protect pedestrians and vehicular traffic from potentially harmful overspray. Photo: NPS files.

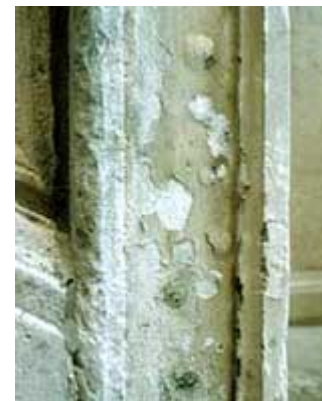
This clear coating has failed and is pulling off pieces of the stone as it peels. Photo: NPS files

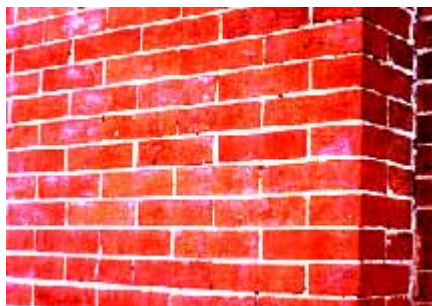
Improper cleaning methods may have been responsible for the formation of efflorescence on this brick. Photo: NPS files.
