# **AGENDA OF THE PARKS COMMITTEE**

**WEDNESDAY, NOVEMBER 30, 2022, 5:00 PM**

Consideration with possible action on the removal of the Porlier Pier and review options for possible replacement.

This report contains preliminary FEL-1 estimates (+50%/- 30%) for various options to replace the Porlier Pier on the Fox River in Green Bay, WI. These budgetary estimates are based on 2023 construction and utilize RSMeans construction cost data adjusted for local pricing. Brief narratives of the options are presented, and line item estimates are included in the appendix.

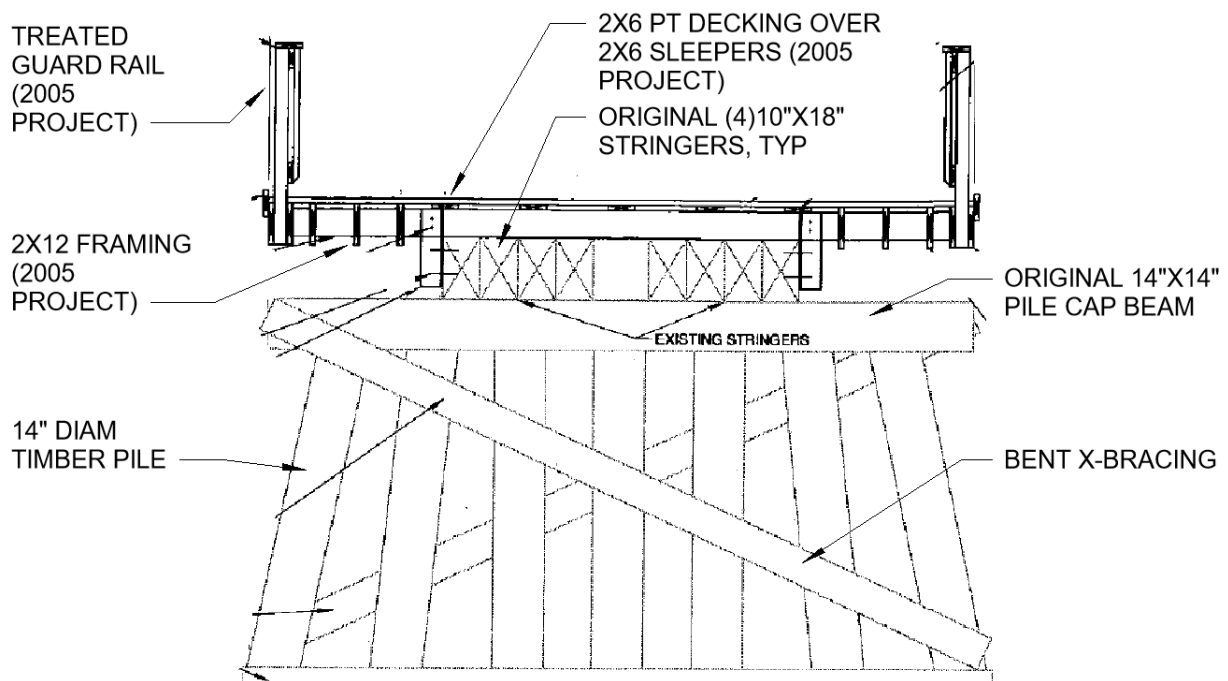
Figure 1 - Typical Cross Section

The stringers are in fair condition. The 10"x16" timber stringers in groups of four provide the main beam support between each bent. There was some minor decay found at the bearing near the end of the pier, however overall the stringers are structurally sound.

The railroad ties are in fair to poor condition. The railroad ties sit on top of the stringers and provide joist support of the deck above. They were inspected visually from below. There is heavy charring and some decay found between the last few bents, however the remainder of these beams did not appear to have any decay. There may be hidden decay which would be revealed at removal of the deck boards.

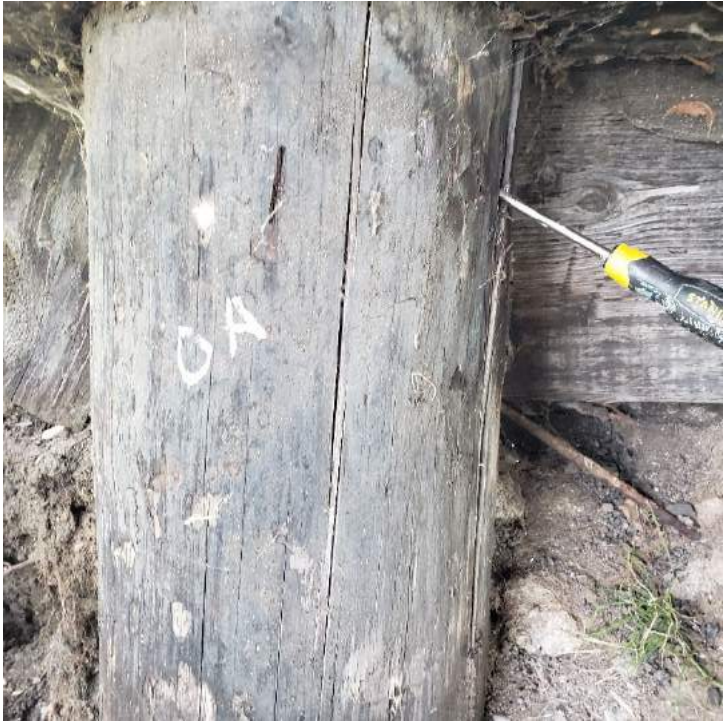
| | PHOTO | 1 |

| | PILE 0A | |

Recommendation: **Do not allow further use until structural repairs are made.** It is necessary to have one sound pier at each side of every bent. It is not feasible to replace piles without removing the entire structure; additional piles could be added to the exterior ends with new beams and bracing tying the piles together. Existing piles could then be removed or left in place. See attached conceptual repair plan.

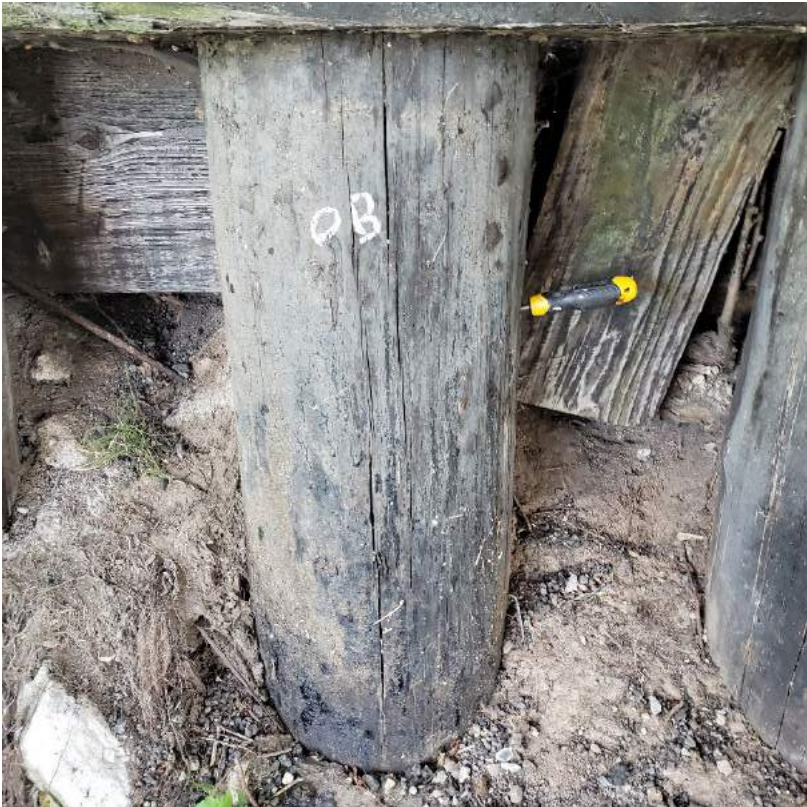
| | PHOTO | 2 |

| MEMBER INSPECTED | FINDINGS | PHOTOS |
|---|---|---|
| PILE 0B | POOR – DECAYED HOLLOW FULL HEIGHT, AWL FULL PENETRATION | 2 |

| | PILE 0B | |

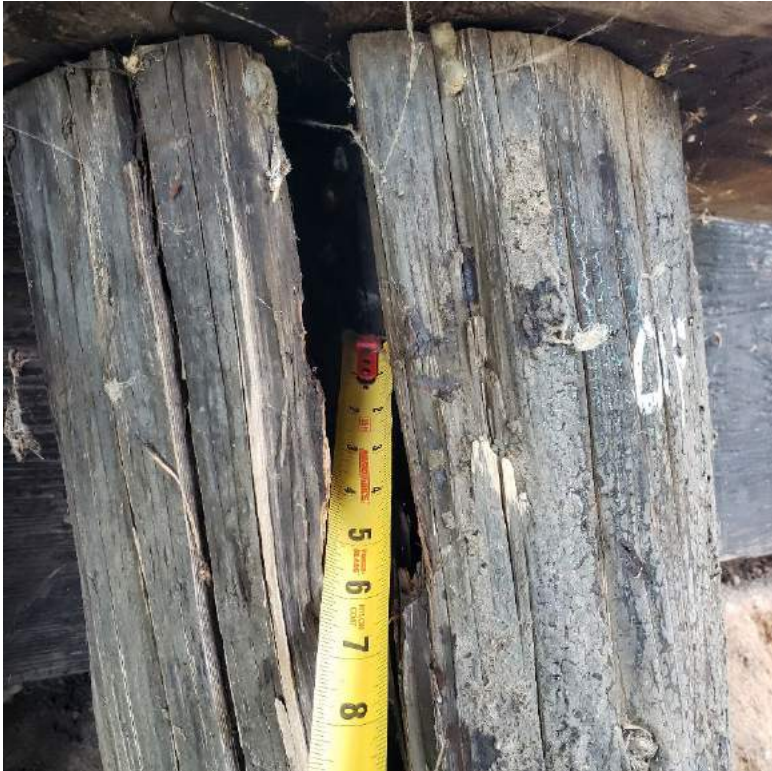
| | PHOTO | 6 |

| MEMBER INSPECTED | FINDINGS | PHOTOS |
|---|---|---|
| PILE 0F | POOR – FAILING DECAYED | 6 |

| | PILE 0F | |

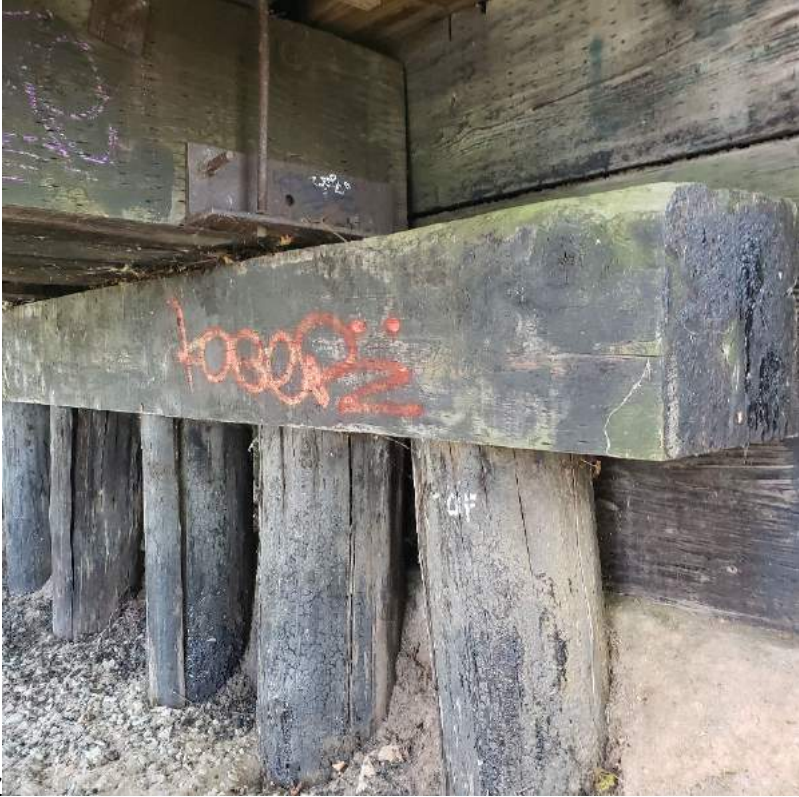
| | PHOTO | 7 |

| MEMBER INSPECTED | FINDINGS | PHOTOS |
|---|---|---|
| BENT 0 PILE CAP BEAM | FAIR – PREVIOUSLY ADDED SHIMS AT BEARING ARE FAILING | 7 |

| | BENT 0 CAP | |

Recommendation: Since the majority of piles below these caps are unsound, these pile caps are at risk of failure. The recommended repairs will no longer utilize these beams and therefore they can remain in place or be removed at the construction phase.

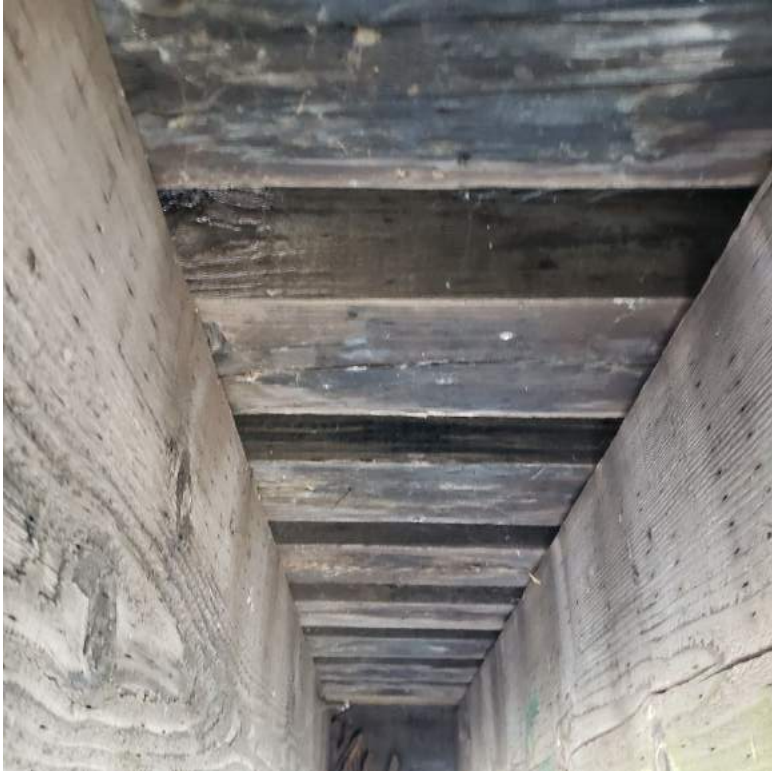
| | PHOTO | 9 |

| MEMBER INSPECTED | FINDINGS | PHOTOS |
|---|---|---|
| RAIL TIES BETWEEN 0 AND 1 | FAIR – NO DECAY FROM BELOW, MAY HAVE HIDDEN DECAY FROM ABOVE | 9 |

| | BENT 0 TO 1 RAIL TIES | |

Recommendation: Upon removal of the 2x6 decking above, it will become clear if there is any decay of the railroad ties. Recommend an allowance of approximately 20% replacement of railroad ties.

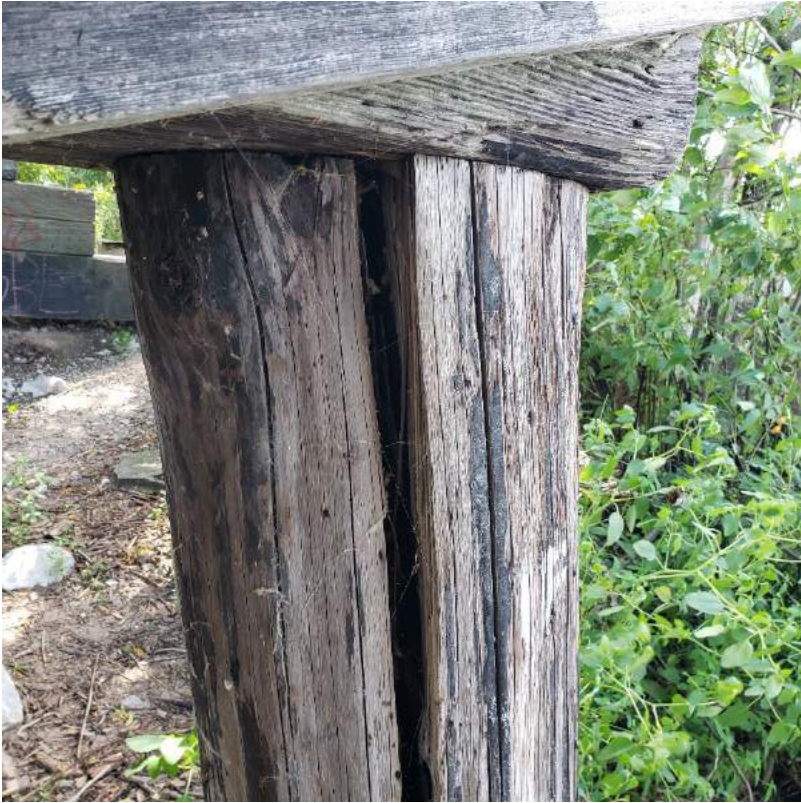
| | PHOTO | 15 |

| MEMBER INSPECTED | FINDINGS | PHOTOS |
|---|---|---|
| PILE 1F | POOR - SPLIT AND FAILING | 15 |

| | PILE 1F | |

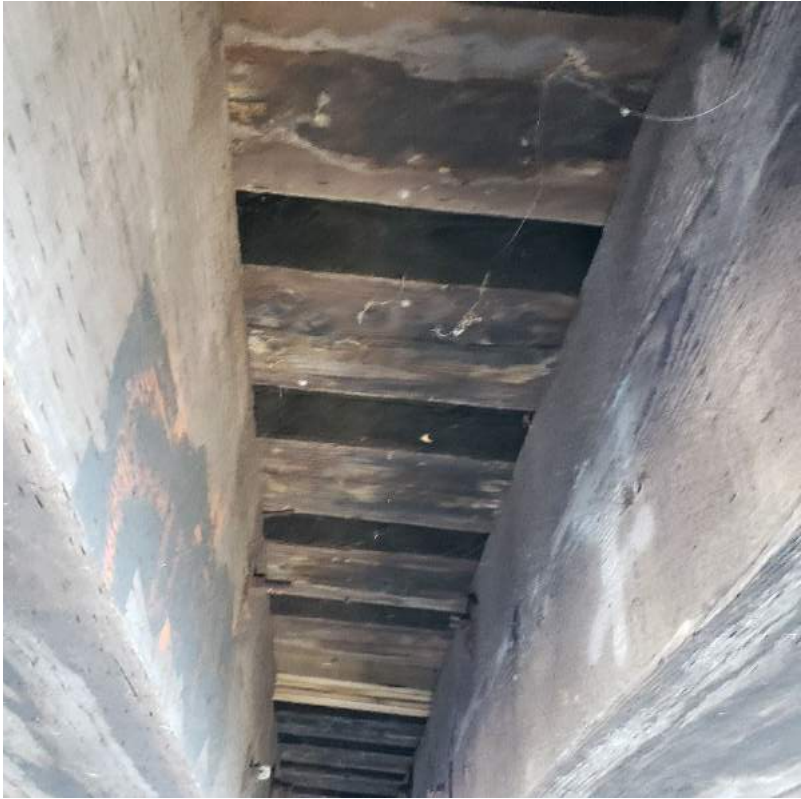
| | PHOTO | 19 |

| MEMBER INSPECTED | FINDINGS | PHOTOS |
|---|---|---|
| RAIL TIES BETWEEN BENT 1 AND 2 | FAIR – NO DECAY FROM BELOW, MAY HAVE HIDDEN DECAY FROM ABOVE | 19 |

| | BENT 1-2 RAIL TIES | |

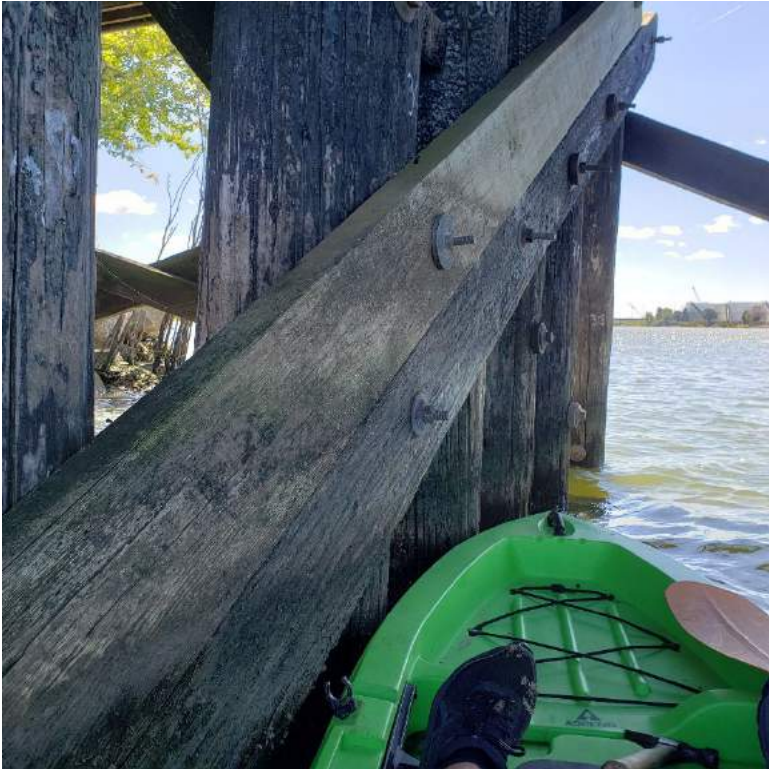
| | PHOTO | 38 |

| <b>MEMBER INSPECTED</b> | <b>FINDINGS</b> | <b>PHOTOS</b> |
|---|---|---|
| BENT 3 WEST SIDE X BRACE | FAIR – 2005 REPAIR IS SOUND | 38 |

| | BENT 3 WEST BRACE | |

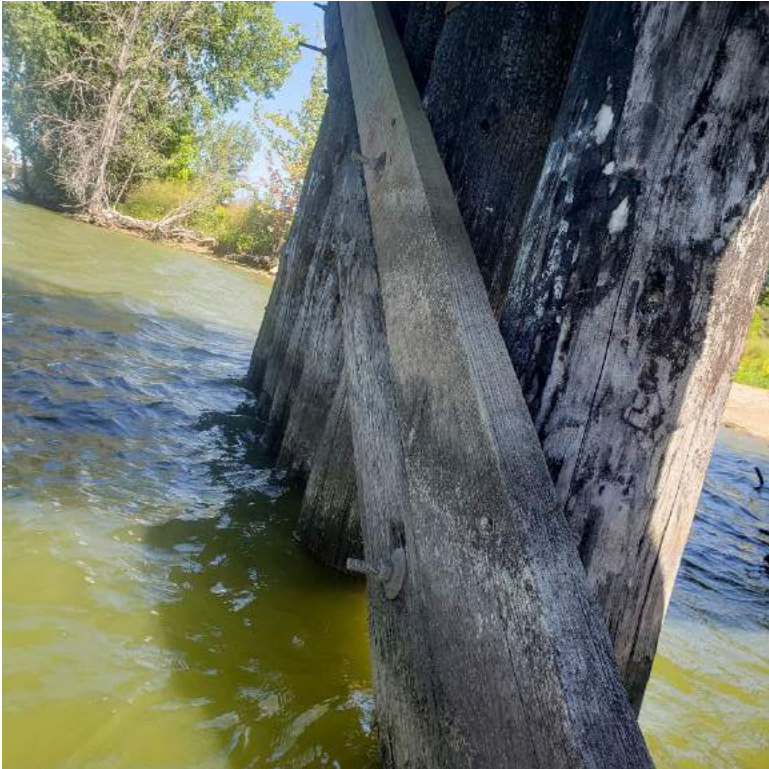
| | PHOTO | 50 |

| <b>MEMBER INSPECTED</b> | <b>FINDINGS</b> | <b>PHOTOS</b> |
|---|---|---|
| BENT 4 WEST SIDE X BRACE | FAIR –REPAIRED W/ 3X10 IN 2005 | 50 |

| | BENT 4 WEST BRACE | |

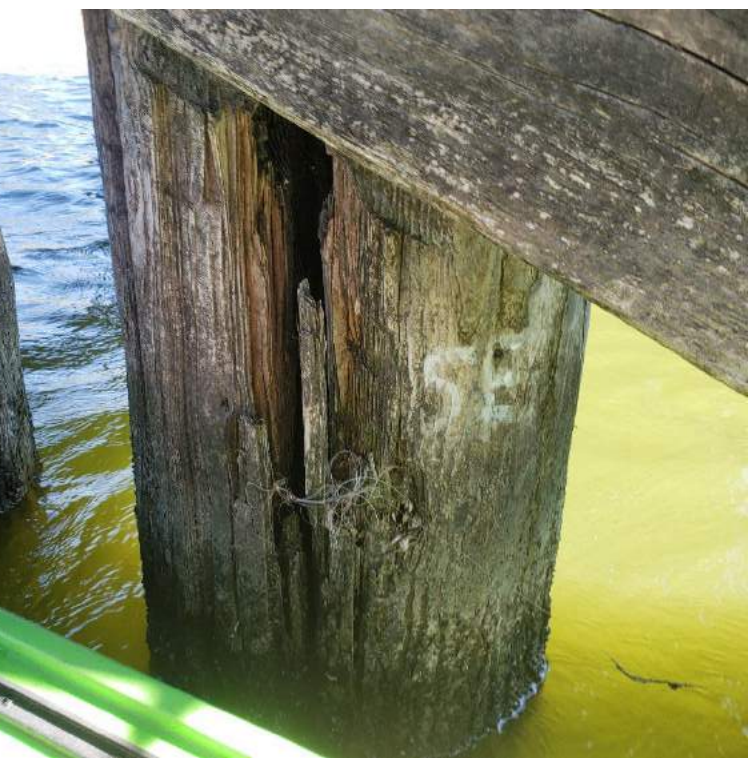
| | PHOTO | 58 |

| <b>MEMBER INSPECTED</b> | <b>FINDINGS</b> | <b>PHOTOS</b> |
|---|---|---|
| PILE 5E | POOR – DECAYED HOLLOW | 58 |

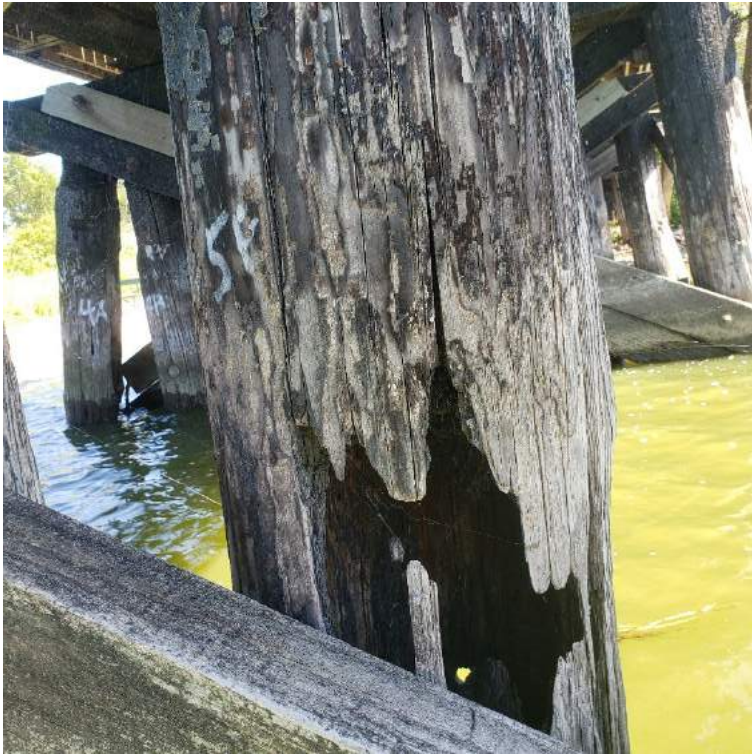
| | PHOTO | 59 |

| <b>MEMBER INSPECTED</b> | <b>FINDINGS</b> | <b>PHOTOS</b> |
|---|---|---|
| PILE 5F | POOR – DECAYED HOLLOW | 59 |

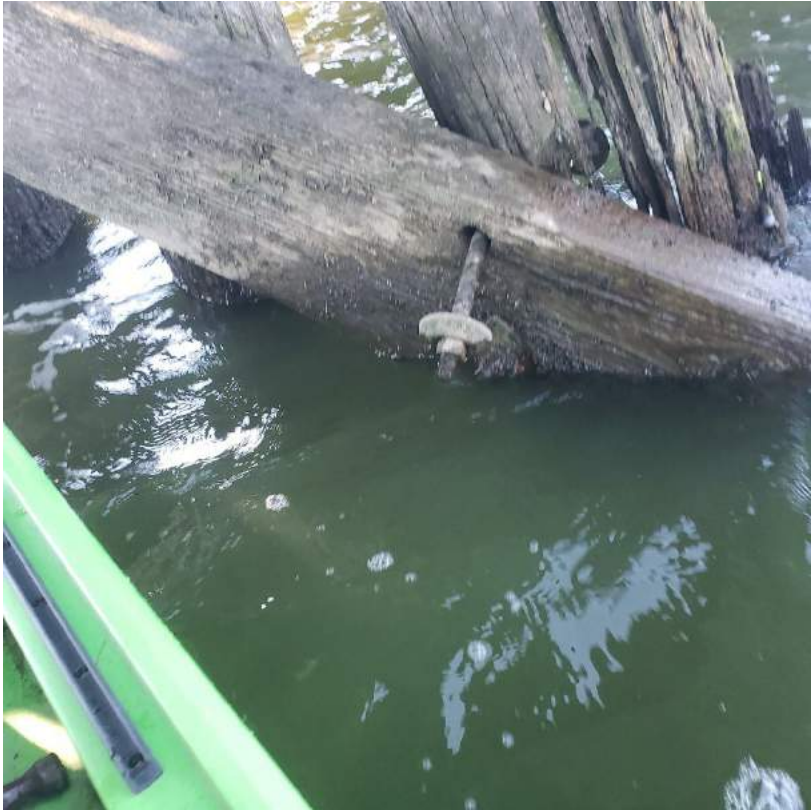
| | PHOTO | 61 |

| <b>MEMBER INSPECTED</b> | <b>FINDINGS</b> | <b>PHOTOS</b> |
|---|---|---|
| BENT 5 EAST SIDE X BRACE | POOR – BRACE OK BUT ITS CONNECTED TO FAILING PILES | 61 |

| | BENT 5 EAST BRACE | |

Recommendation: Install new bracing at new pile locations in both the North-South direction at each bent and the East-West Direction along both sides to provide a new braced framework.

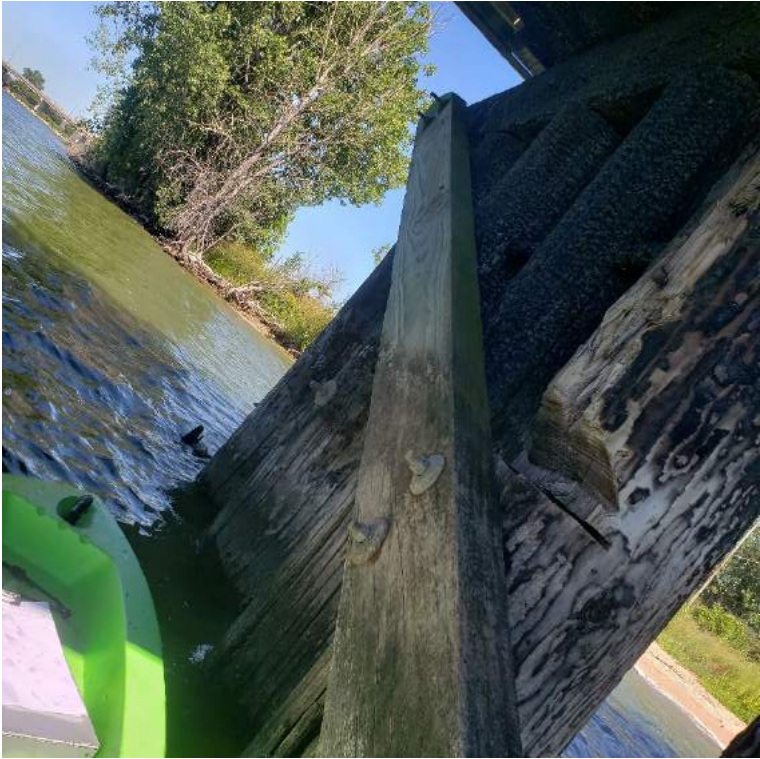
| | PHOTO | 62 |

| <b>MEMBER INSPECTED</b> | <b>FINDINGS</b> | <b>PHOTOS</b> |
|---|---|---|
| BENT 5 WEST SIDE X BRACE | FAIR – 3X10 REPAIR COMPLETED IN 2005 IS SOUND | 62 |

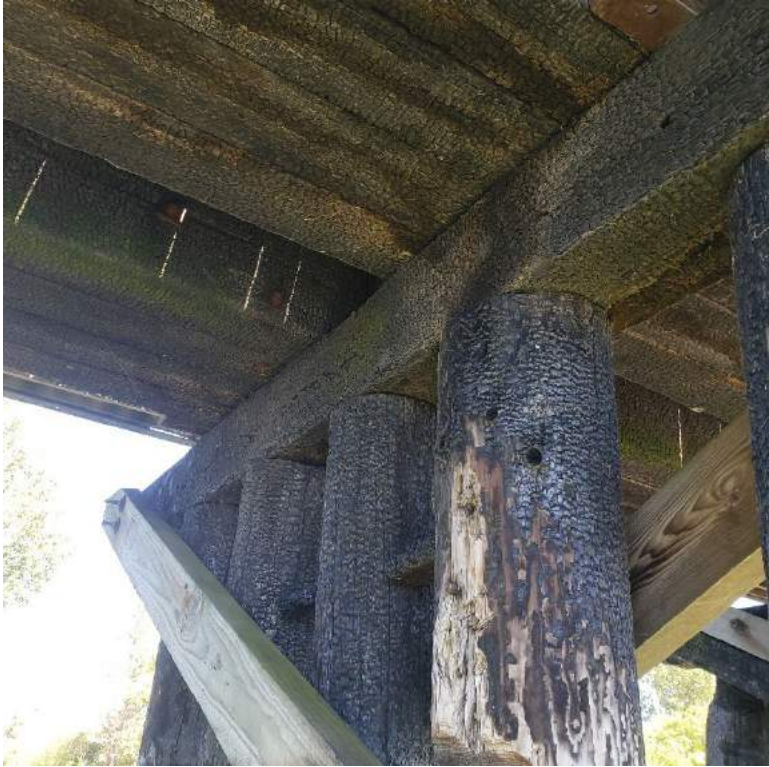
| | PHOTO | 63 |

| <b>MEMBER INSPECTED</b> | <b>FINDINGS</b> | <b>PHOTOS</b> |
|---|---|---|
| BENT 5 PILE CAP BEAM | FAIR – APPROX ½” CHAR NO VISIBLE DECAY | 63 |

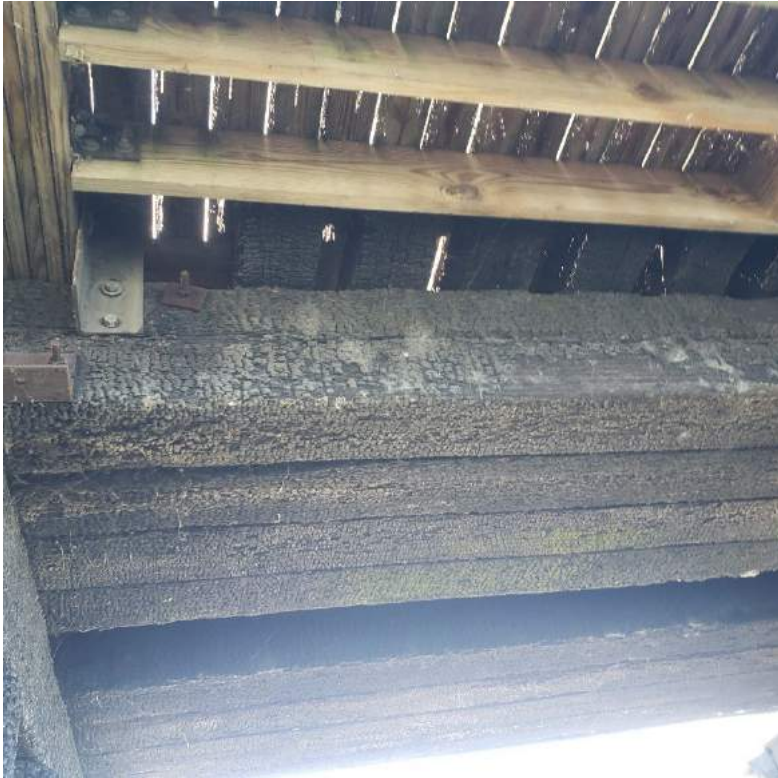
| | PHOTO | 75 |

| <b>MEMBER INSPECTED</b> | <b>FINDINGS</b> | <b>PHOTOS</b> |
|---|---|---|
| STRINGERS BETWEEN BENT 6 AND 7 | FAIR – SOME LOCALIZED DECAY AT BEARING | 75 |

| | BENT 6 TO 7<br>STRINGERS | |

Recommendation: Continue future inspection and monitoring to observe any future deterioration.

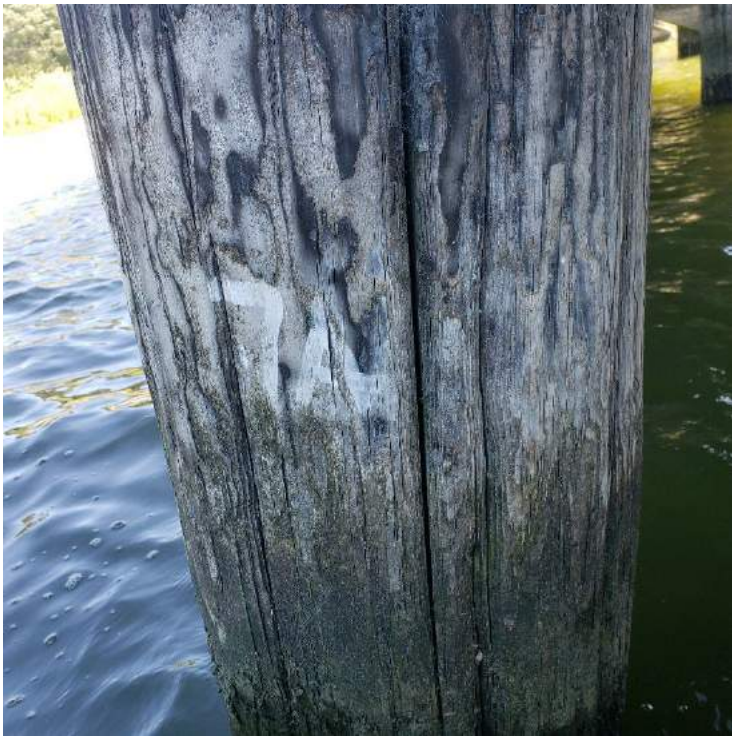
| | PHOTO | 77 |

| <b>MEMBER INSPECTED</b> | <b>FINDINGS</b> | <b>PHOTOS</b> |
|---|---|---|
| PILE 7A | POOR – DECAYED AND HOLLOW @ WATER LINE – SUPPORTS STEEL | 77-79 |

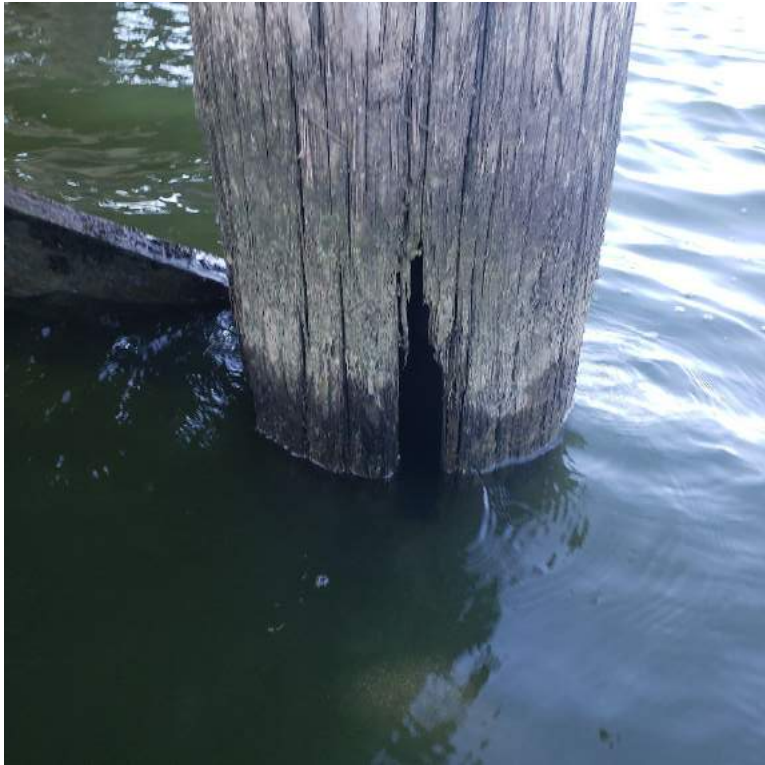
| | PHOTO | 79 |

| | PILE 7A ROT | |

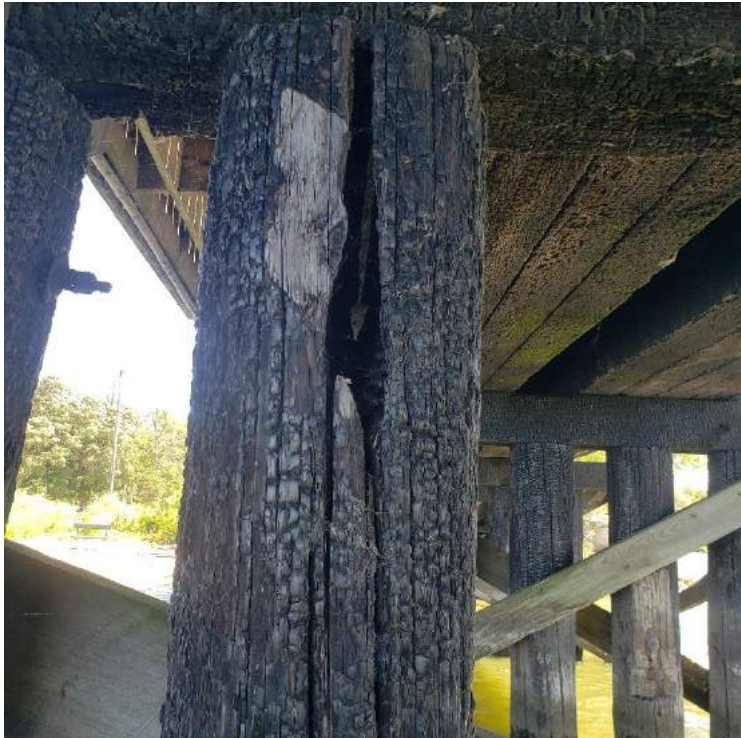
| | PHOTO | 80 |

| <b>MEMBER INSPECTED</b> | <b>FINDINGS</b> | <b>PHOTOS</b> |
|---|---|---|
| PILE 7B | POOR – DECAYED HOLLOW AT BEARING | 80 |

| | PILE 7B | |

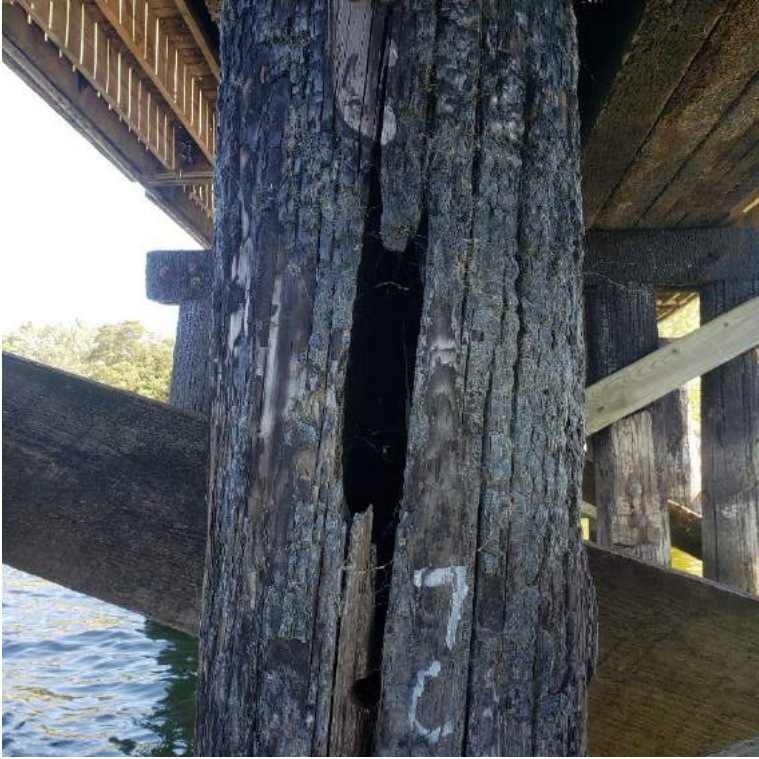
| | PHOTO | 81 |

| <b>MEMBER INSPECTED</b> | <b>FINDINGS</b> | <b>PHOTOS</b> |
|---|---|---|
| PILE 7C | POOR – DECAYED HOLLOW | 81 |

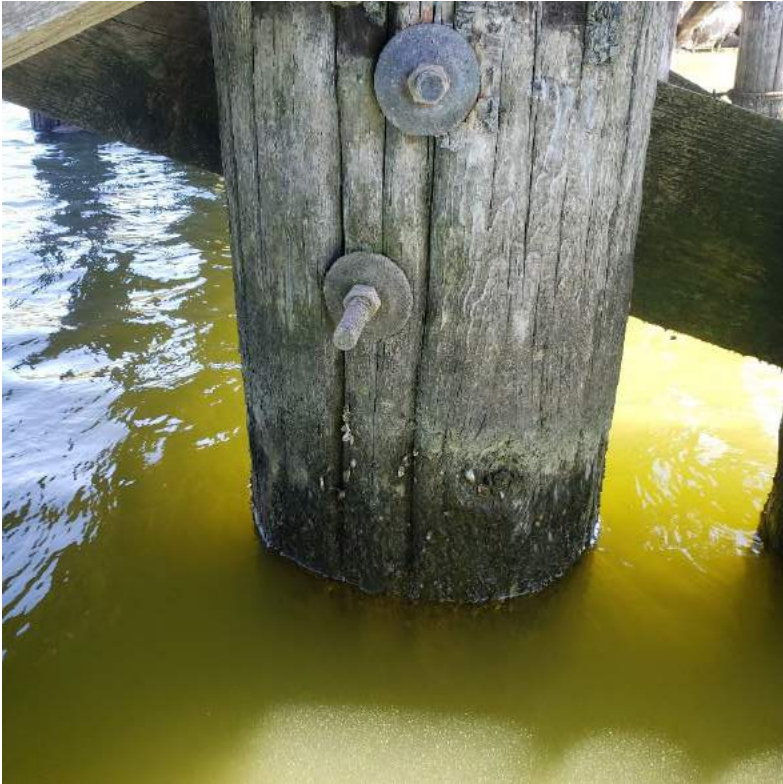
| | PHOTO | 82 |

| <b>MEMBER INSPECTED</b> | <b>FINDINGS</b> | <b>PHOTOS</b> |
|---|---|---|
| PILE 7D | POOR – DECAYED HOLLOW | 82 |

| | PILE 7D | |

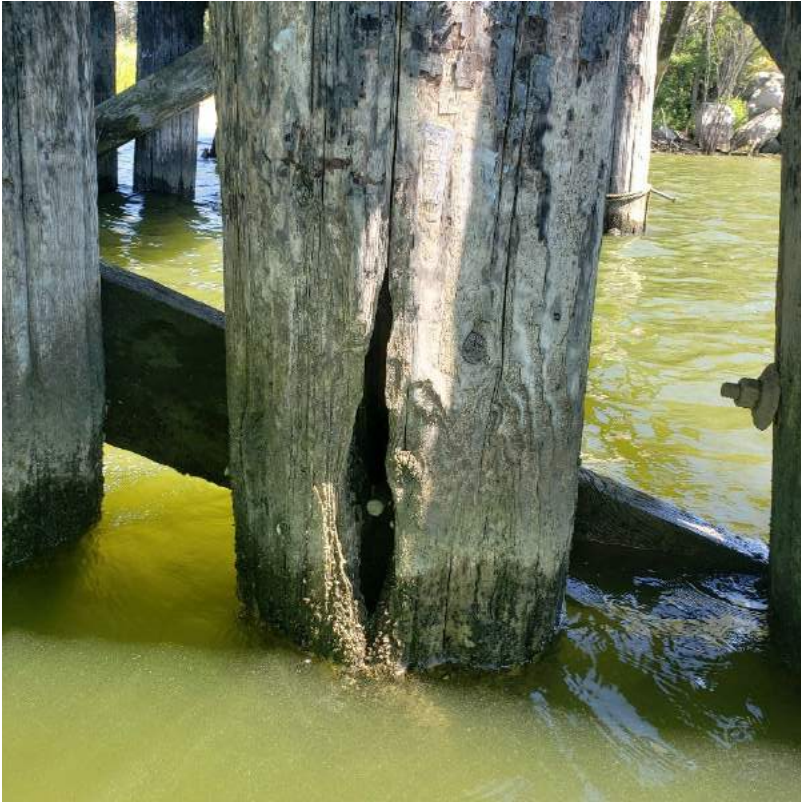
| | PHOTO | 83 |

| <b>MEMBER INSPECTED</b> | <b>FINDINGS</b> | <b>PHOTOS</b> |
|---|---|---|
| PILE 7E | POOR – DECAYED HOLLOW | 83 |

| | PILE 7E | |

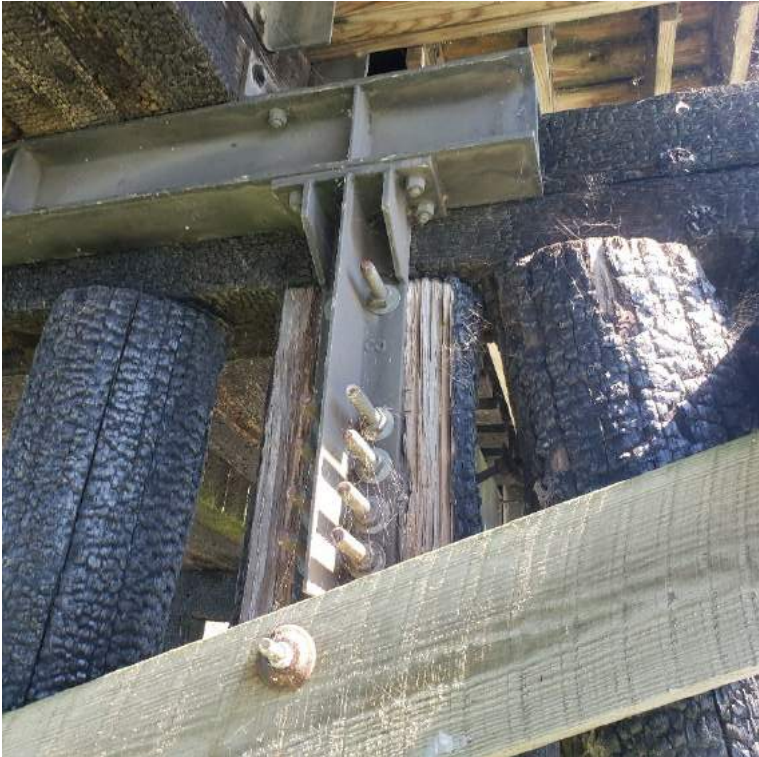
| | PHOTO | 84 |

| <b>MEMBER INSPECTED</b> | <b>FINDINGS</b> | <b>PHOTOS</b> |
|---|---|---|
| PILE 7F | POOR – DECAYED HOLLOW SUPPORTS STEEL | 84 |

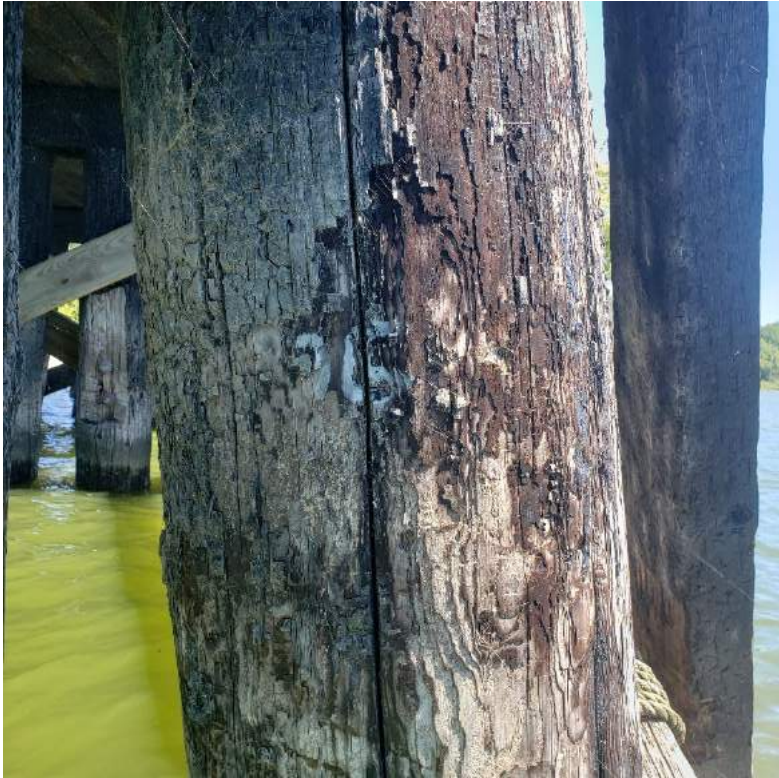
| | PHOTO | 85 |

| <b>MEMBER INSPECTED</b> | <b>FINDINGS</b> | <b>PHOTOS</b> |
|---|---|---|
| PILE 7G | POOR – HEAVY CHAR AND DECAY AT BEARING, NO LONGER SUPPORTING ANYTHING | 85 |

| | PILE 7G | |

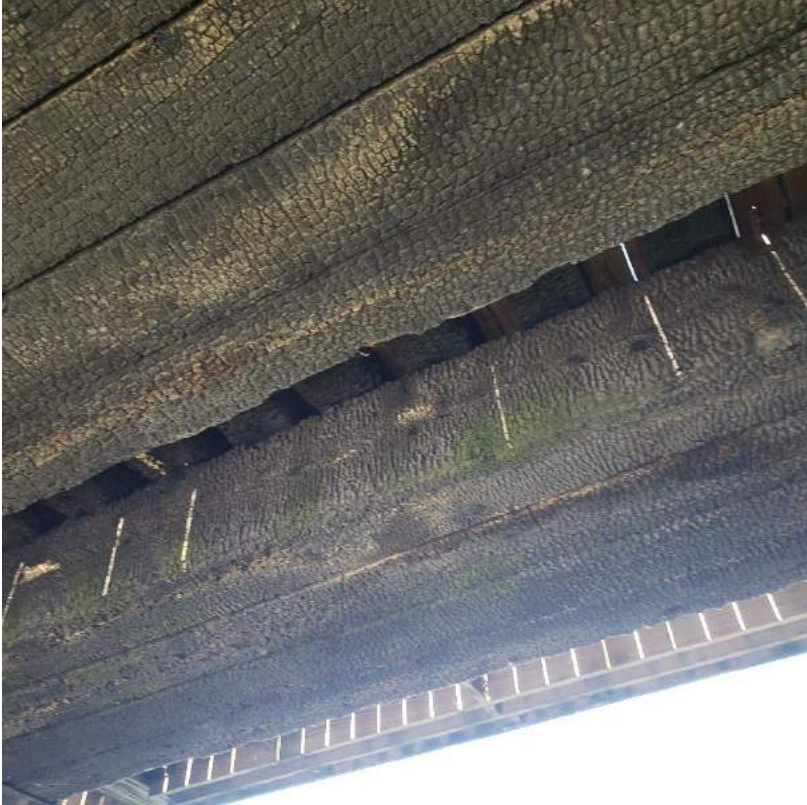
| | PHOTO | 89 |

| <b>MEMBER INSPECTED</b> | <b>FINDINGS</b> | <b>PHOTOS</b> |
|---|---|---|
| STRINGERS BETWEEN BENT 7 AND 8 | FAIR – APPROX 1” CHAR NO VISIBLE DECAY | 89 |

| | BENT 7 TO 8<br>STRINGERS | |

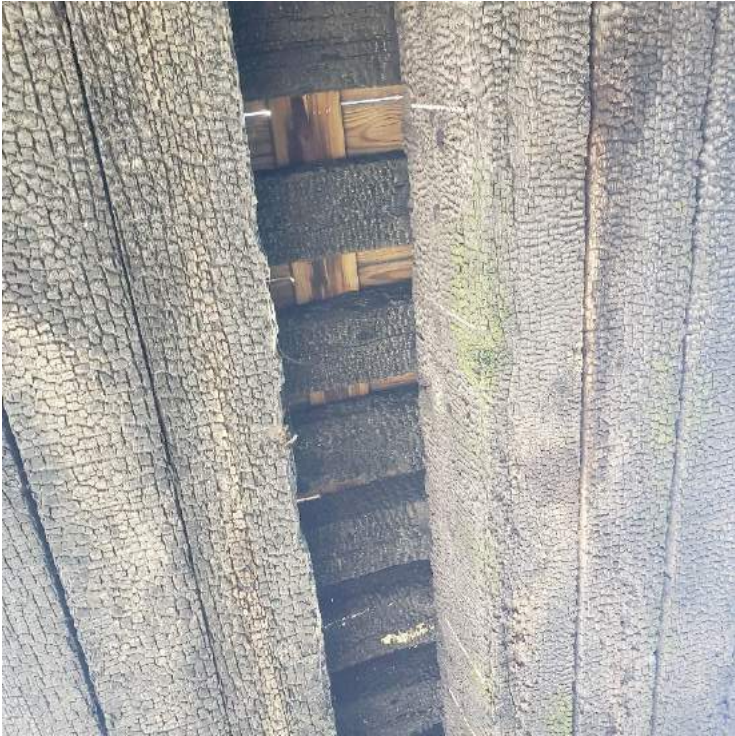
| | PHOTO | 90 |

| <b>MEMBER INSPECTED</b> | <b>FINDINGS</b> | <b>PHOTOS</b> |
|---|---|---|
| RAIL TIES BETWEEN BENT 7 AND 8 | POOR – HEAVY CHAR AND SOME DECAY SEEN FROM BELOW | 90 |

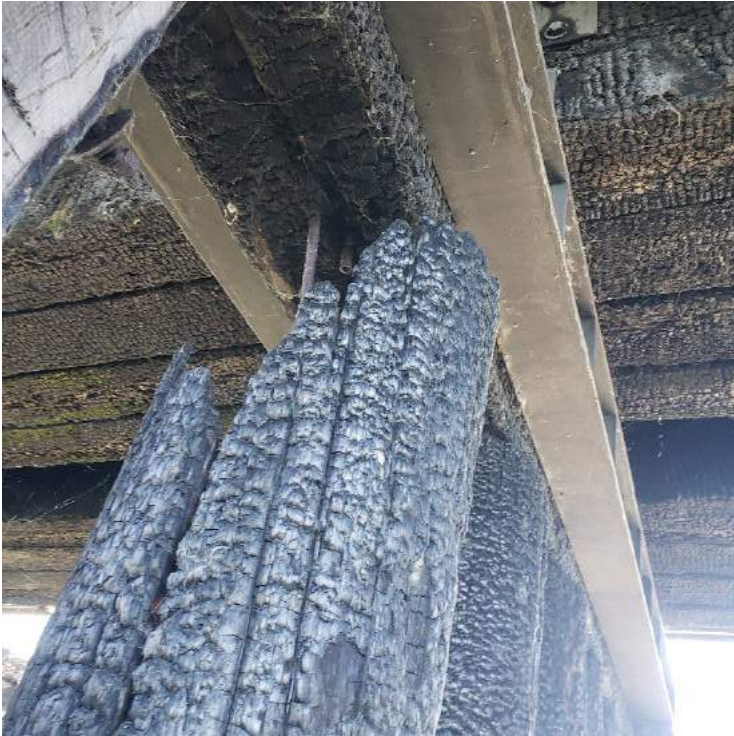
| | PHOTO | 92 |

| <b>MEMBER INSPECTED</b> | <b>FINDINGS</b> | <b>PHOTOS</b> |
|---|---|---|
| PILE 8B | POOR – DECAYED HOLLOW AT BEARING | 92 |

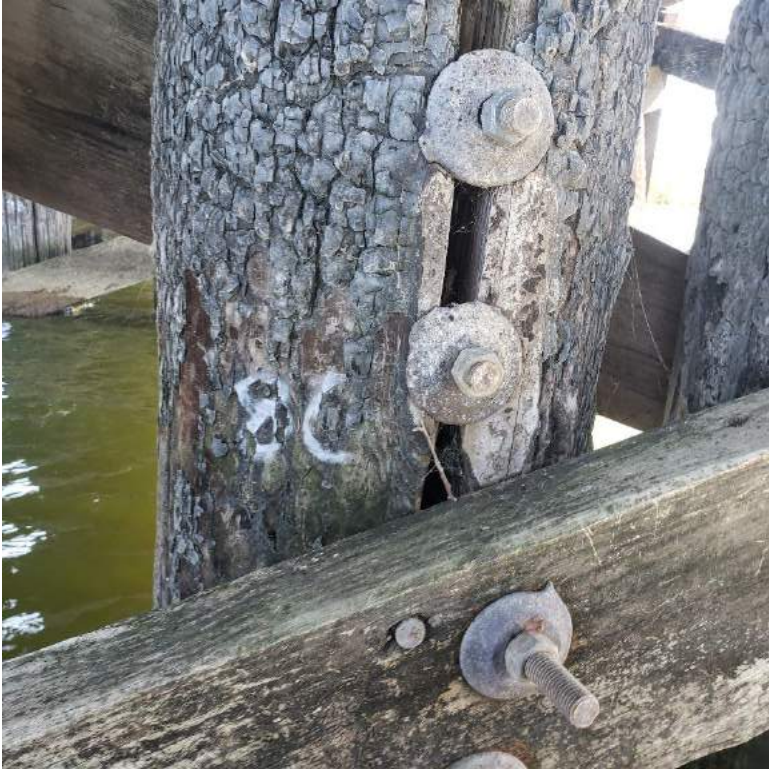
| | PHOTO | 93 |

| <b>MEMBER INSPECTED</b> | <b>FINDINGS</b> | <b>PHOTOS</b> |
|---|---|---|
| PILE 8C | POOR – DECAYED HOLLOW | 93 |

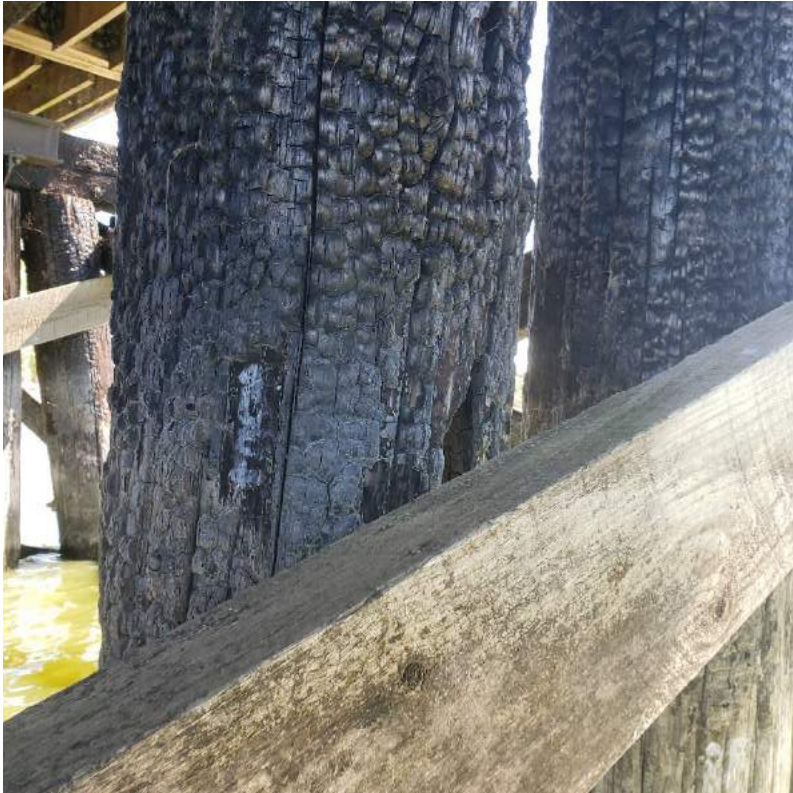
| | PHOTO | 95 |

| <b>MEMBER INSPECTED</b> | <b>FINDINGS</b> | <b>PHOTOS</b> |
|---|---|---|
| PILE 8E | POOR – DECAYED HOLLOW | 95 |

| | PILE 8E | |

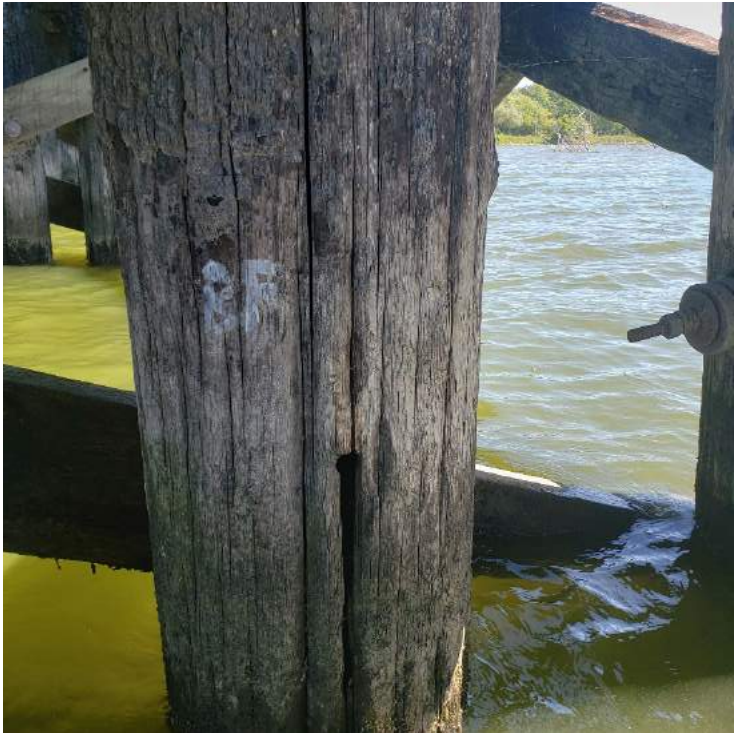
| | PHOTO | 96 |

| <b>MEMBER INSPECTED</b> | <b>FINDINGS</b> | <b>PHOTOS</b> |
|---|---|---|
| PILE 8F | POOR – DECAYED HOLLOW | 96 |

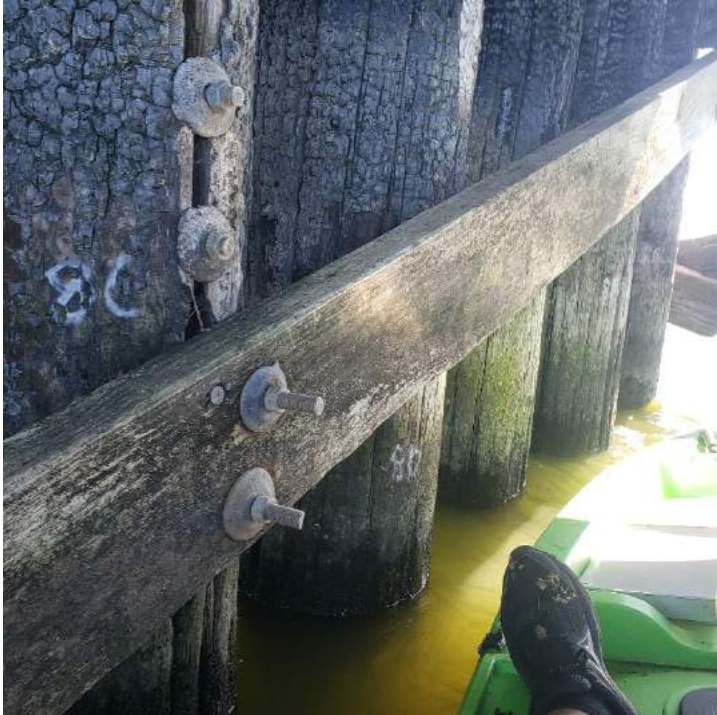
| | PHOTO | 99 |

| | PILE 8 WEST BRACE | |

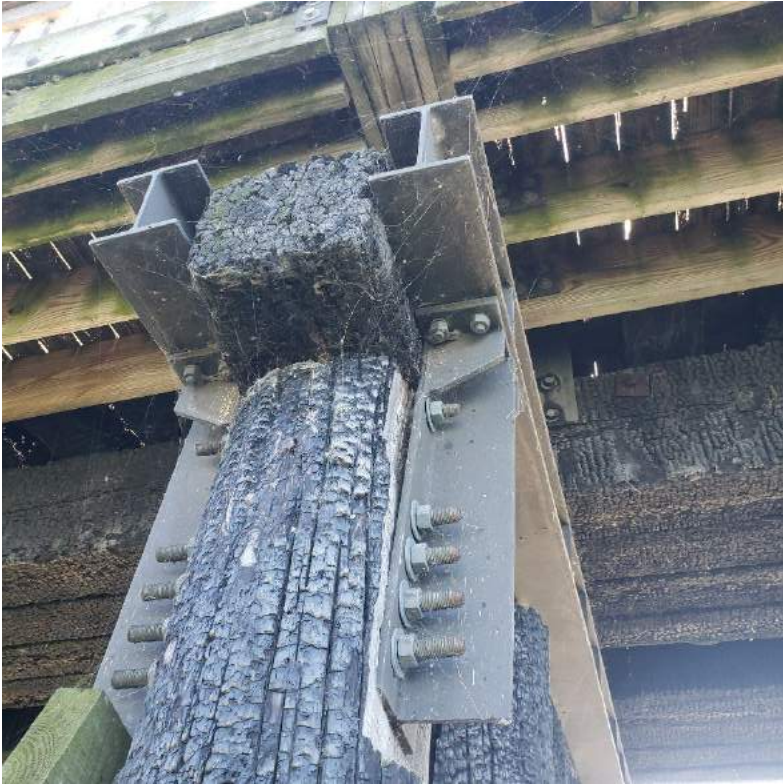
| | PHOTO | 100 |

| | BENT 8 CAP | |

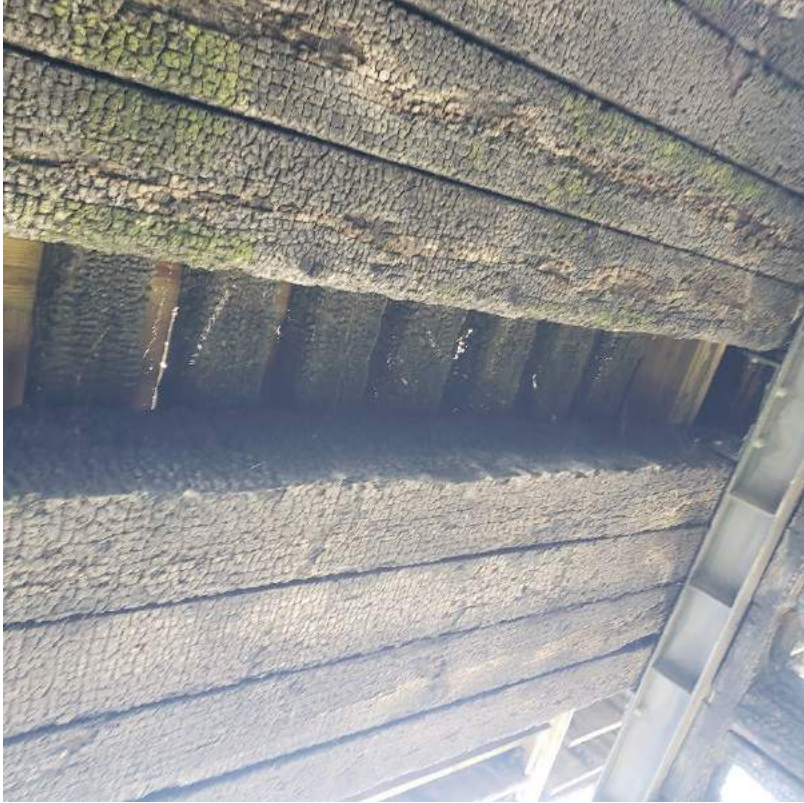
| | PHOTO | 101 |

| <b>MEMBER INSPECTED</b> | <b>FINDINGS</b> | <b>PHOTOS</b> |
|---|---|---|
| STRINGERS BETWEEN BENT 8 AND 9 | FAIR – APPROX 1” CHAR NO DECAY | 101 |
| RAIL TIES BETWEEN BENT 8 AND 9 | POOR – HEAVY CHAR AND SOME DECAY SEEN FROM BELOW | 101,122-123 |

| | BENT 8 TO 9<br>STRINGERS AND RAIL<br>TIES | |

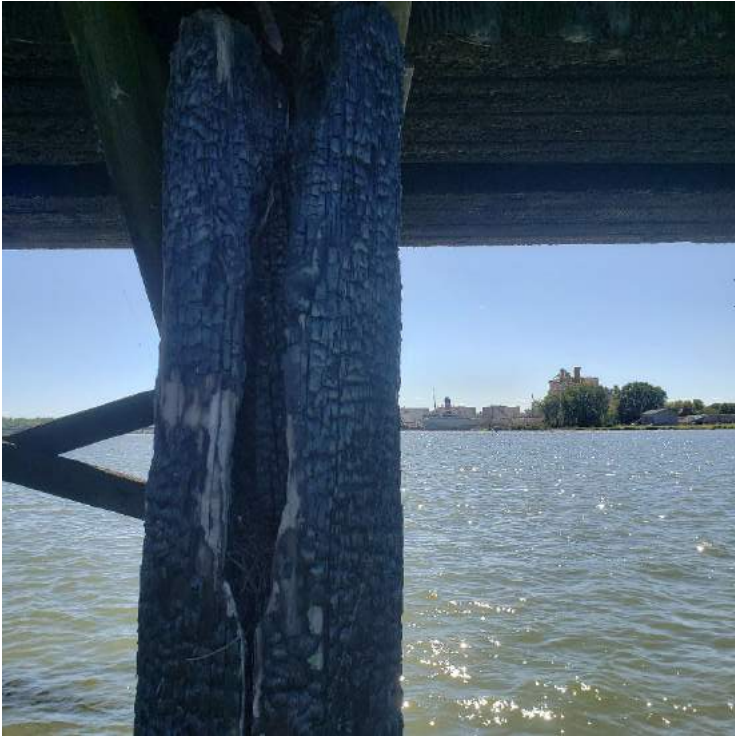
| | PHOTO | 102 |

| <b>MEMBER INSPECTED</b> | <b>FINDINGS</b> | <b>PHOTOS</b> |
|---|---|---|
| PILE 9A | POOR – DECAYED HOLLOW | 102 |

| | PILE 9A | |

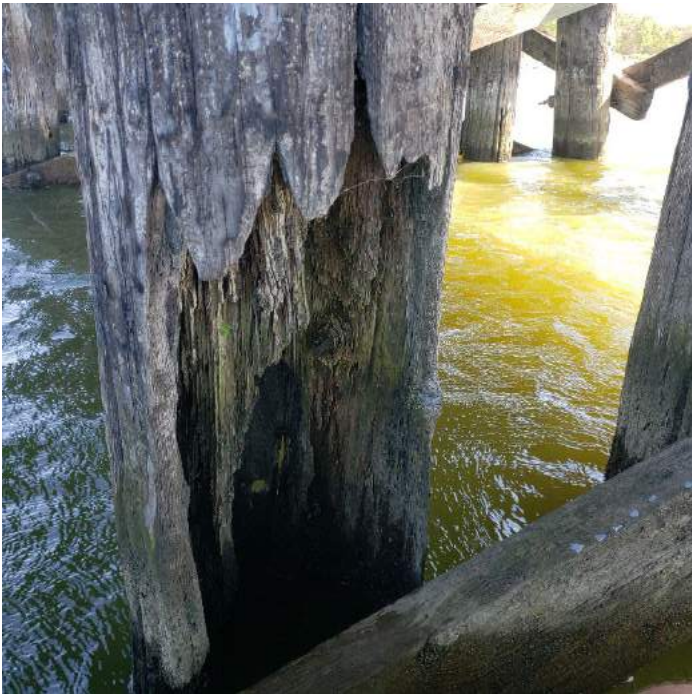
| | PHOTO | 103 |

| <b>MEMBER INSPECTED</b> | <b>FINDINGS</b> | <b>PHOTOS</b> |
|---|---|---|
| PILE 9B | POOR – DECAYED HOLLOW | 103 |

| | PILE 9B | |
