# **AGENDA OF THE PARKS COMMITTEE**

**WEDNESDAY, NOVEMBER 30, 2022, 5:00 PM**

Consideration with possible action on the removal of the Porlier Pier and review options for possible replacement.

This report contains preliminary FEL-1 estimates (+50%/- 30%) for various options to replace the Porlier Pier on the Fox River in Green Bay, WI. These budgetary estimates are based on 2023 construction and utilize RSMeans construction cost data adjusted for local pricing. Brief narratives of the options are presented, and line item estimates are included in the appendix.

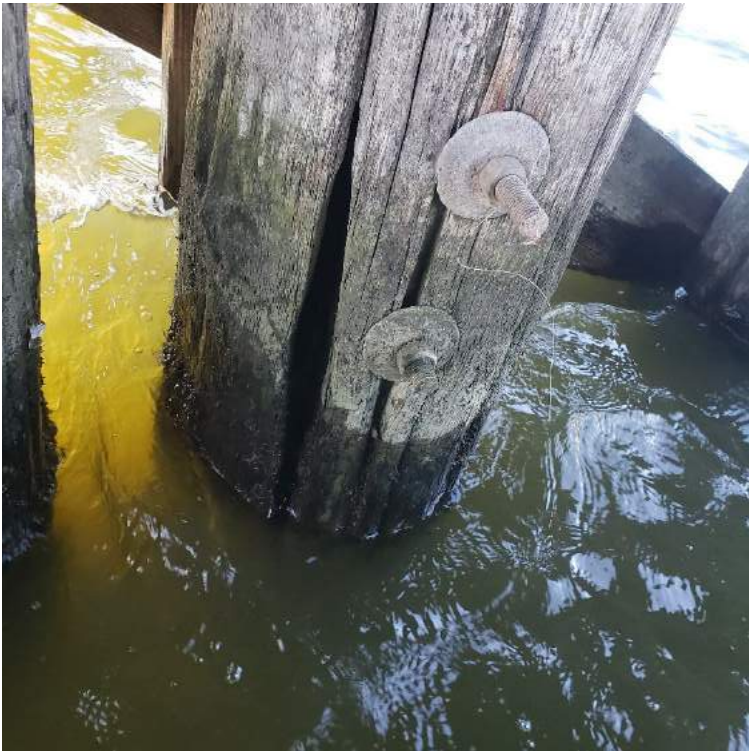
| | PHOTO | 104 |

| <b>MEMBER INSPECTED</b> | <b>FINDINGS</b> | <b>PHOTOS</b> |
|---|---|---|
| PILE 9C | POOR – DECAYED HOLLOW – SUPPORTS STEEL | 104-105 |

| | PILE 9C | |

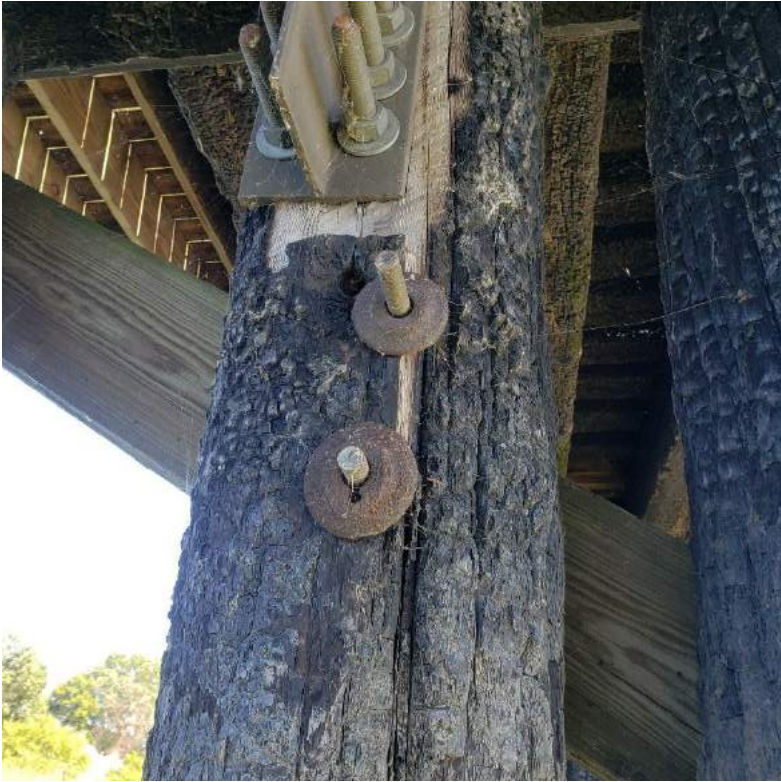
| | PHOTO | 105 |

| | PILE 9C AT STEEL REINFORCEMENT | |

Recommendation: **Do not allow further use until structural repairs are made.** It is necessary to have one sound pier at each side of every bent. It is not feasible to replace piles without removing the entire structure; additional piles could be added to the exterior ends with new beams and bracing tying the piles together. Existing piles could then be removed or left in place. See attached conceptual repair plan.

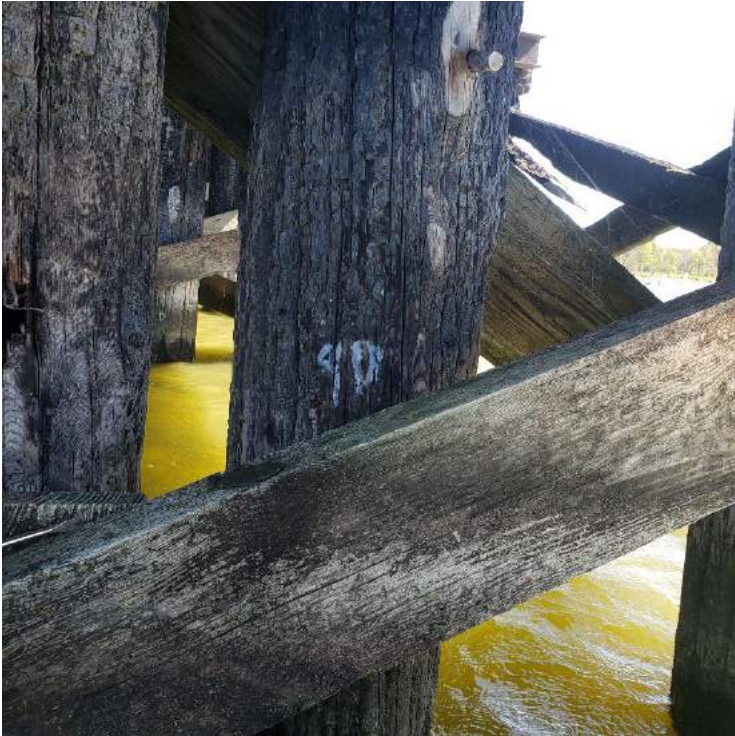
| | PHOTO | 106 |

| | PILE 9D | |

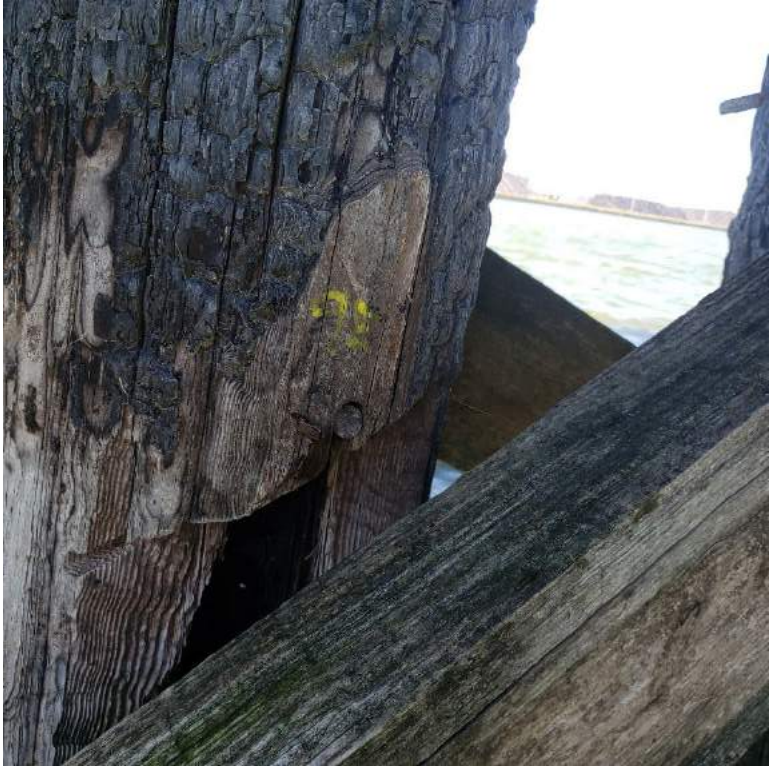
| | PHOTO | 107 |

| <b>MEMBER INSPECTED</b> | <b>FINDINGS</b> | <b>PHOTOS</b> |
|---|---|---|
| PILE 9E | POOR – DECAYED HOLLOW | 107 |

| | PILE 9E | |

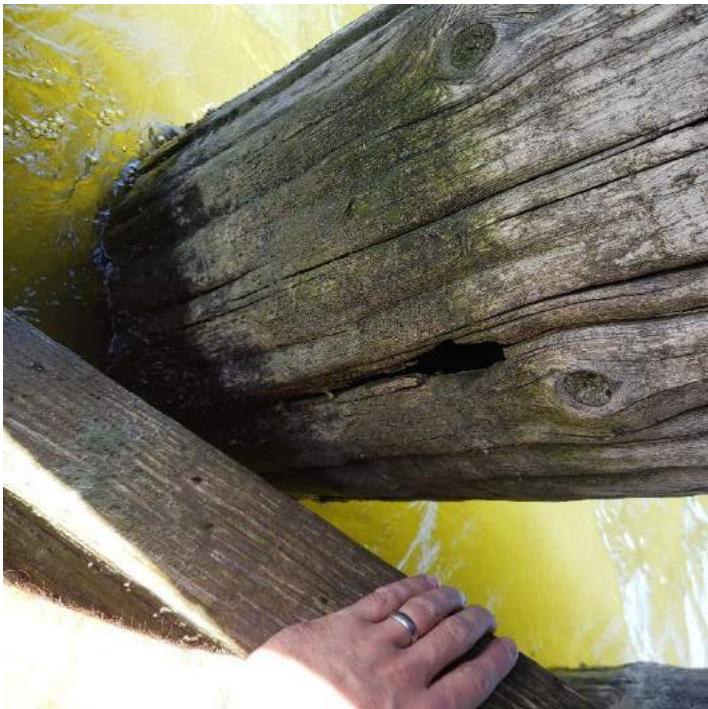
| | PHOTO | 108 |

| <b>MEMBER INSPECTED</b> | <b>FINDINGS</b> | <b>PHOTOS</b> |
|---|---|---|
| PILE 9F | POOR – DECAYED HOLLOW | 108 |

| | PILE 9F | |

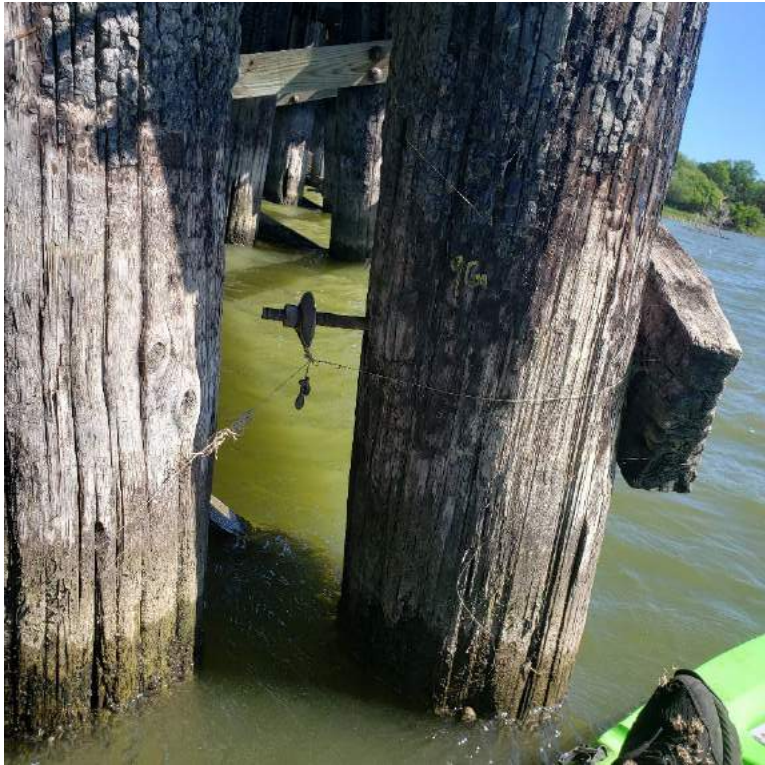
| | PHOTO | 109 |

| | PILE 9G | |

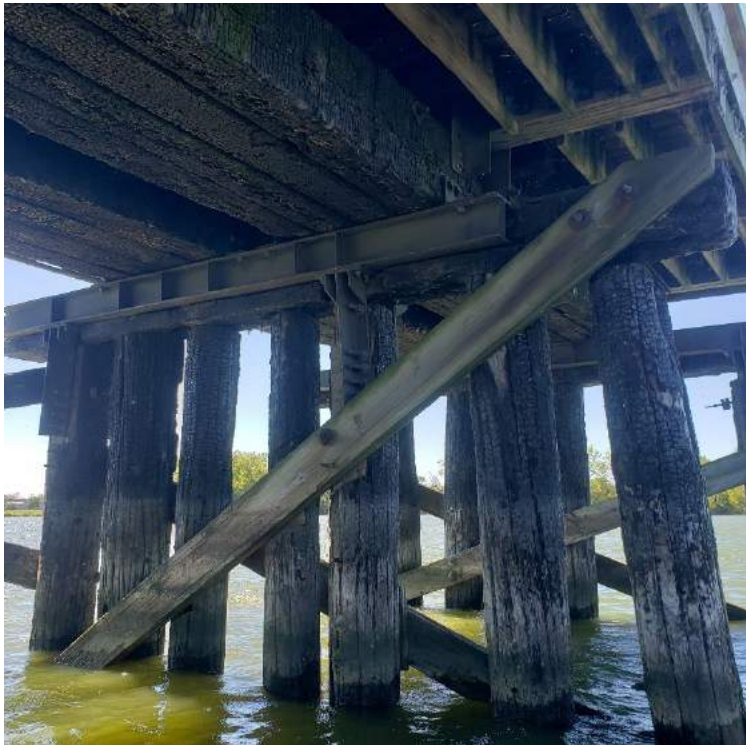
| | PHOTO | 110 |

| | BENT 9 EAST BRACE | |

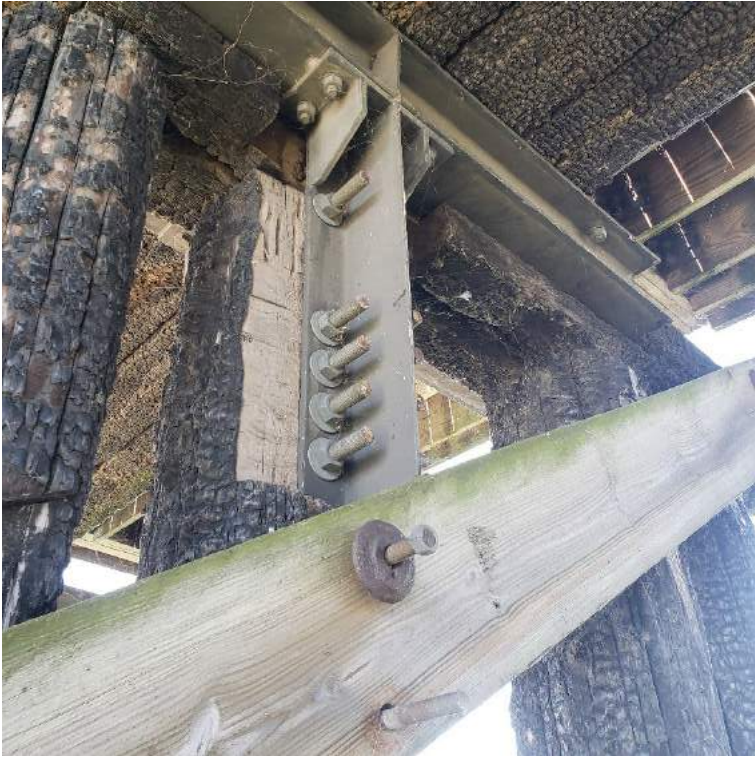
| | PHOTO | 111 |

| | BENT 9 WEST BRACE | |

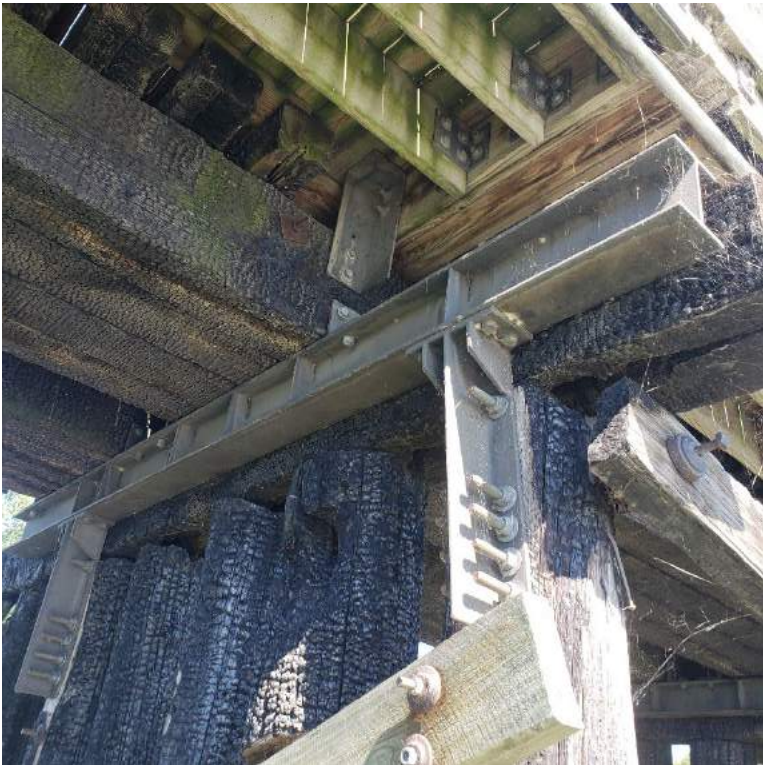
| | PHOTO | 112 |

| | BENT 9 CAP | |

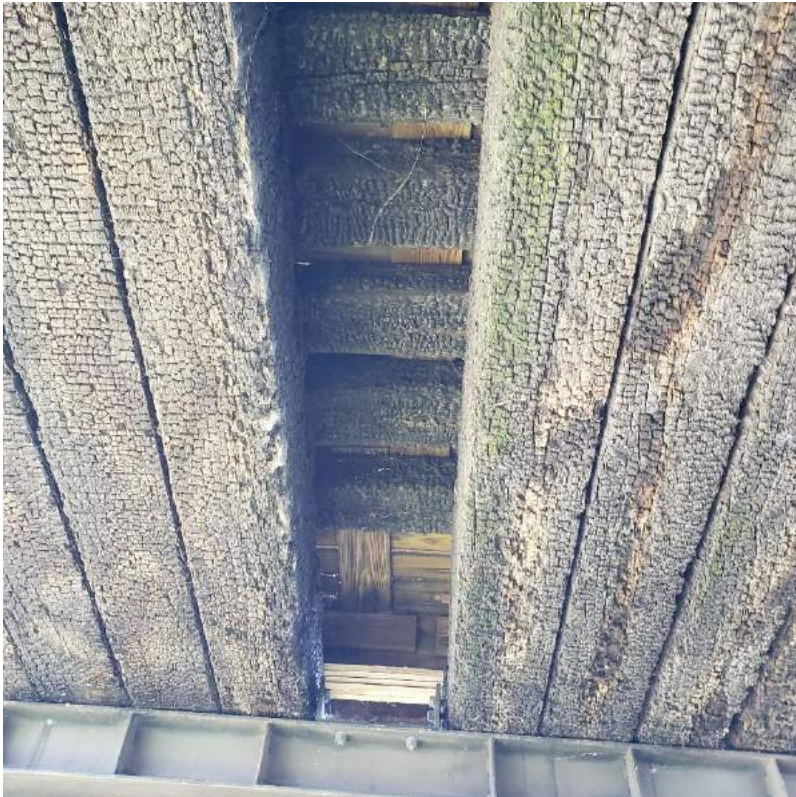
| | PHOTO | 113 |

| | BENT 9 TO 10<br>STRINGERS AND RAIL<br>TIES | |

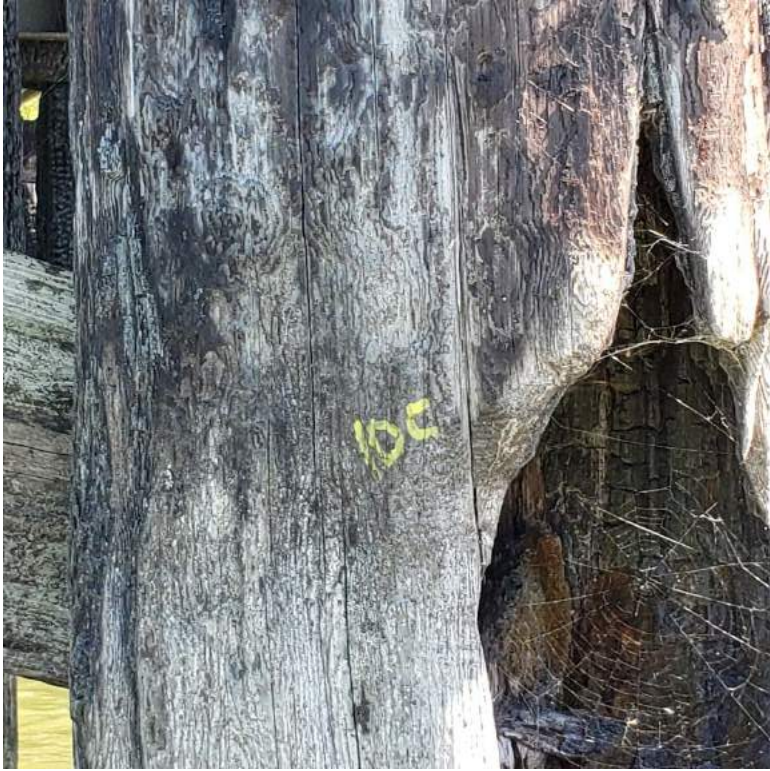
| | PHOTO | 115 |

| <b>MEMBER INSPECTED</b> | <b>FINDINGS</b> | <b>PHOTOS</b> |
|---|---|---|
| PILE 10C | POOR – DECAYED HOLLOW | 115 |

| | PILE 10C | |

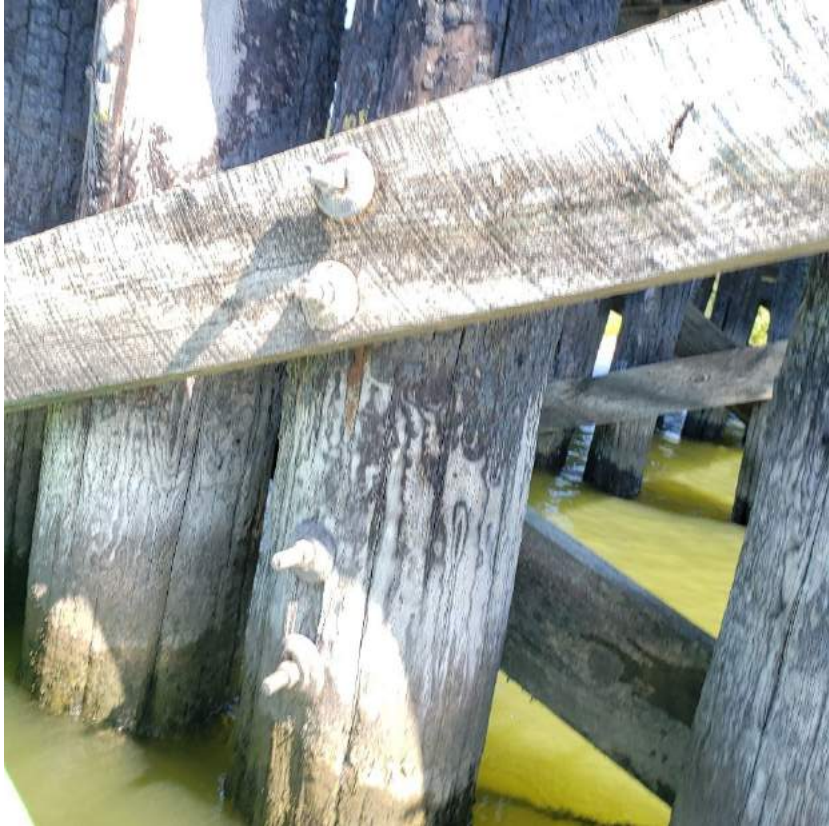
| | PHOTO | 117 |

| | PILE 10E | |

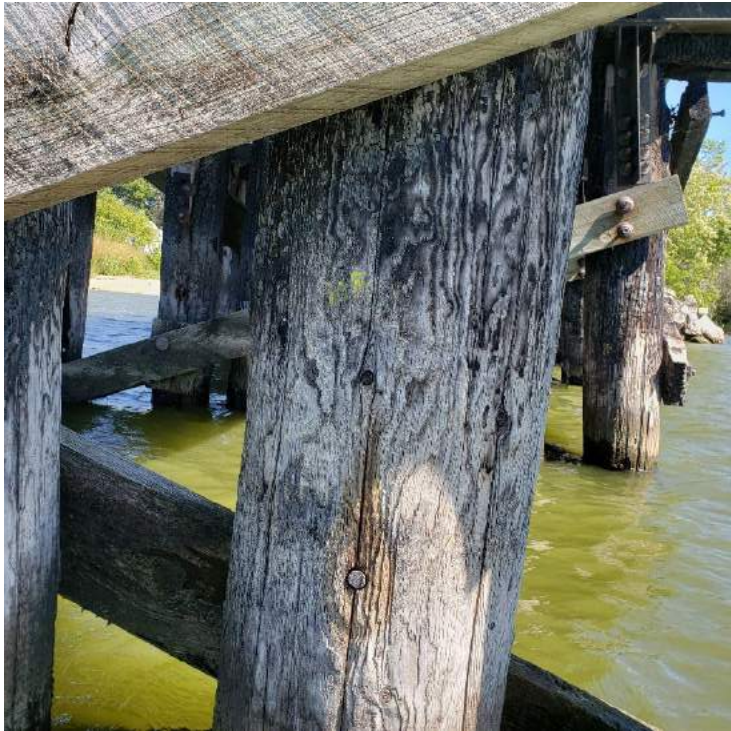
| | PHOTO | 118 |

| <b>MEMBER INSPECTED</b> | <b>FINDINGS</b> | <b>PHOTOS</b> |
|---|---|---|
| PILE 10F | POOR – SOUNDING PARTIALLY HOLLOW, TOP BEARING DECAYED | 118 |

| | PILE 10F | |

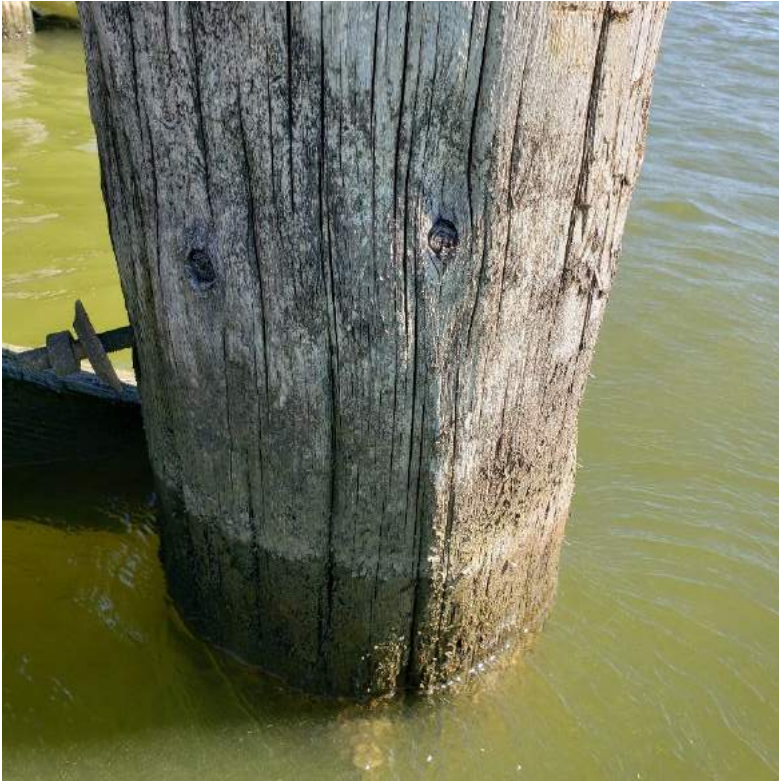
| | PHOTO | 119 |

| | PILE 10G | |

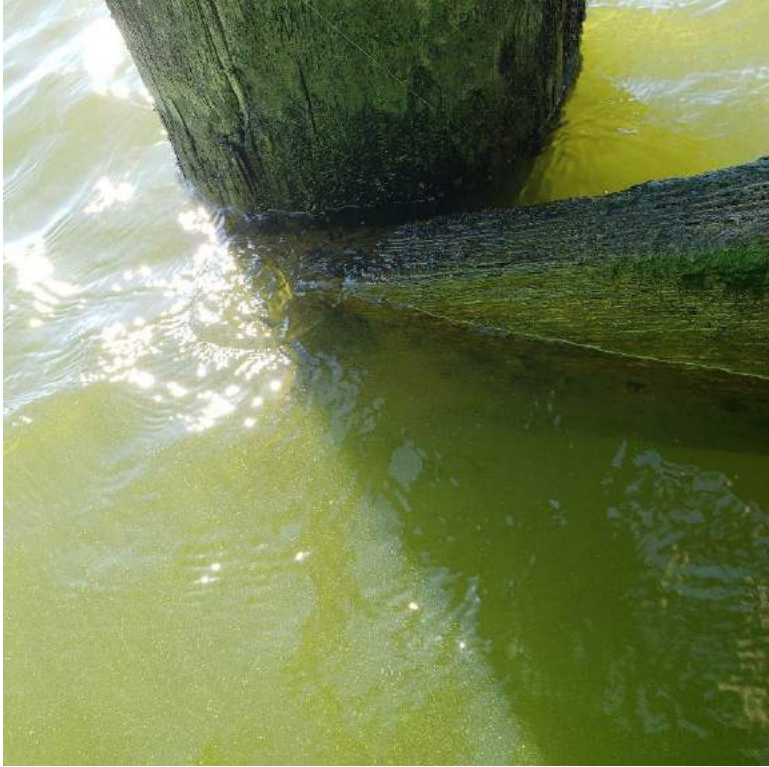
| | PHOTO | 121 |

| | BENT 10 EAST BRACE<br>– CONNECTION<br>UNDERWATER IS<br>DECAYED AND<br>FAILING | |

Recommendation: Install new bracing at new pile locations in both the North-South direction at each bent and the East-West Direction along both sides to provide a new braced framework.

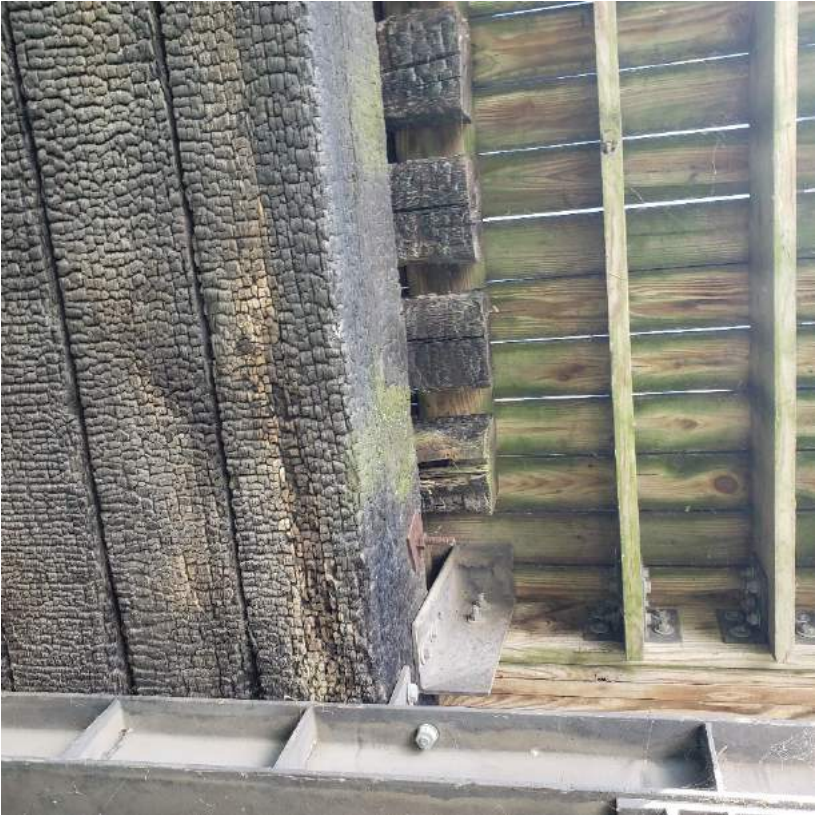
| | PHOTO | 122 |

| <b>MEMBER INSPECTED</b> | <b>FINDINGS</b> | <b>PHOTOS</b> |
|---|---|---|
| RAIL TIES BETWEEN BENT 8 AND 9 | POOR – HEAVY CHAR AND SOME DECAY SEEN FROM BELOW | 101,122-123 |

| | BENT 8-9 RAIL TIES<br>DECAY | |

Recommendation: Upon removal of the 2x6 decking above, it will become clear if there is any decay of the railroad ties. Recommend an allowance of approximately 20% replacement of railroad ties.

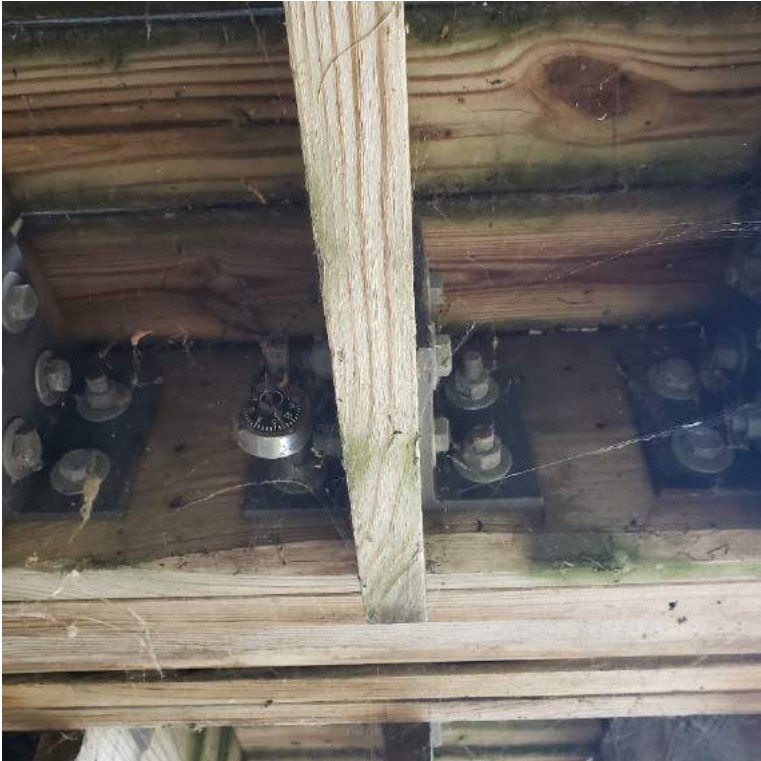
| | <p>PHOTO</p> <p>124</p> |

All the treated 2x joists and framing members added on the East and West side of the pier were found to be structurally sound in good condition. See attached photos. Note: there are 2x6 sleepers located under the 2x6 decking, above the railroad ties. The large contact area between these sleepers and the decking and railroad ties provides an area prone to decay from sitting water.

| <b>MEMBER INSPECTED</b> | <b>FINDINGS</b> | <b>PHOTOS</b> |
|---|---|---|
| 2X12 PT FRAMING AT N AND S SIDES SUPPORTING DECK | GOOD – NO SIGNS OF DECAY | 124-130 |

| | <p>BENT 8-9 RAIL TIES<br/>DECAY</p> <p>TYPICAL 2X12 PT<br/>FRAMING NORTH<br/>AND SOUTH SIDES</p> |

Recommendation: At replacement of the deck, also replace the sleepers with a narrower material and provide waterproofing material over the top of any wood sleepers and wood joists in direct contact with the decking.

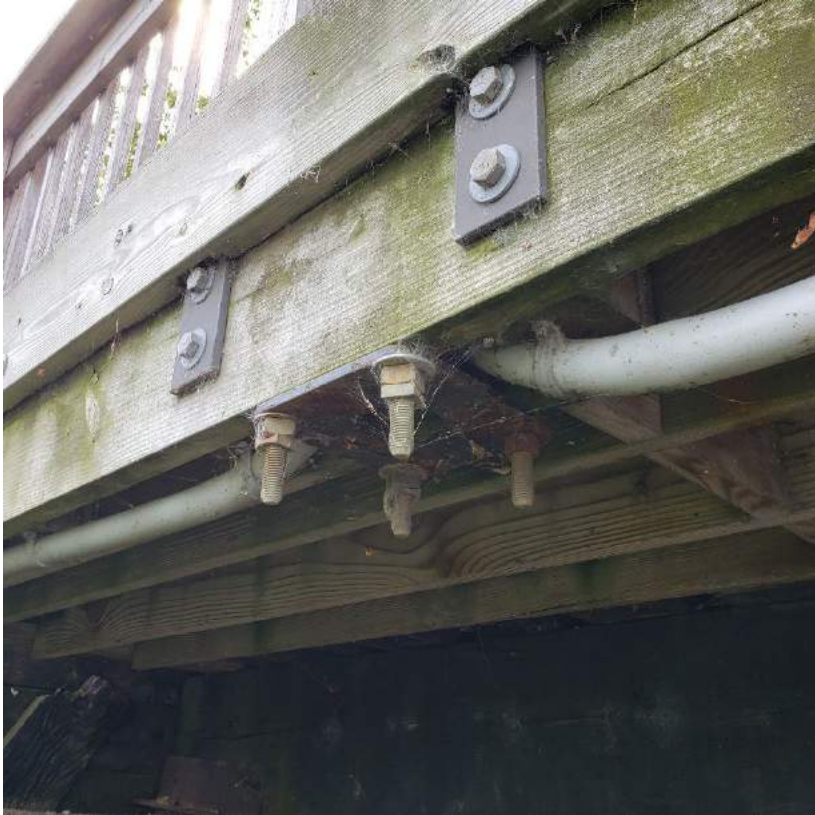
| | PHOTO | 125 |

The anchorage of the light poles is questionable. Significant movement is possible in the poles with applied pressure. Recommend reinforcing light pole anchorage for reduced sway movement.

| | TYPICAL SIDE SKIRTING AND PT FRAMING AT LIGHT POLE CONNECTION (2005) | |

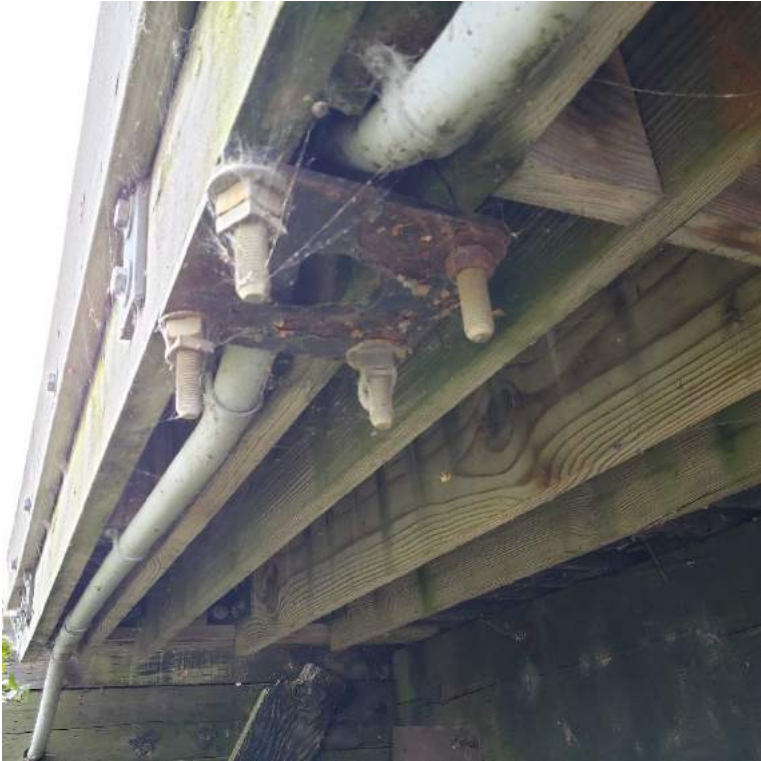
| | PHOTO | 126 |

| | LIGHT POLE CONNECTION DETAIL | |

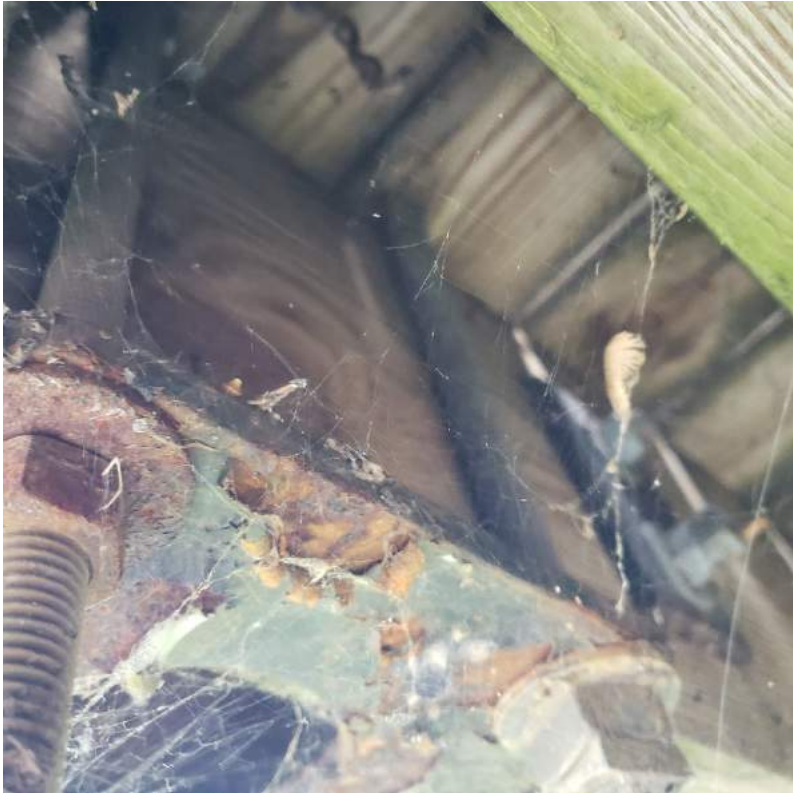
| | PHOTO | 127 |

| | LIGHT POLE<br>CONNECTION DETAIL | |

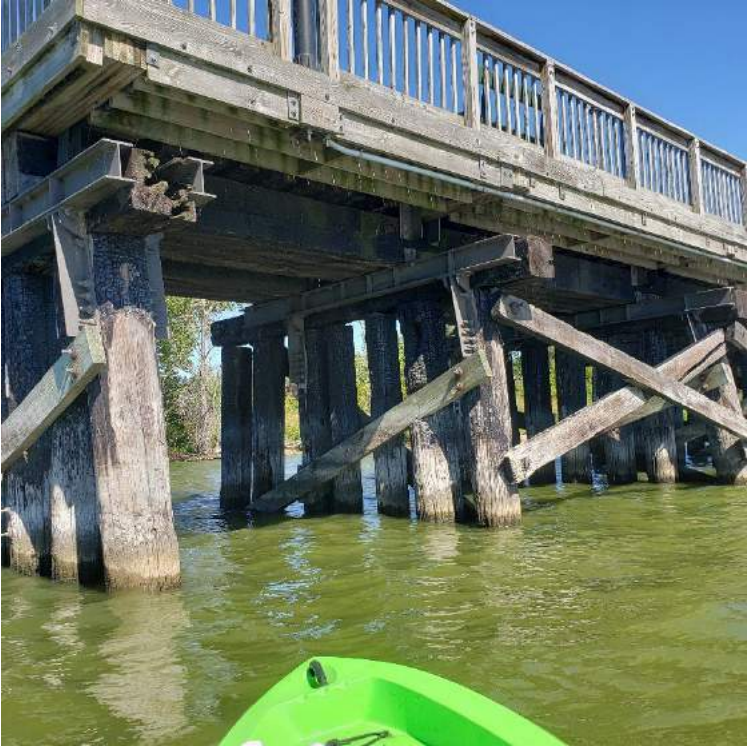
| | PHOTO | 128 |

| <b>MEMBER INSPECTED</b> | <b>FINDINGS</b> | <b>PHOTOS</b> |
|---|---|---|
| SOUTH SIDE X-BRACE BETWEEN BENT 8 AND 9 | POOR - CONNECTIONS FAILING | 128-133 |
| SOUTH SIDE X-BRACE BETWEEN BENT 9 AND 10 | POOR - MISSING | 128 |

| | SOUTH SIDE BRACING<br>BENTS 8-10 | |

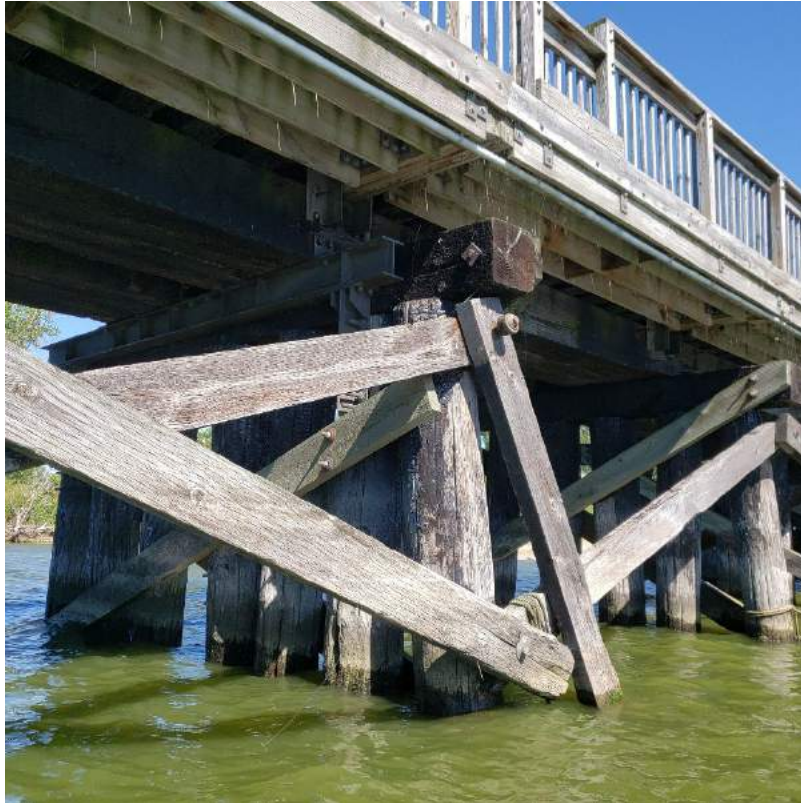
PHOTO

SOUTH SIDE BRACING  
AT BENT 7

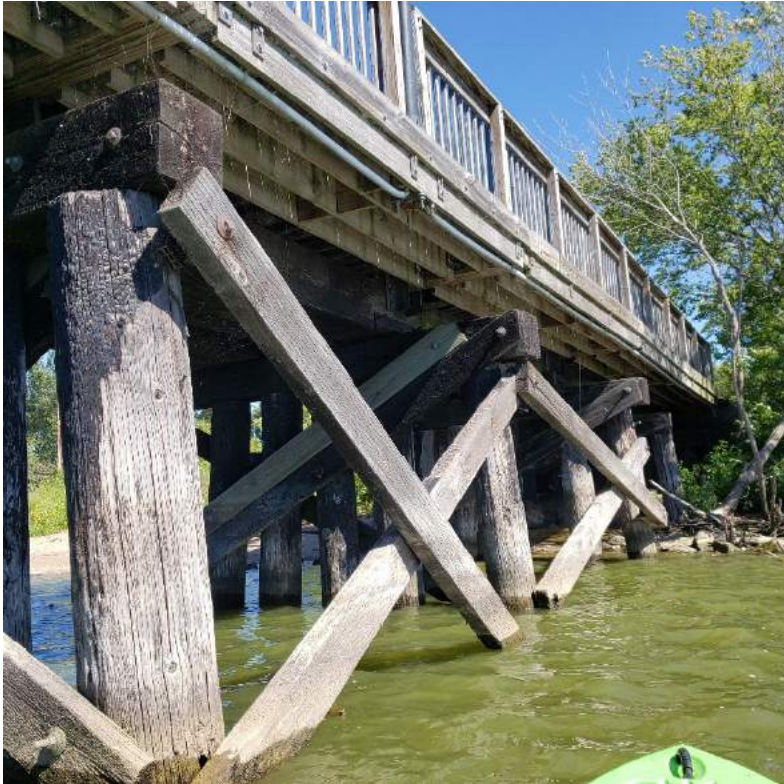
| | PHOTO | 131 |

There is also cross bracing that ties each bent together along the south side of the pier. Most of this bracing is in poor condition or has failed.

| <b>MEMBER INSPECTED</b> | <b>FINDINGS</b> | <b>PHOTOS</b> |
|---|---|---|
| SOUTH SIDE X-BRACE BETWEEN BENT 3 AND 4 | POOR - CONNECTIONS FAILED | 131-133 |

| | SOUTH SIDE BRACING<br>BENTS 0-4 | |

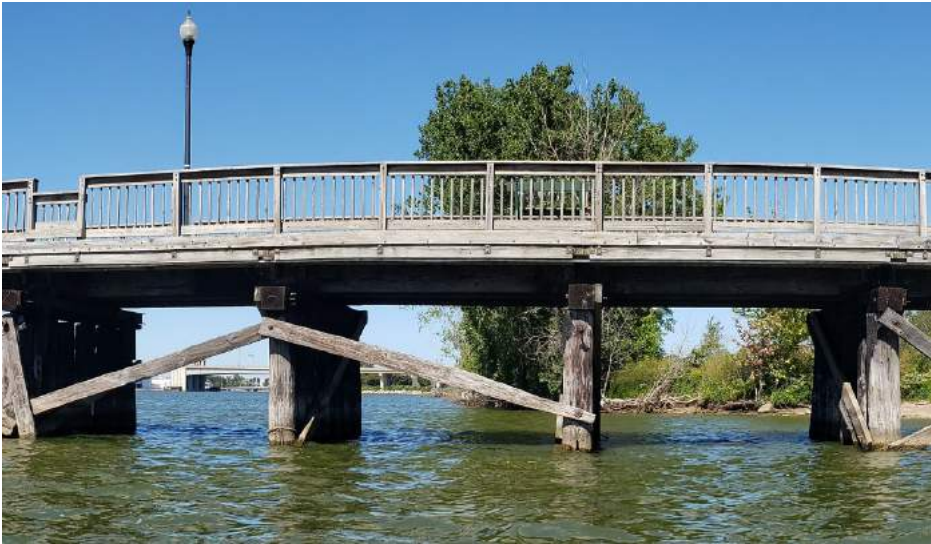
| | PHOTO | 132 |

| | SOUTH SIDE BRACING<br>BENTS 7-4 | |

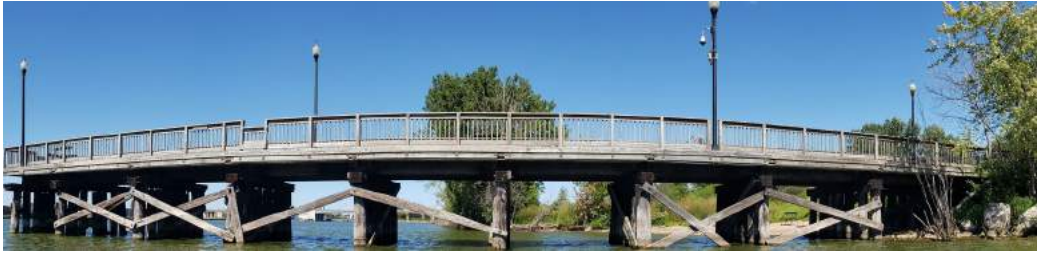
| | PHOTO | 133 |

| | SOUTH SIDE OVERALL | |

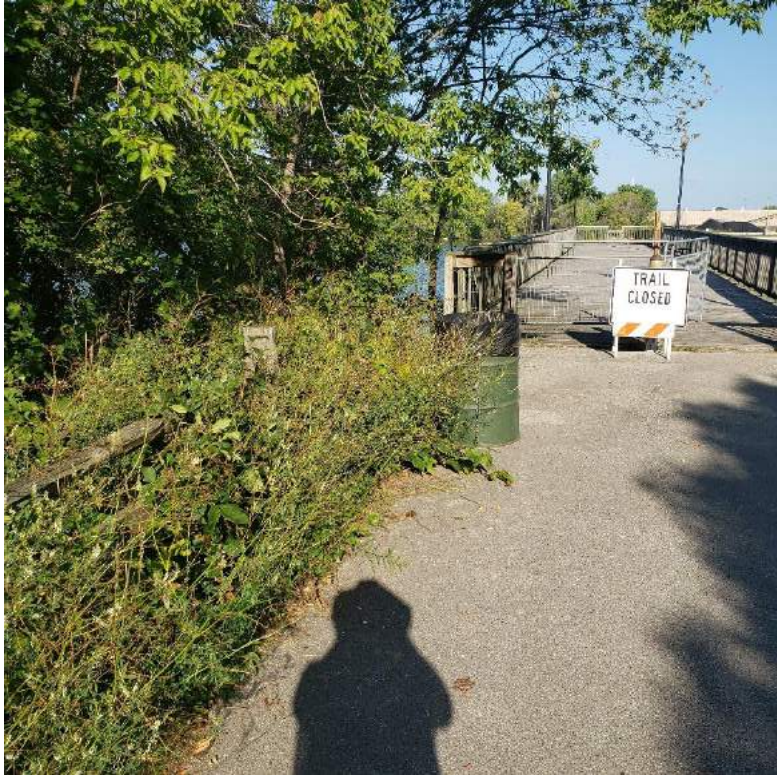
| | PHOTO | 134 |

| <b>MEMBER INSPECTED</b> | <b>FINDINGS</b> | <b>PHOTOS</b> |
|---|---|---|
| APPROACH SPLIT CEDAR RAILS | POOR- MISSING RAILS AT SOUTH SIDE AND TIPPING RAILS AT NORTH SIDE | 134-135 |

| | APPROACH SOUTH<br>RAIL MISSING | |

Recommend rebuilding the retaining walls on the East and West side of the pavement at the approach and placing new pavement. The split cedar railings at the approach are also failing or missing and should be replaced.

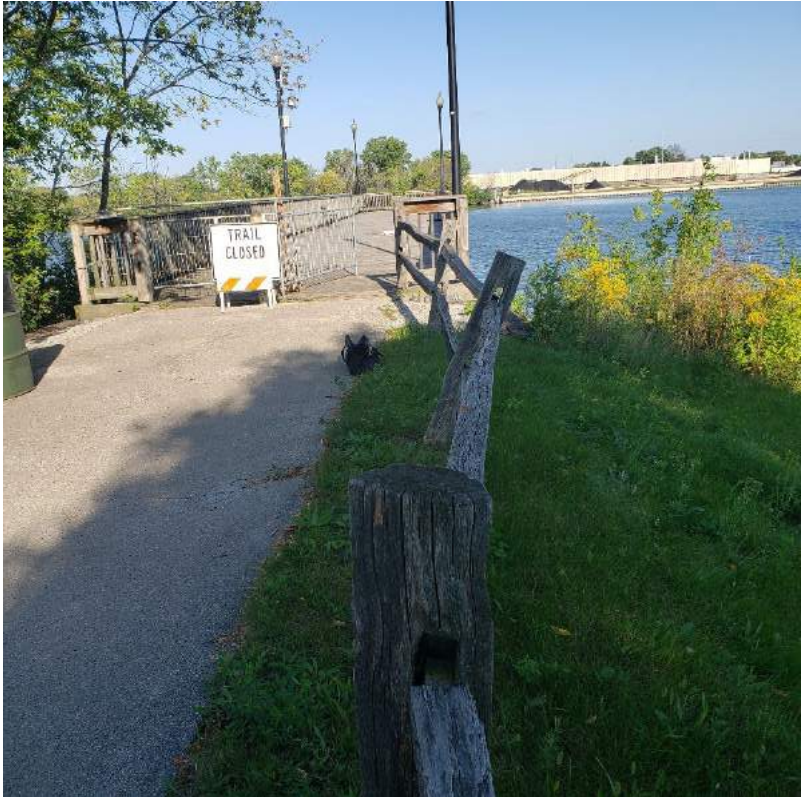
| | PHOTO | 135 |

| | APPROACH NORTH<br>RAIL FAILING | |

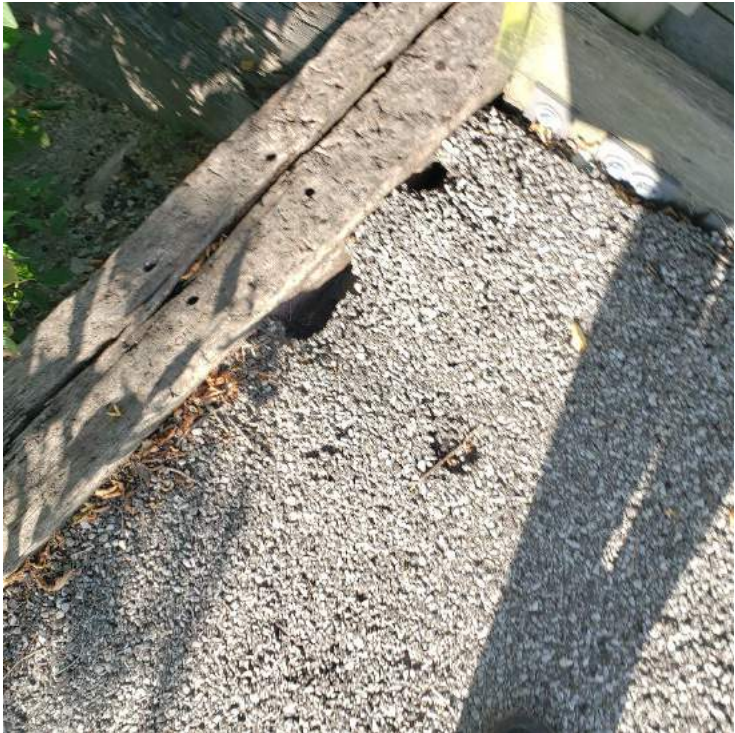
| | PHOTO | 136 |

The approach retaining walls are in poor condition. Significant wash out and sink holes have appeared.

| | SINK HOLE /<br>WASHOUT AT SOUTH<br>SIDE OF ABUTMENT | |

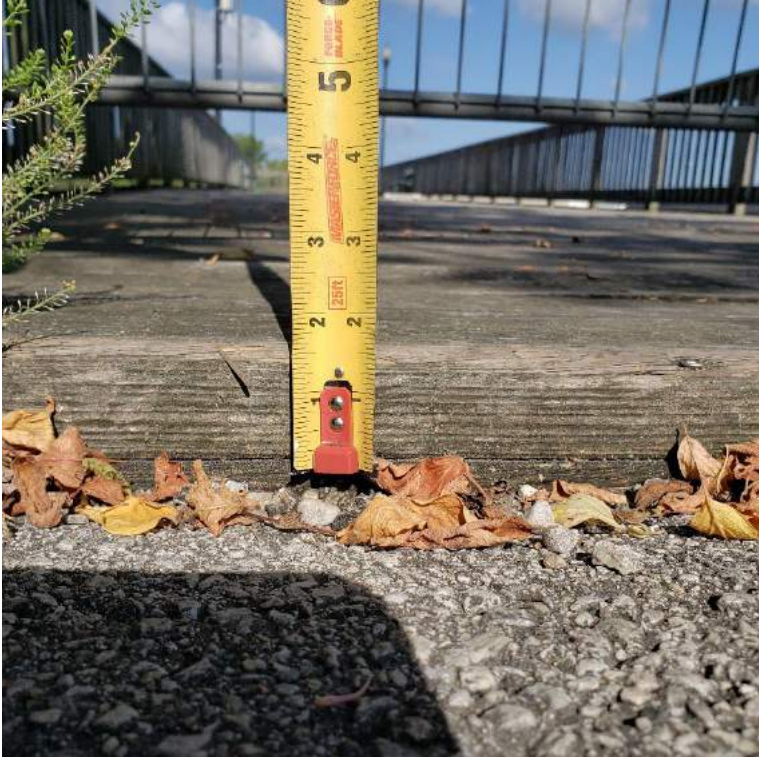
| | PHOTO | 137 |

| | SETTLEMENT AT ABUTMENT CAUSING LARGE BUMP | |

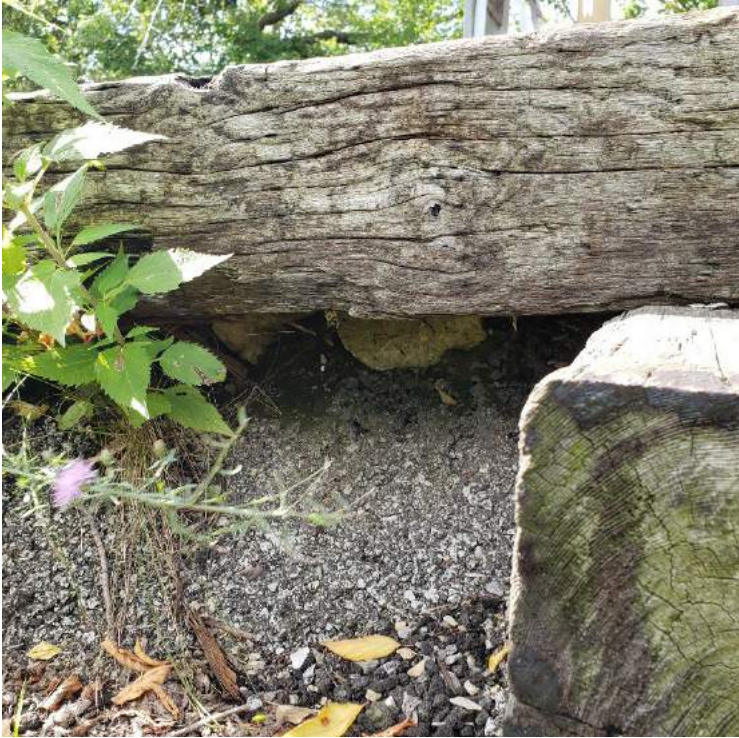
| | PHOTO | 138 |

| | ERROSION/WASHOUT AT NORTH SIDE ABUTMENT RETAINING | |

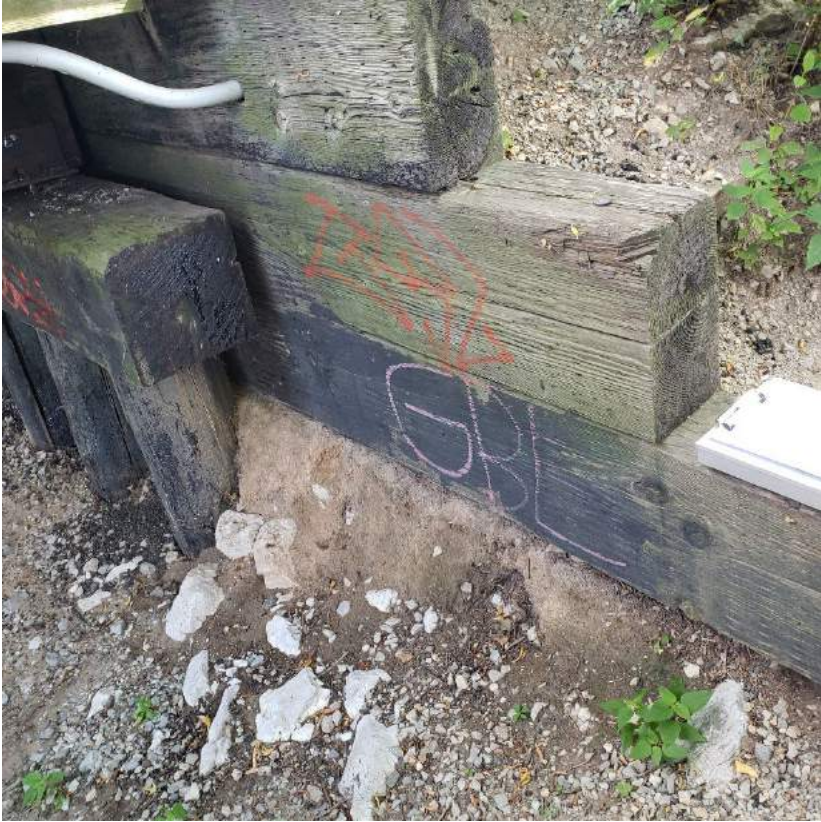
| | PHOTO | 139 |

| | ERROSION/WASHOUT<br>AT SOUTH SIDE<br>ABUTMENT | |

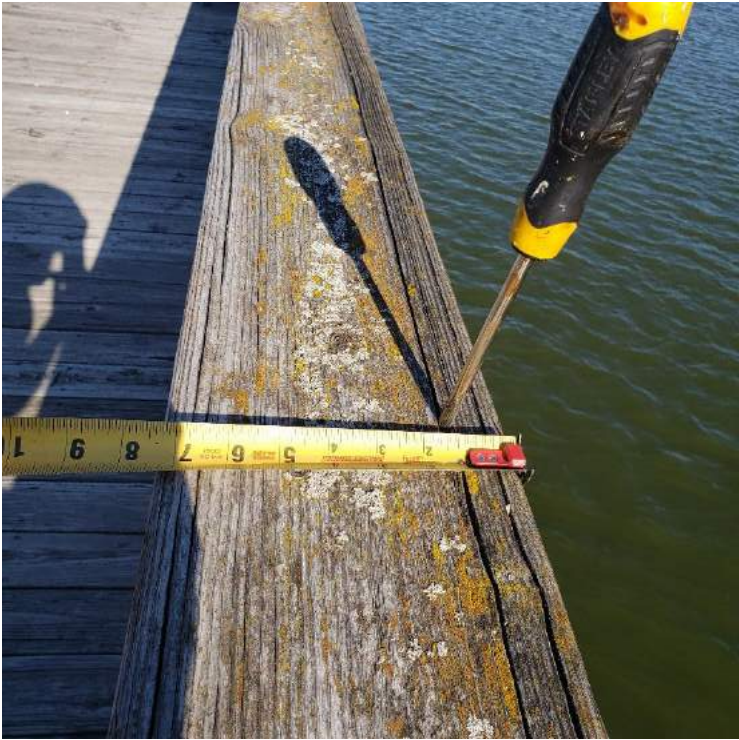
| | PHOTO | 140 |

| | TYPICAL<br>WEATHERING OF TOP<br>RAIL | |

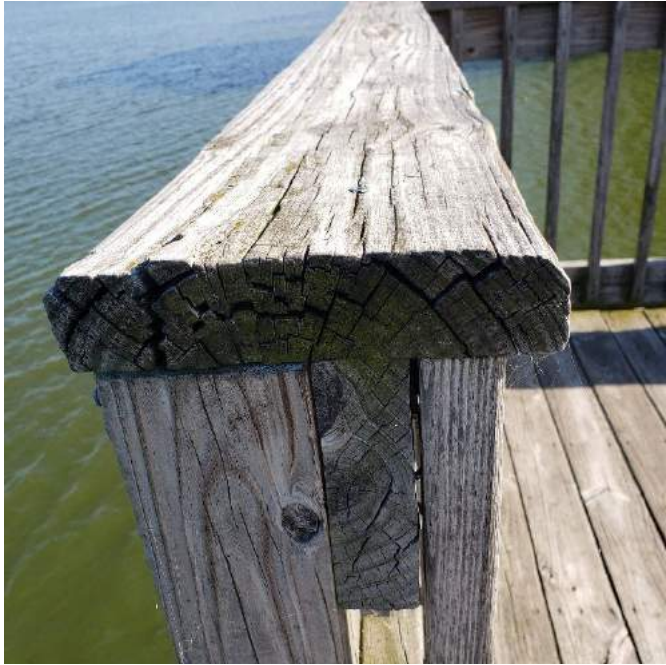
| | PHOTO | 141 |

| | TYPICAL WEATHERING OF TOP RAIL | |

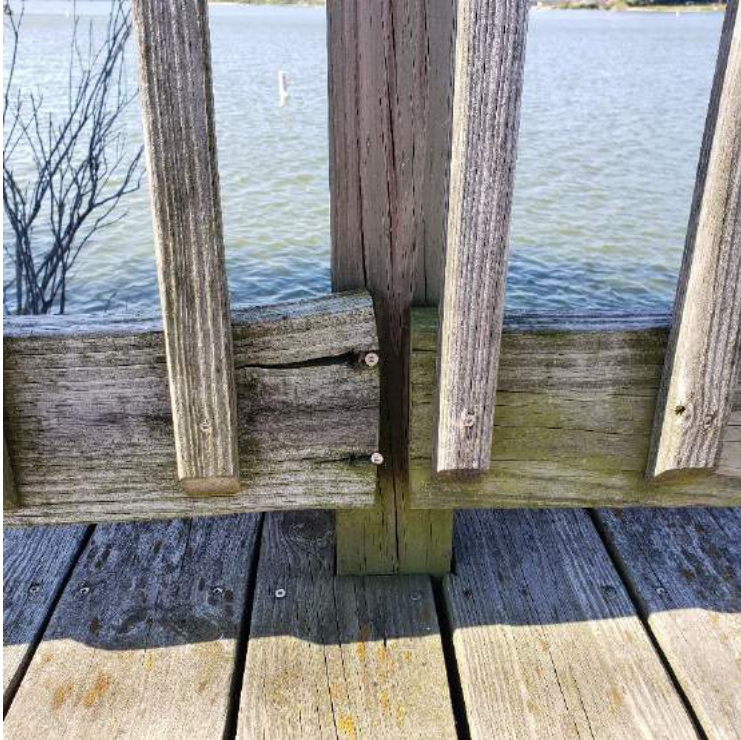
| | PHOTO | 142 |

The guard rails are in fair to poor condition. The top rails have significant weathering. Approximately 5 of the spindles are broken and the bottom rail is in poor condition due to weathering. The posts are in fair condition.

| | FAILING CONNECTION AT LOWER RAIL | |

Recommendation: Replace the rails, and spindles. Consider changing the design to a water shedding angle the does not allow water to collect on the top surface. The existing 4x4 posts can be re-used.

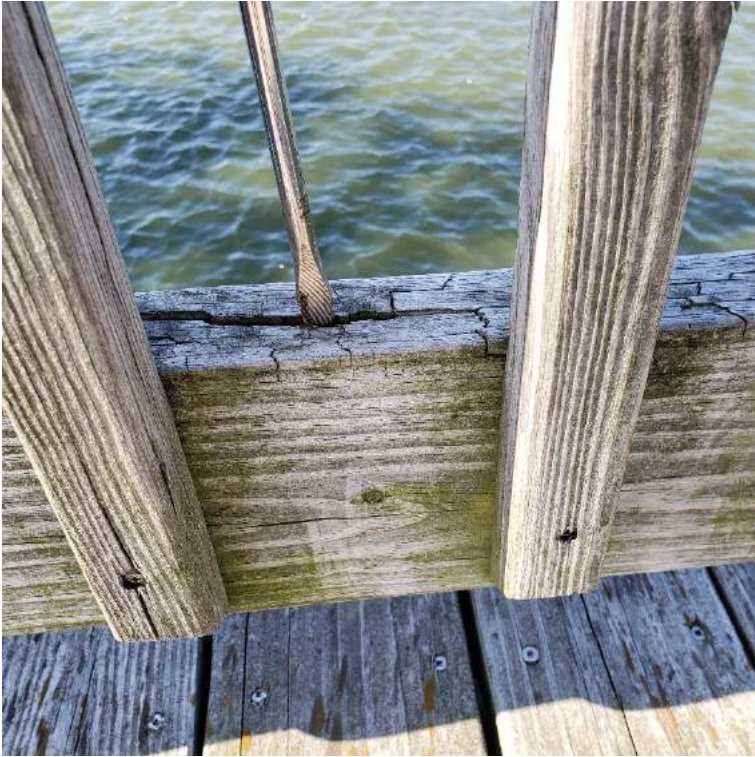
| | PHOTO | 143 |

| | DECAY AT BOTTOM RAIL | |

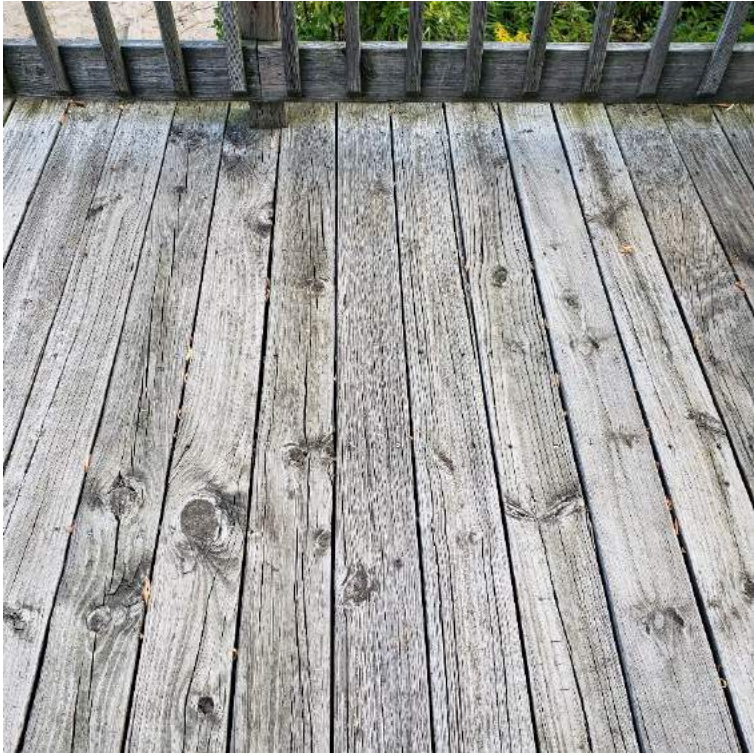
| | PHOTO | 144 |

The decking is in poor condition; it has significant deterioration on the top surface and some of the deck boards have completely failed. See photo report for additional details.

| | TYPICAL DECK BOARDS | |

Recommendation: Remove and replace all decking. Consider use of composite decking or other materials with longer lifespan.
