# **AGENDA OF THE PARKS COMMITTEE**

**WEDNESDAY, NOVEMBER 30, 2022, 5:00 PM**

Consideration with possible action on the removal of the Porlier Pier and review options for possible replacement.

This report contains preliminary FEL-1 estimates (+50%/- 30%) for various options to replace the Porlier Pier on the Fox River in Green Bay, WI. These budgetary estimates are based on 2023 construction and utilize RSMeans construction cost data adjusted for local pricing. Brief narratives of the options are presented, and line item estimates are included in the appendix.

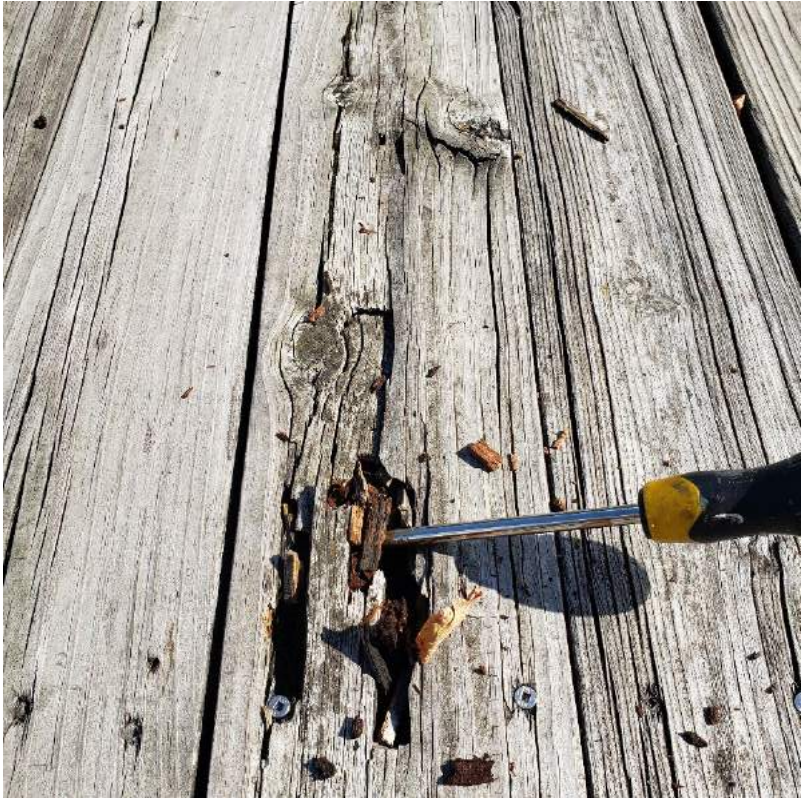
| | PHOTO | 145 |

The decking is in poor condition; it has significant deterioration on the top surface and some of the deck boards have completely failed. See photo report for additional details.

| | DECAYED DECK BOARDS | |

Recommendation: Remove and replace all decking. Consider use of composite decking or other materials with longer lifespan.
