AGENDA OF THE AD HOC FACILITIES COMMITTEE

- I. Consideration with possible action the review of the Facilities Assessment Updates for City Hall, Municipal Court, Police Station, and Fire Station #1.

An assessment of City Hall was conducted in 2015 by Berners Schober which reviewed the condition of the building's architectural, structural, mechanical, plumbing and electrical elements. This report, done in the summer of 2022, is an update to the previous assessment. Each building was re-surveyed by trade and the reports updated. Below are brief summaries of the changes to the building in the intervening 7 years.

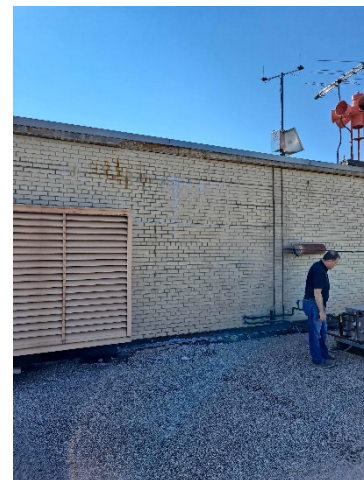
Mechanical penthouse - tuck pointing

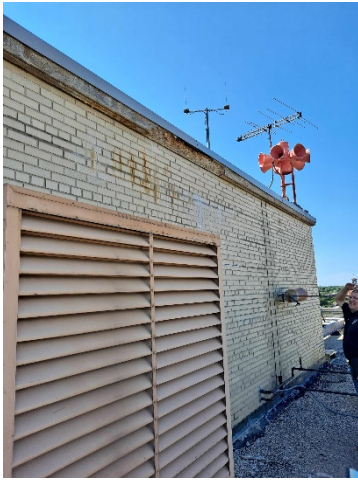
Penthouse pre-cast coping replacement

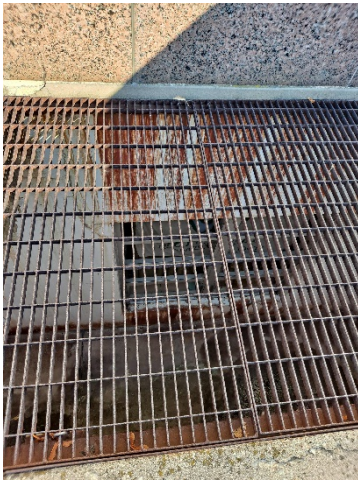
Rust on window well walls

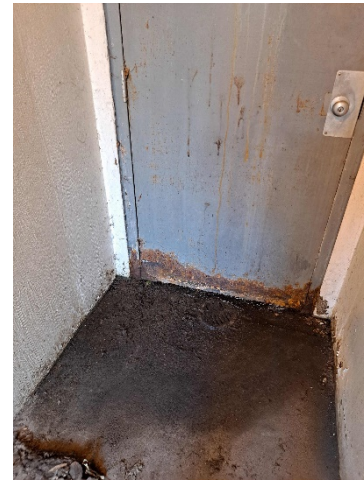
Rusted door to window well

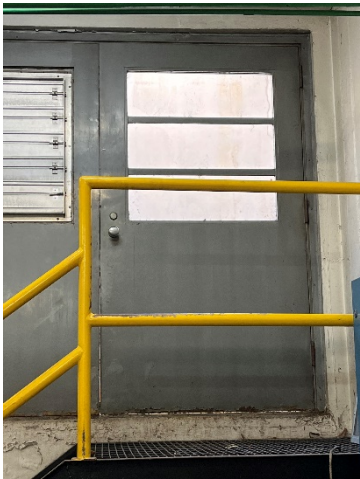
- Paint at frames is worn and chipped in multiple locations.
- Metal door from boiler room to exterior is rusted at sill. Weatherstripping is missing at door. Daylight visible at door perimeter.

Missing weatherstripping at rusted door

- A10.** Touch-up chipped paint at interior doors and frames as needed.
- A11.** Short-term recommendation: replace weatherstripping at perimeter of exterior door. Sand rusted surfaces and apply rust-inhibiting paint. Long-term recommendation: plan for replacement of door and frame.

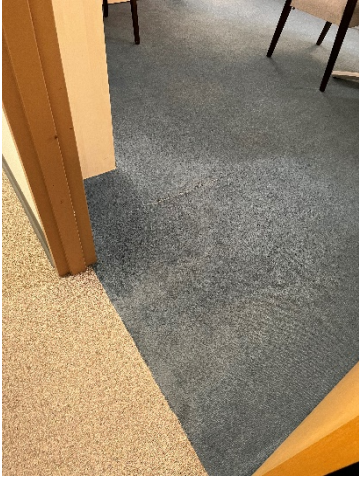
Ripped carpet seam

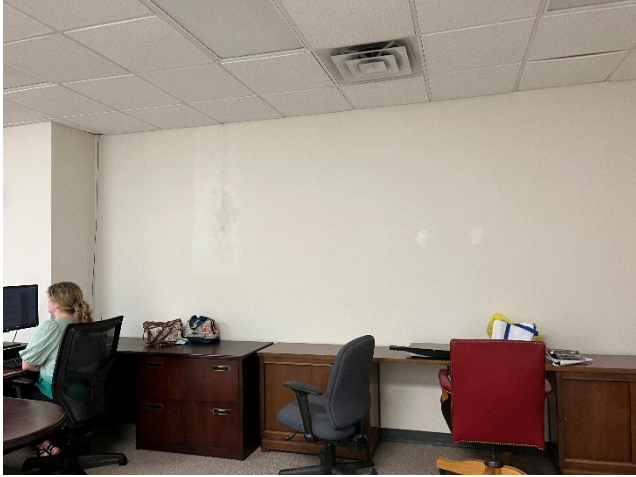
Visible wall patches

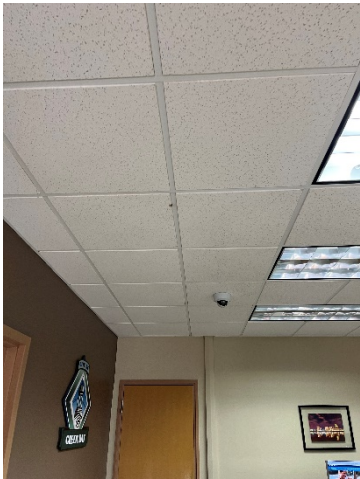
Small chip in ceiling panel

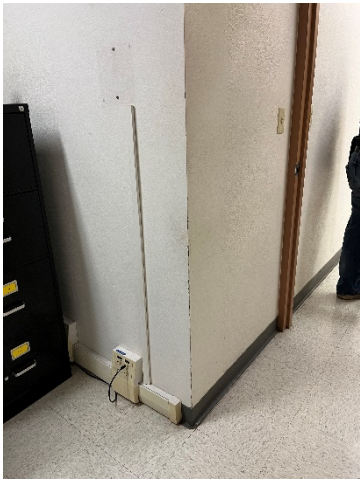
2nd & 3rd floors: typical chipped paint at exterior corner

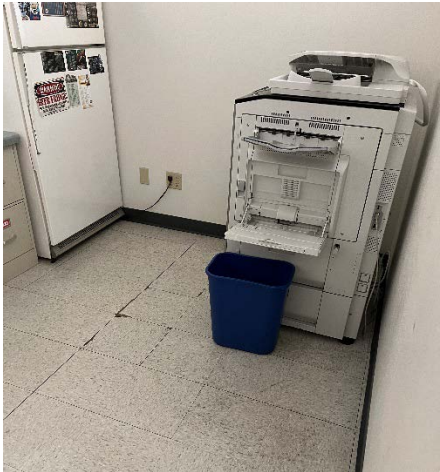
Chipped floor tiles

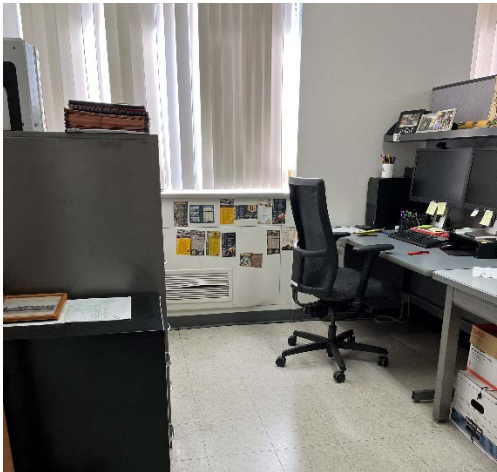
Bent louver blades

- A6.** Remove existing sealant at perimeter of lavatory. Patch paint if necessary and re-apply sealant.
- A7.** Maintenance staff: correct bent metal louver blade; replace missing switch cover; in-fill gap at wall in Human Resources (wood or gypsum board patch and paint).

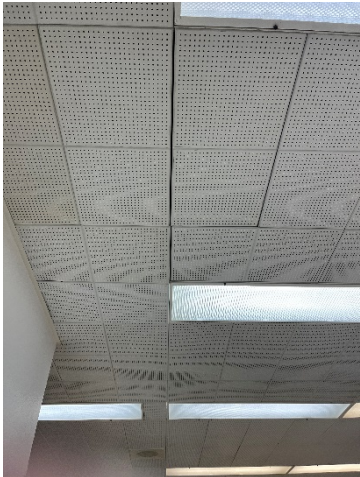
Typical spline ceiling issues

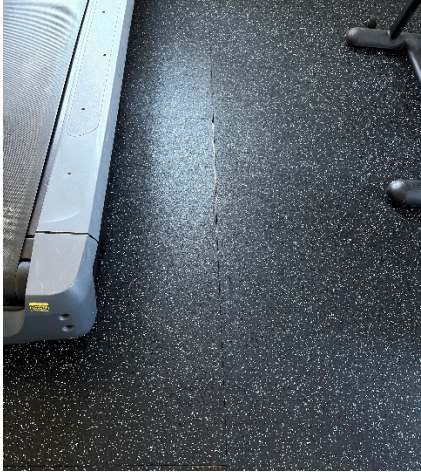
- Athletic flooring is shifting, causing gaps between floor tiles.
- Older athletic flooring with interlocking edges has de-laminating surface at several tiles.
- Bubbled carpet at NE office. Long-term condition. Carpet is worn at traffic areas.

Gap in rubber floor tile

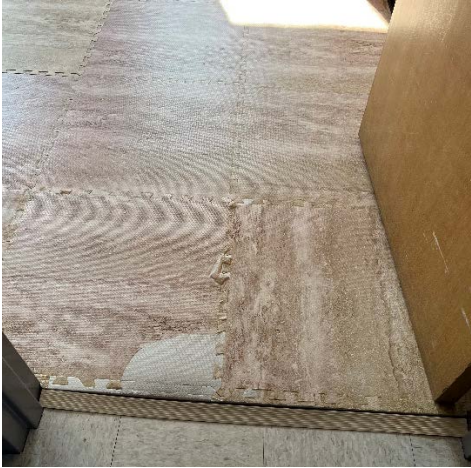
De-laminated interlocking floor tiles

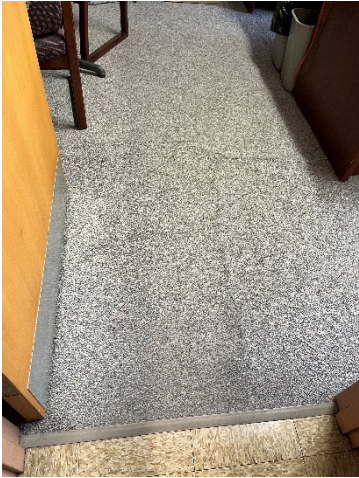
Bubbled carpet at NE office

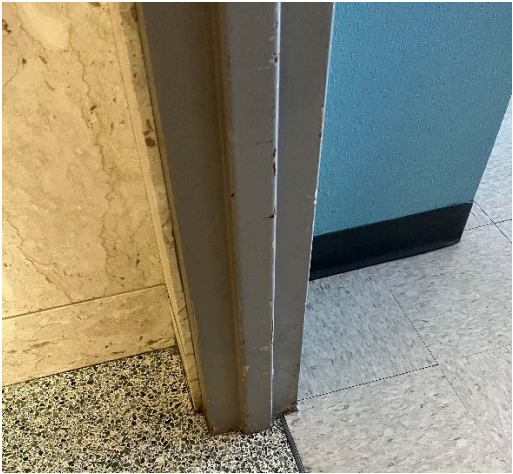
Chipped paint at HM frames

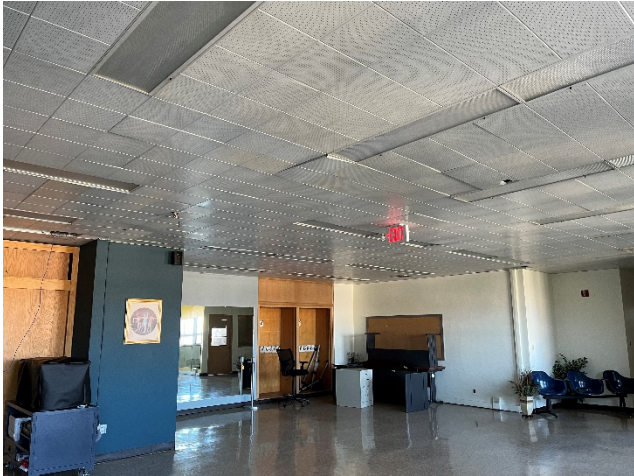
Typical spline ceiling issues

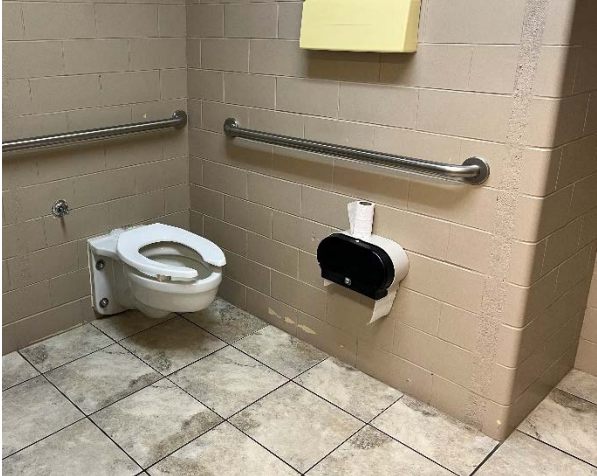
Peeling paint from glazed block

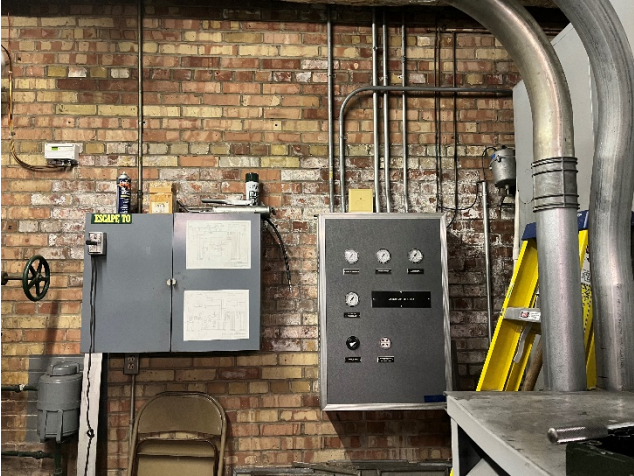
- Brick on interior southwest wall is effervescing. This appears to be due to a deteriorated roof edge condition on the exterior portion of the penthouse at this location.
- Efflorescence under windowsill at east wall.

Effervescence on west wall

- A8.** Clean effervescence off brick in penthouse and monitor for reoccurrence after exterior conditions are corrected.
- A9.** Lightly sand and re-finish scratched wood doors and wood frames.

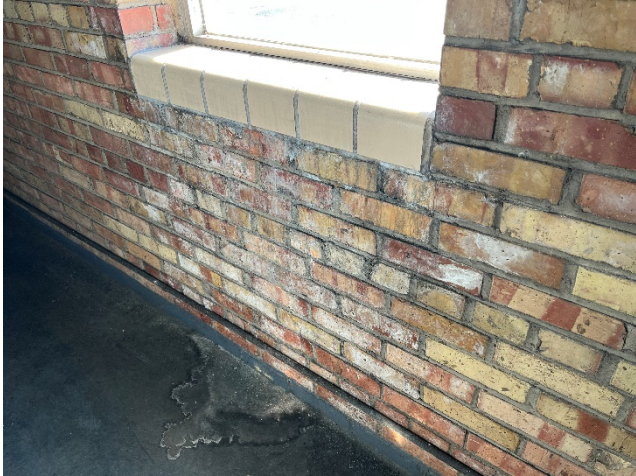
Effervescence on east wall

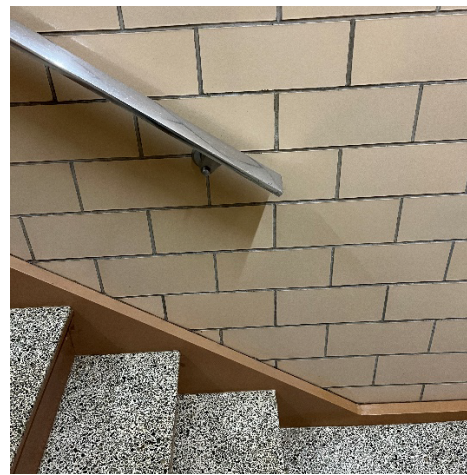
Lack of handrail extension past lowest tread

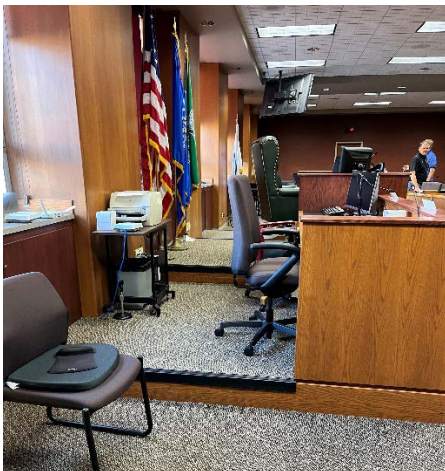
Council platform not accessible

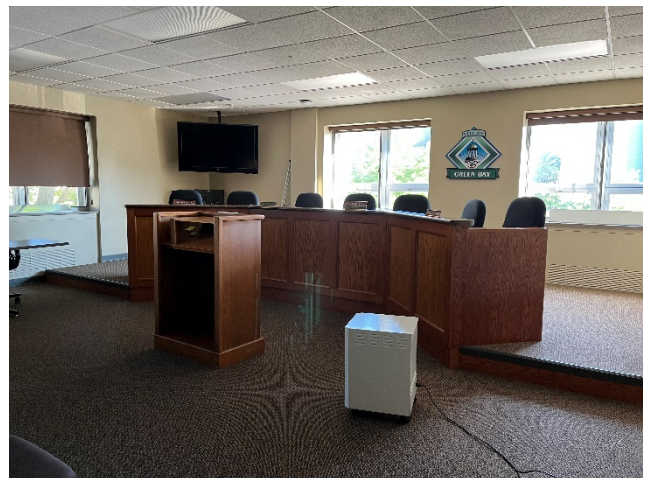
Committee room platform not accessible

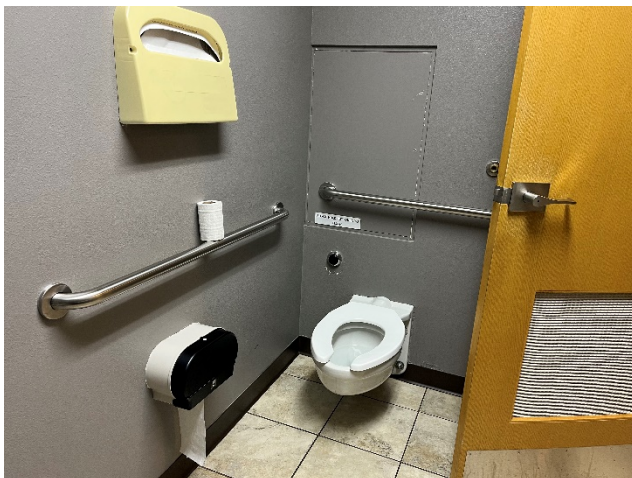
Toilet room on third floor has a grab bar mounted to an access panel. It was not verified whether this supports the required amount of weight for compliance. (ADA 609.8 requires grab bars to support a vertical or horizontal force of 250 lbs.)

3rd floor: grab bar mounted on panel

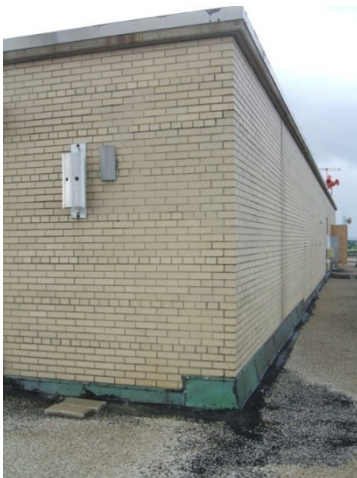
**Expansion cracking of brick penthouse
(Note S3)**

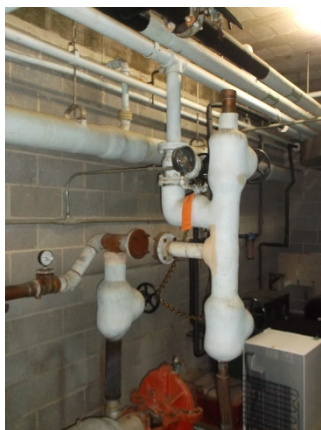
Storm and water piping

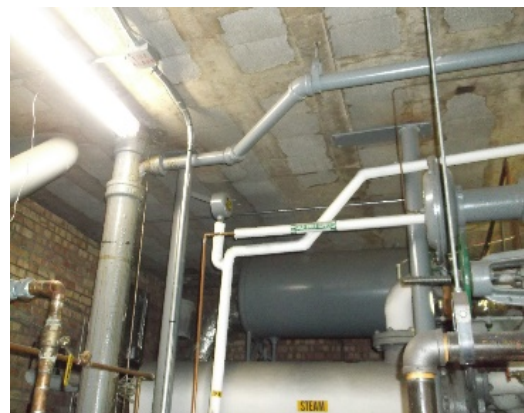
Cast iron vent piping

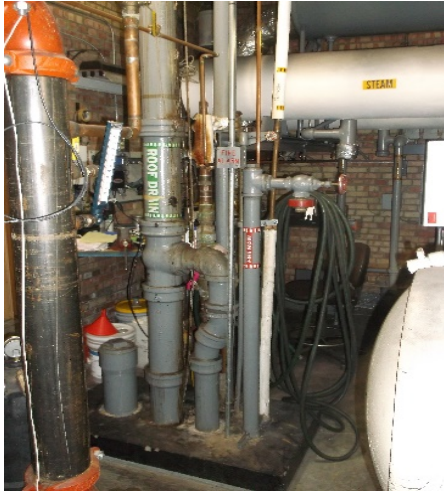
Vent, water piping in penthouse

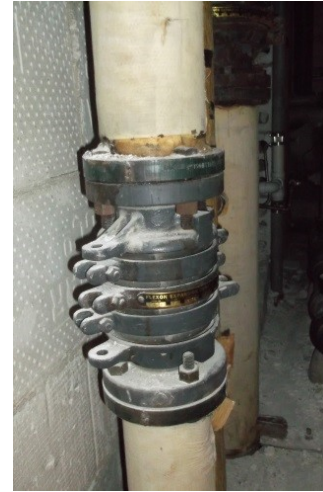
Expansion joint (4th floor) toilet chase

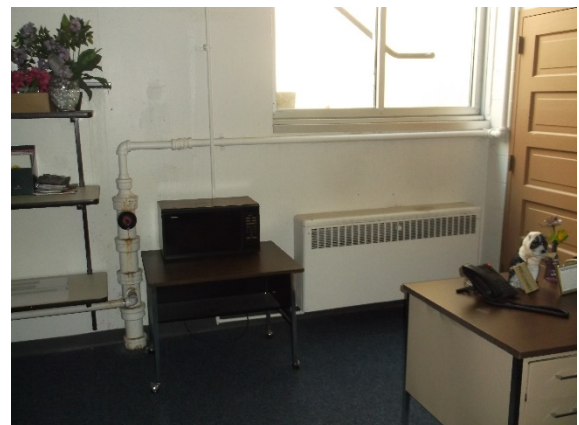
Sanitary vent piping

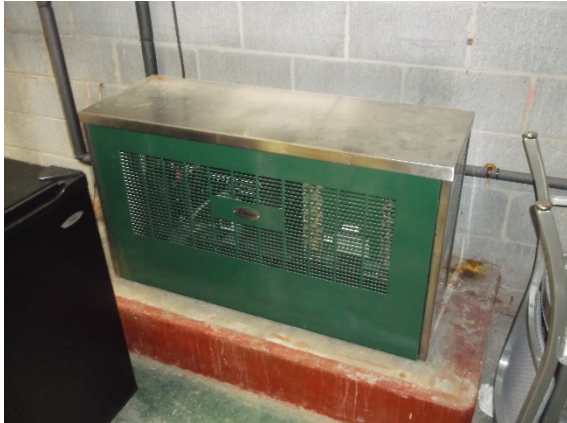
P17. There is a Filtrine chiller in the basement with a dedicated piping system that serves the drinking fountain in the basement and the newer electric water coolers on each floor. Presently the chiller is serving electric water coolers that already have a cooler on them. If the last remaining drinking fountain in the basement was replaced, the chiller unit in the basement could be removed.

Chiller for drinking fountain(s)

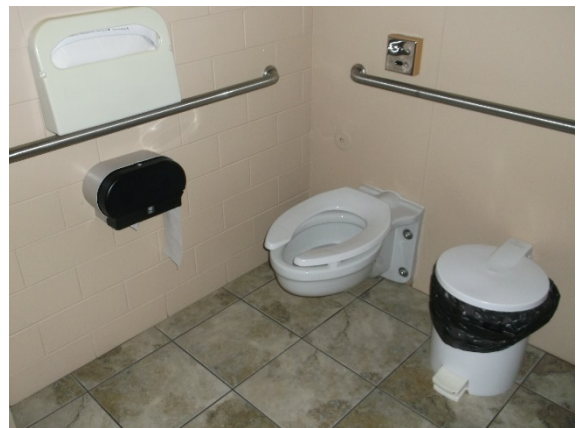
WC – ADA (typical per floor)

Recommendation: replace existing 3.5 gpf water closets with 1.6 gpf fixtures as required. Install safety covers at lavatory p-trap and water stops, especially at the ADA toilet rooms.

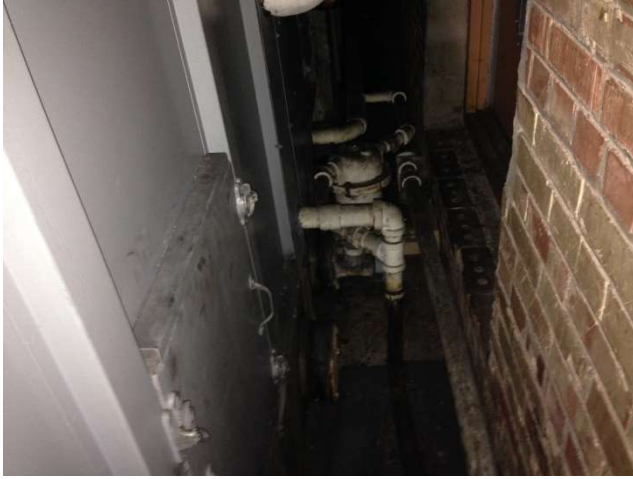
HVAC systems	grade	budget cost	notes	comments
AHU-1				Original 1956.
Housing	HP	\$520,000	H1	Upstream of coils in fair condition.
Air intake	D	(incl.)	H1	Outside air dampers are shut.
Coils	CP	(incl.)	H1	Steam, Chilled water. Chilled water coil casing is deteriorating.
Fan	HP			20000 CFM, 50HP
Filters	HP			30%
Controls	HP			Pneumatic actuators, some DDC interface.
Insulation	HP	(incl.)	H1	Insulation missing at some ductwork. Minor damage to insulation throughout penthouse. Cooling coil piping is in poor condition.
Mechanical room ductwork	D	(incl.)	H1	Original except where replaced during projects. The main exit corridor is used as a return plenum on each floor. No economizer.
Distribution ductwork	HP	\$1,252,000	H1	No fire dampers at the floor penetrations. Shafts are not fire rated/protected.
Exterior room comfort				
Induction terminals	HP	\$3.38M	H2	Most units original to building. Two-pipe system. Thermal issues throughout building. No filters on unit. Deteriorating drain pans.

AHU-1 steam coil

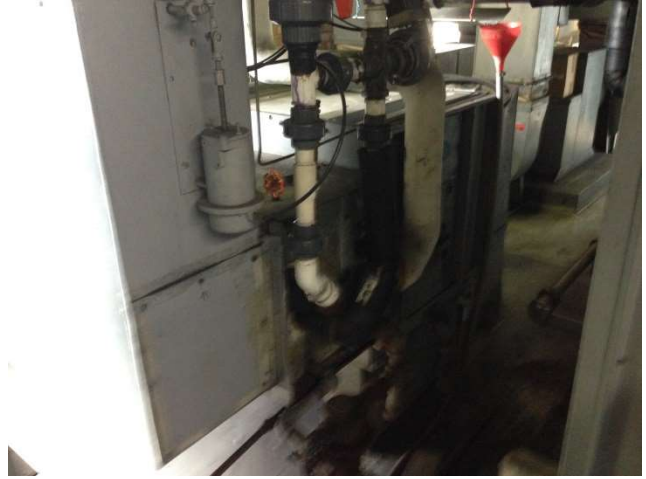
AHU-2				Original 1956
Housing	HP	\$210,000	H3	Rusting around the coils.
Air intake	D			From AHU-1
Coils	HP	(incl.)	H3	Chilled water coil casing is deteriorating.
Fan	F			4800 CFM, 3 HP
Filters	F			30% (From AHU-1)
Controls	F			Pneumatic actuators, some DDC interface.
Ductwork	D	(incl.)	H3	Original except where replaced during projects. The corridor is used as a return plenum. No economizer.

AHU-2 and 3 coils

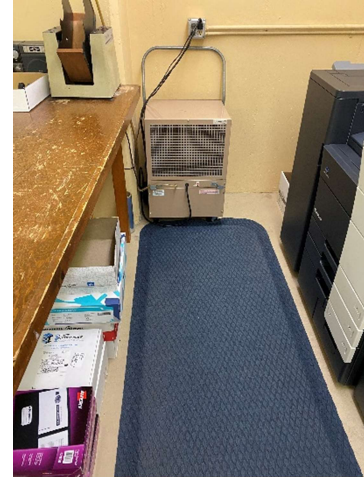
**Print room dehumidification
(humidity issues)**

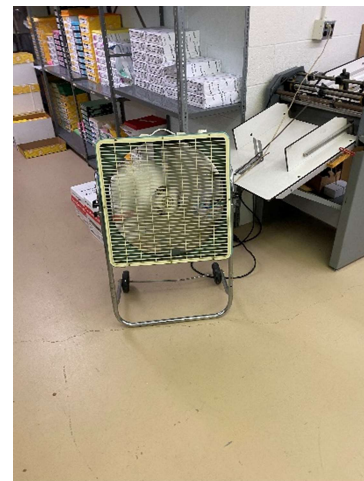
**Hazardous storage
(poor ventilation)**

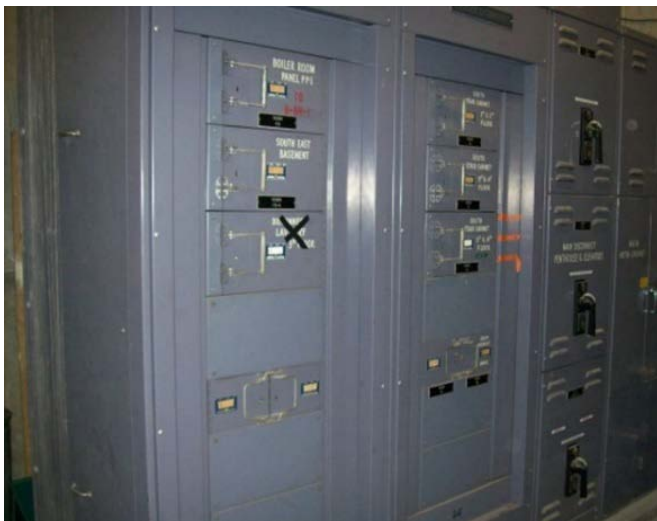
City Hall is served by a 2000 Amp, 120/208 Volt, three phase electrical service. The Main Switchboard (MSB) is a Square D model Saflex fusible-switch type; it is in the basement. The MSB is original to the building (circa 1956). Although the equipment appears in fair condition, Square D no longer supports this style of switchboard. Often the mechanical component of a switch (the action of OPENING and CLOSING) becomes difficult to operate or simply fails to operate. Eventually replacement parts become difficult to find. The MSB consists of three service disconnect switches, and a distribution section. Each of the service disconnects is labeled – although more prominent labels and labels identifying each disconnect by number (e.g. – Service Disconnect No. 1, Service Disconnect No. 2, etc.) is recommended. The switch providing the normal power feed to the automatic transfer switch (ATS) is labeled “Emergency Circuits Disconnect”. Recommend changing this label to “Normal Power to ATS” since “emergency” circuits are fed from the generator and are not disconnected by this switch when utility power is lost. There is a project waiting for funding which replaces all the distribution equipment.

MSB main switchboard

- E1. A Service Upgrade and Emergency and Normal Power Distribution project (approximately \$1.5 million) was bid but never constructed.
- E2. A second ATS and branch panels dedicated to emergency egress lighting is the better option long term since the facility already has a standby generator. While unit equipment (battery operated emergency lighting) is the least expensive first-dollars solution, it has ongoing maintenance material and labor costs related to replacing batteries every 3 to 5 years.
- E3. Continue to upgrade all light fixtures to LED when feasible. Approximately \$150K per floor.
- E4. Consideration should be given to replacing older exterior HID fixtures with new LED ones.
- E5. At a minimum, consider adding additional visual and audible devices to be code compliant. Approximate budget of \$25K.

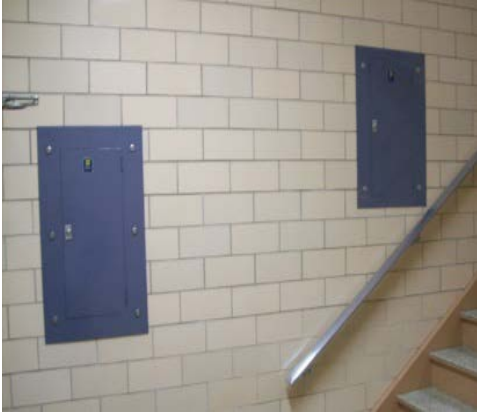
Branch panels for both normal and emergency power are manufactured by Square D. Many of these panels are Square D model QO and are recessed (flush-mounted) in walls in the stairwells. One panel is in the Men’s room on the first floor. Although the condition of these panels is good, Square D no longer manufactures the model QO, and replacement parts are becoming more difficult to acquire. Having them located in the stairwells is unusual, and the fact they are flush mounted makes it difficult to access if a new conduit is needed for a new circuit. In some instances, proper working access (standing on a level surface) is not provided. Overall, the condition of the branch panels is good, but their age means replacement circuit breakers will become increasingly difficult to acquire. It would be very difficult and costly to relocate the panels, but it is possible to improve a poor situation by replacing the interiors and panel covers to improve reliability and ease of access. There is a project waiting for funding which replaces all the distribution equipment.

Panels in stairway

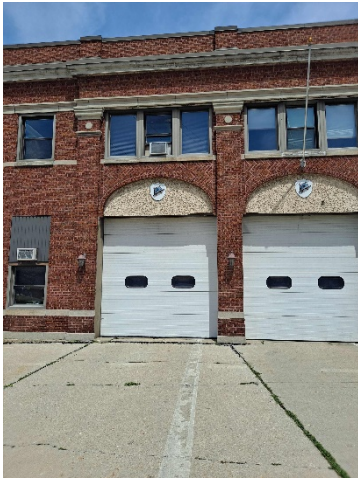
Brick and stone trim on all sides. The exterior walls appear to be in good condition with a few minor repair areas to be addressed.

Exterior brick in good condition

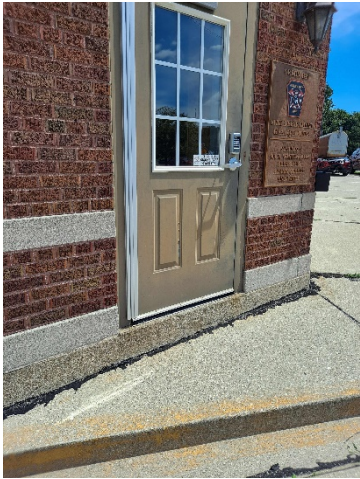
None of the exterior doors are ADA compliant due to the exterior concrete stoop settlement. See Code section of this report for additional information. The hollow metal doors are faded and could use a coat of paint. When doors are painted, it would be recommended to replace the weatherstripping around the doors. Plywood transoms over the doors are weather-damaged and should be replaced. Note that these panels were noted as Category II non-friable in the Hazardous Materials Assessment provided to the City of Green Bay.

Door not egressing to grade

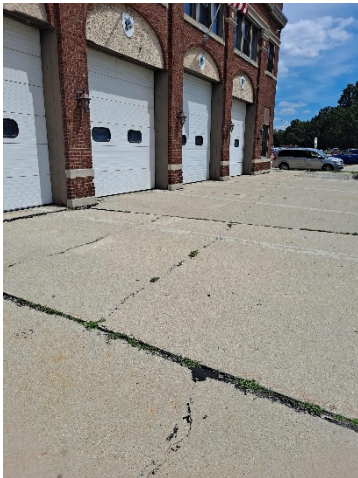
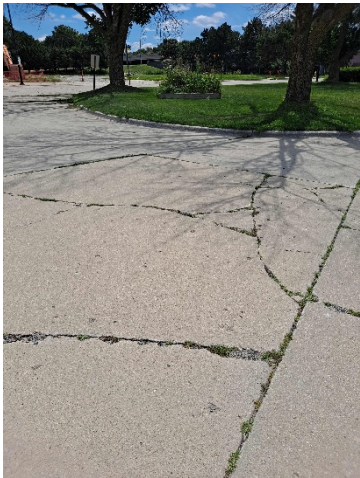
Cracked driveway apron

- A1. Tuck-point as needed on few wall locations. Tuck-point and repair masonry at chimney.
- A2. Replace plywood transom in-fill panels. Paint doors and frames. Replace weatherstripping.
- A3. Concrete at driveways is cracked and spalling. Recommend replacement.
- A4. Plan to continue carpet replacement of worn areas.
- A5. Re-paint wood door frames.
- A6. Recommend replacing missing ceiling tiles to help maintain conditioned space.
- A7. Refer to plumbing section for notes on replacing pipe insulation at women’s room.

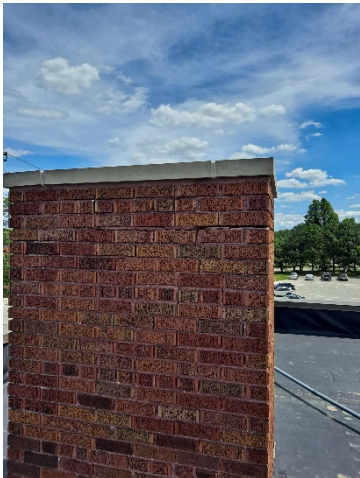
Fire Station #1 is a historic structure built in 1929 and constructed of brick with stone accent bands. The exterior brick is in very good condition for a building of this age. There only a few areas where some tuck pointing could be addressed to prevent further damage to the building. The area most in need of tuck pointing is the chimney on the roof. There are large settlement cracks that should be addressed on the chimney.

Tuck pointing needed at chimney

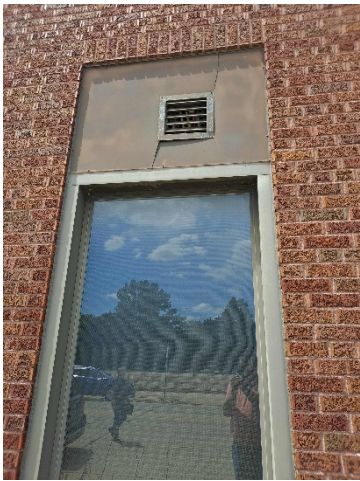
Transom faded and broken

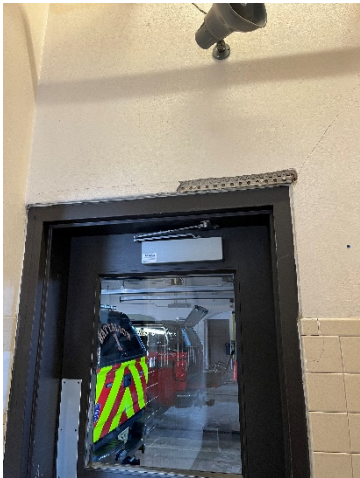
Cracked/missing plaster over door

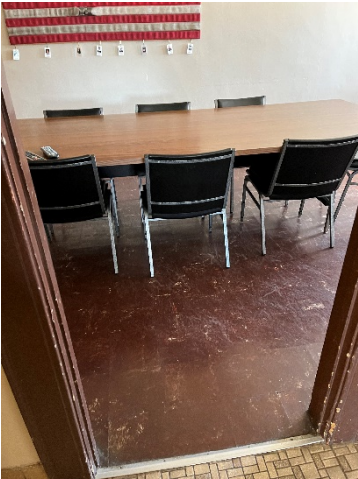
Chipped paint at wood door frame

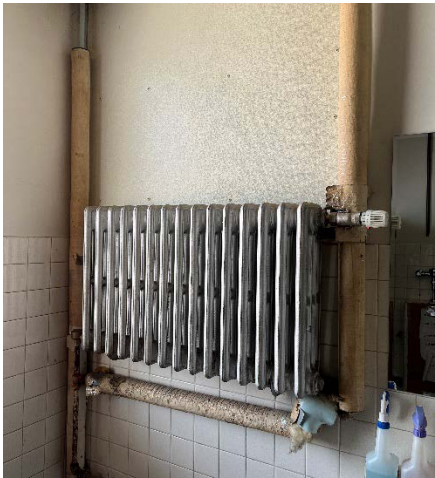
Friable insulation on piping

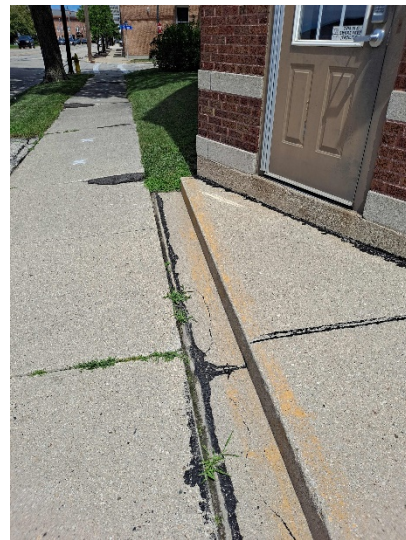
Egress door not at level of egress

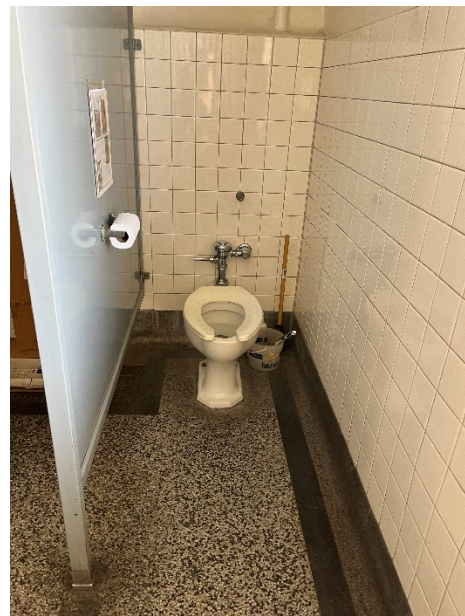
Potential area for accessible toilet

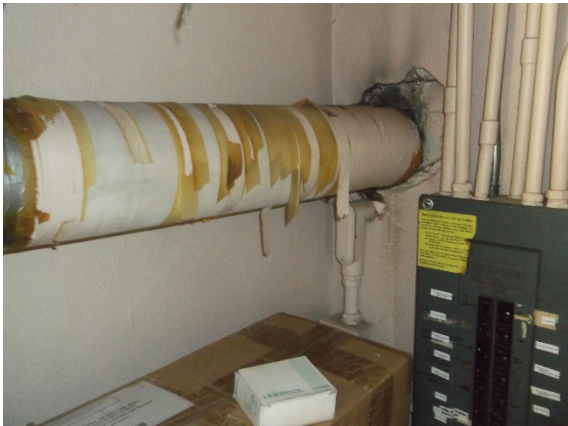
- CA8.** The plumbing main is in the electrical room on the mid-level floor. This is a code violation. See Plumbing section of this report for cost estimate.

Water piping thru electrical closet

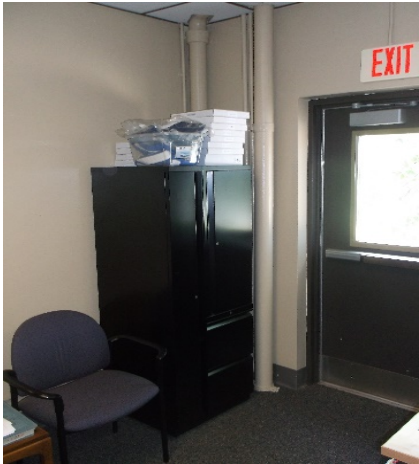
- P16. There are two 4" roof drains (east and west side of roof) which discharge separately to the street. Drains are in fair condition but have some issues with tree debris clogging the drains. There is no secondary roof drainage. Parapet relief drains should be added for secondary drainage. (Secondary drainage is now a code requirement but was probably not required in 1926 when the building was erected). Storm piping through the building is not insulated.

Storm piping, sanitary vent

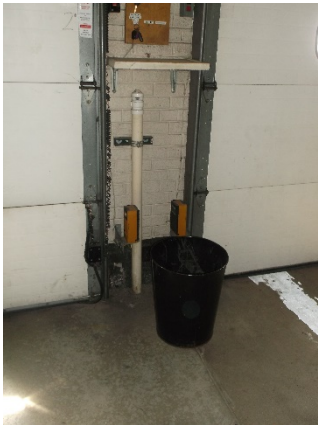
Studor vent - garage

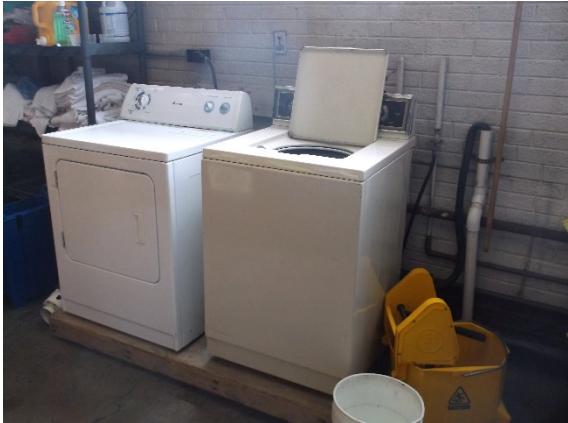
Washer/dryer in garage bay

- H13.** A laundry dryer is located in the apparatus garage. The dryer terminates inside the room. This termination allows warm, moist air to be vented directly into the garage. This vent should be terminated outside.

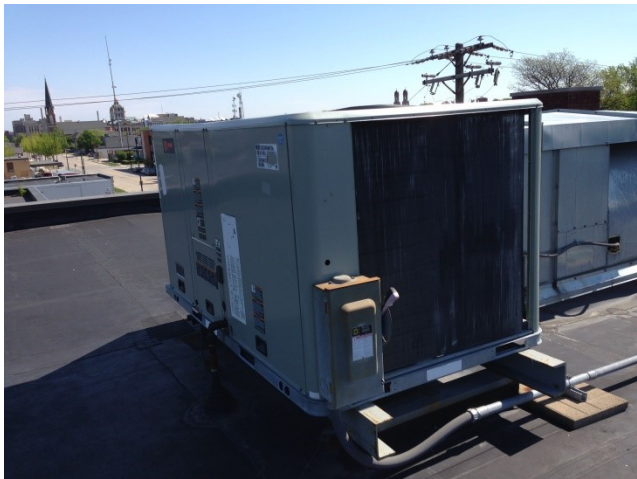
HVAC systems	grade	budget cost	notes	comments
air unit			H1	Installed 2007. Trane roof top packaged YSC series, 10-ton cooling with gas heat.
Housing	F			
Air intake	C			
Condenser fins	F			
Fan	F			4000 CFM, 3 HP
Filters	C			30% filters
Controls	F			Low voltage, zone dampers.
Ductwork	C		H3	Installed 2007. Not revised during last remodeling project. Rain cap over exterior ductwork.
Insulation	C			Duct liner in exterior ductwork.
Humidity	HP	\$15,000	H1	Residential type unit. Manually filled. Humidification is not a code requirement.
Occupied space ventilation (Office)	D	\$22,000	H2	No ventilation in first floor office.
Occupied space thermal comfort	CP	\$65,000	H3	Air unit zone thermostat and manual radiation control conflict. Air unit discharge temperature is affected. Zones are not split to serve rooms modified in last project.
	HP	\$170,000		
exhaust fans				
Men's room exhaust	D	\$6,000	H4	Ceiling mounted fan. Timer switch operated.

Roof top air unit

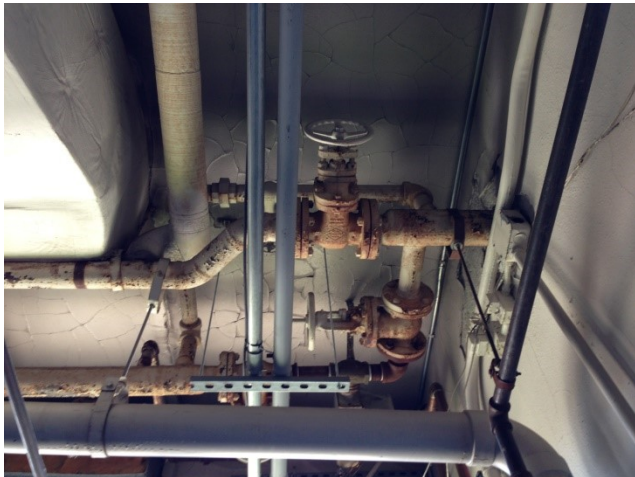
HVAC systems	grade	budget cost	notes	comments
Pumps	C		H7	1/3 HP Simplex Condensate pump.
Piping	C			Mostly original throughout building.
Pipe insulation	D	\$17,000	H8	Most of the piping is bare and uninsulated throughout the boiler room and apparatus room. Damaged insulation in multiple exposed locations.
Room terminal units	CP	\$8,000	H9	Radiators and fin tube with Danfoss Valves.
Mechanical room ventilation	D	\$12,000	H10	Damper for boiler combustion. No intake for generator combustion air. Gas meter regulator vent close to intake louver.
controls				
Air compressor	C		H11	Serves boiler room and apparatus room equipment.
Garage ventilation			H12	
Heaters	HP	\$28,000	H12	Steam unit heater and unit ventilator.
Make-up air unit	D	\$56,000	H12	Outside air cut off. 1300 CFM, ½ HP motor.
Exhaust	D	\$133,000	H12	1500 CFM, ½ HP fan motor
Truck exhaust	C			Replaced in last couple years
Control	D	\$17,000	H12	Pneumatic control. 60-minute timer switch.

Uninsulated pipe (typical)

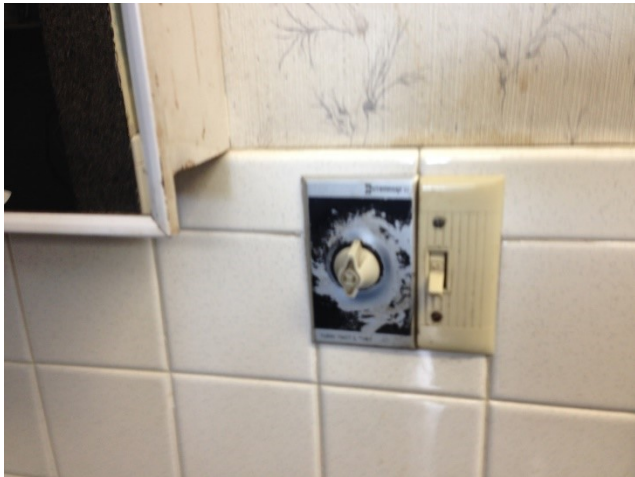
Typical thermostat (This one too close to fridge)

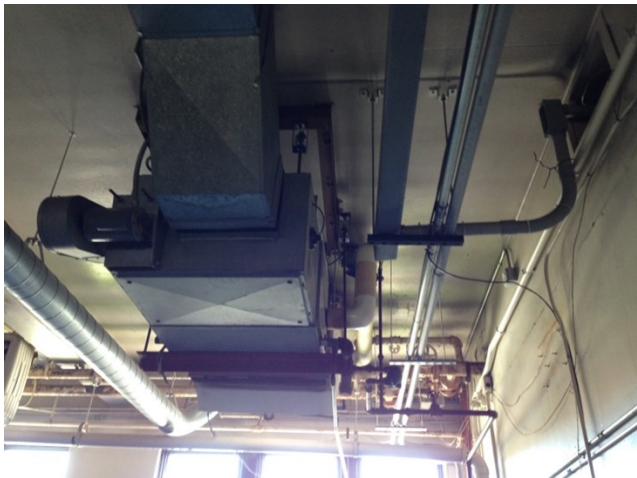
Steam unit heater (bare piping)

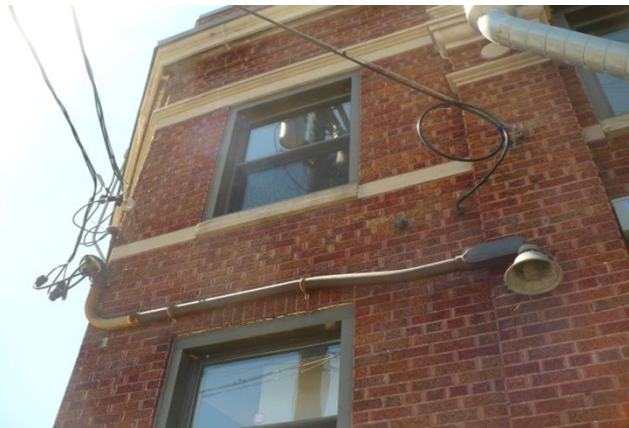
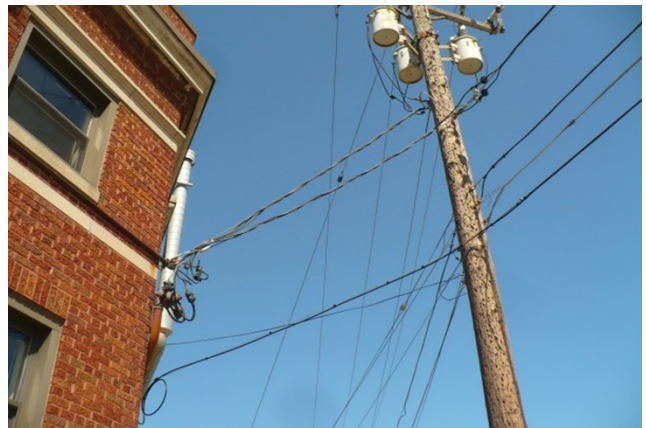
The building is served by two utility services, a 200 Amp and a 100 Amp, 120/208 Volt, three phase. The panels are in fair condition but have limited future capacity. The water main over the panels is a code violation. The emergency generator serving the building is in fair condition. The emergency system is fed from a single transfer switch which feeds three separate small emergency panels. The panels are in fair condition but have limited future capacity. An additional transfer switch and panel board is recommended to separate the critical and equipment loads from the life safety loads.

Electrical utility service entrance

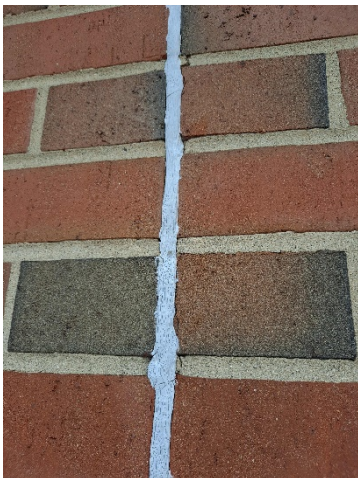
Brick wall are in generally good condition. Sealant at expansion joints is beginning to show signs of cracking. The fascia panels at the southwest corner of the building are out of alignment with the rest of the fascia. Building maintenance personnel report that this area was hit last winter by a payloader plowing snow. The structure itself was not damaged.

Dried and cracking expansion joint material

- A1.** Replace dried or cracked sealant at expansion joints.
- A2.** Replace or repair loose aluminum fascia panels at southwest corner of building.
- A3.** Plan for future replacement of metal spandrel panels at windows.
- A4.** Replace missing vinyl composite tiles in back stair. Repair ripped carpet at Cardio room.
- A5.** Repaint door frames in basement.
- A6.** Touch up stain and re-seal finish at reception counter.
- A7.** Short-term maintenance: remove rust and re-paint toilet partitions at basement. Long-term planning: coordinate new partitions with accessibility upgrades. See Code report.
- A8.** Replace all missing or stained ceiling tiles. At back (west) entry, provide hold-down clips to prevent tiles from being dislodged by winter winds and pressure changes.
- A9.** Replace rusted ceiling diffuser in toilet rooms.

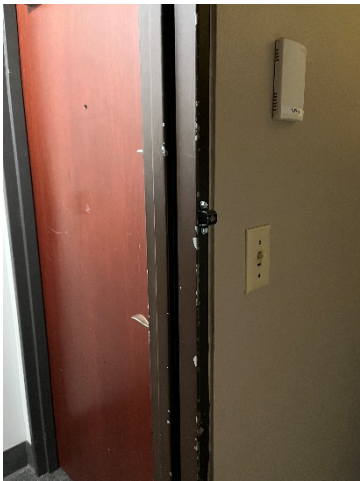
Chipped paint at basement door frames

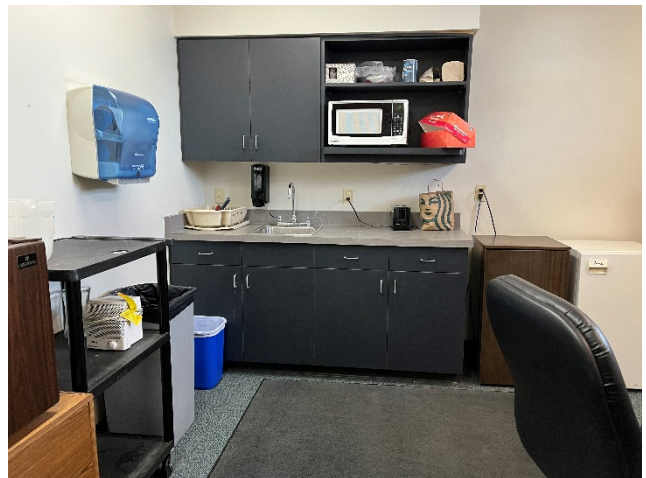
Break room counter/sink at 36"

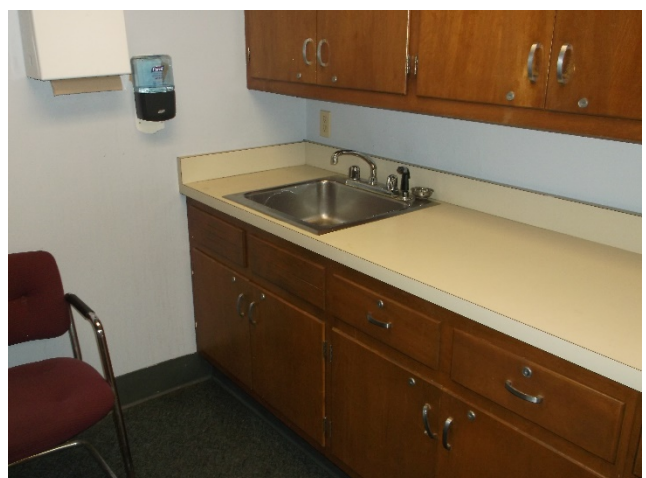
Break room counter/sink at 36"

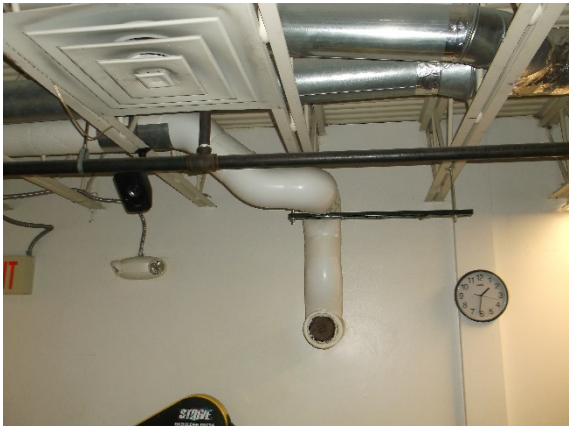
Storm piping - insulated

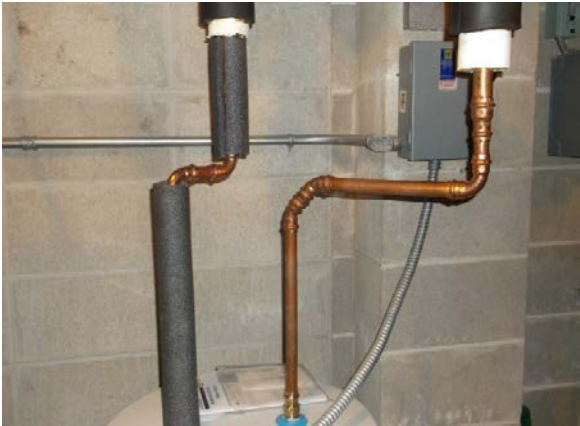
- P8.** Water heater is electric, AO Smith model #ECS 40 200, 208/240Volt, 40-gallon unit. Piping has pro-press connections, also missing insulation. Repair as required. 1" HCW connections.

Water piping at water heater, pro-press piping

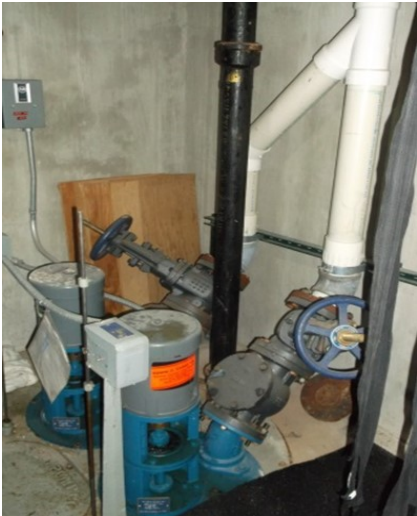
- P15.** Sanitary ejector pumps are duplex top-mount. Pumps are 1 ½ hp, 208Volt, 3-phase.
- P16.** Building is served by four 3" roof drains with 4" roof leaders to below grade. Piping is insulated with glass fiber. There is no secondary roof drainage installed, which is a code issue. (International Plumbing Code 1108.1) Secondary drainage could have been added during the last re-roofing project.

Sanitary ejector – duplex pumps

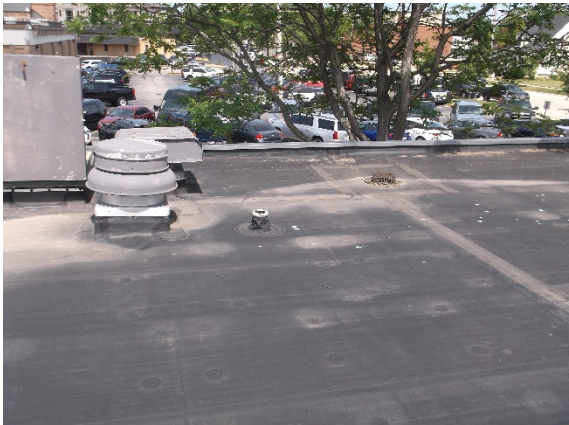
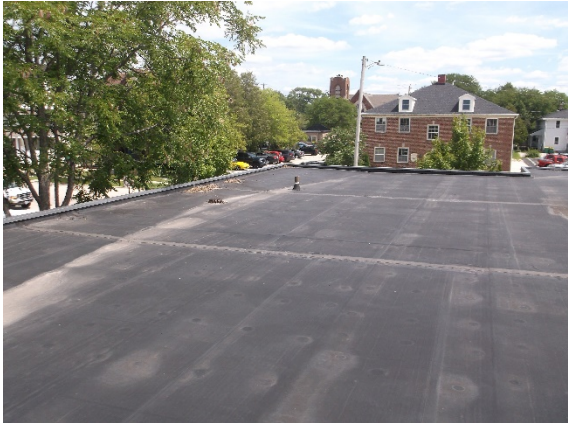
Sanitary vent & roof drain

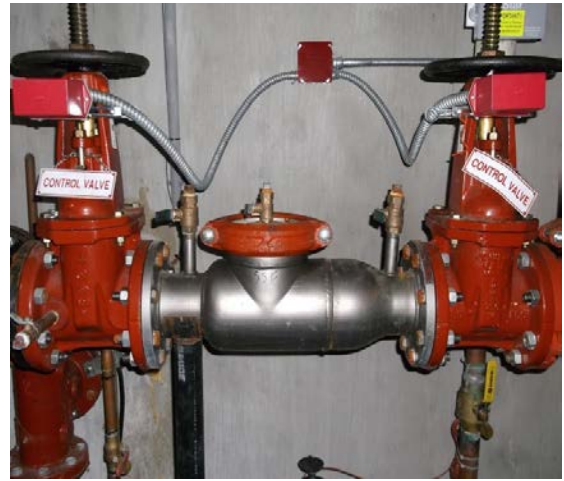
- FP2.** The backflow preventer is an Ames 2000 SS 4" double check valve backflow preventer with OS&Y gate valves. The backflow preventer and the gate valves are in good condition.

4" double check backflow preventer

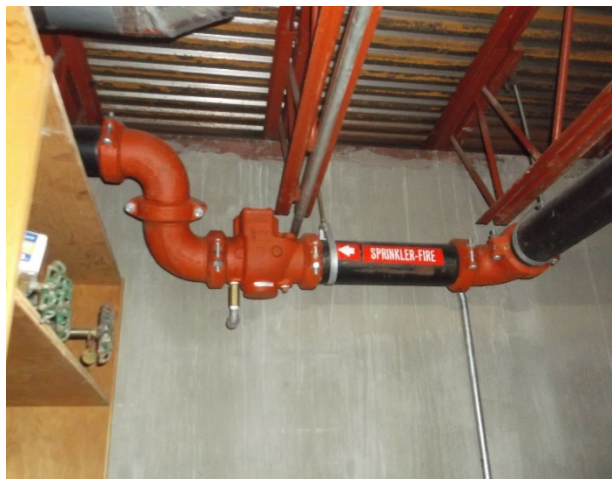
- FP3.** The basement level and the stairwells are fully sprinkled. The deficiencies on the fire sprinkler system include the following. The sprinkler flow indicator stickers installed on the piping to the fire department connection are pointing in the wrong direction. The automatic ball drip valve on the fire department connection check valve is capped. This drip valve is meant to allow water in the check valve to drip out to prevent freezing. A pendent sprinkler head was discovered that was not replaced with an upright head when the ceiling was removed. The inspector's test drain is piped to a sink. There are a few upright sprinkler heads that are not piped to within 6" of the bottom of the metal deck – minor deficiency. All valves, piping, and sprinkler heads appear to be in good condition. The piping shows no indication of corrosion and the valves appear to be in good condition.

Flow direction points the wrong direction

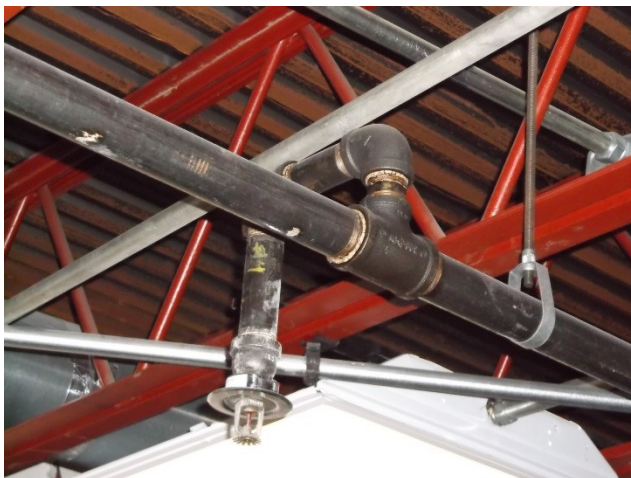
Pendent sprinkler head too far from ceiling

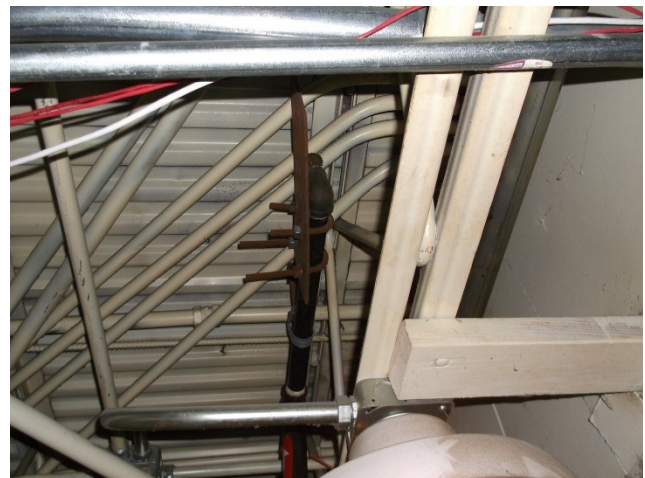
Sprinkler head with baffle in electrical room

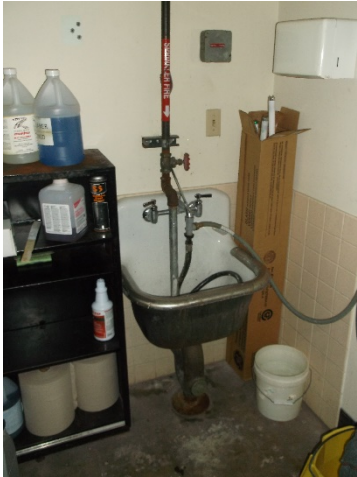
Inspector's test drain discharging in sink

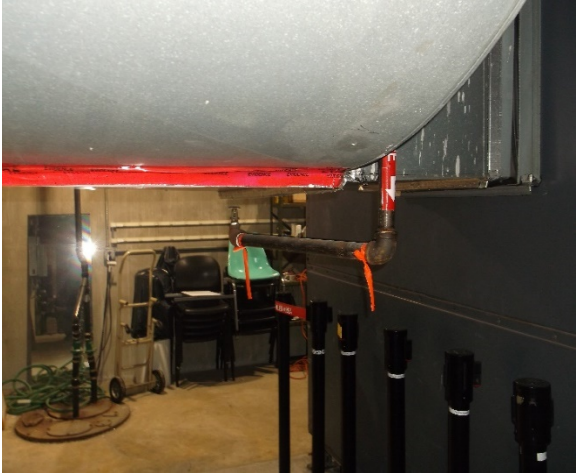
Sprinkler head under duct

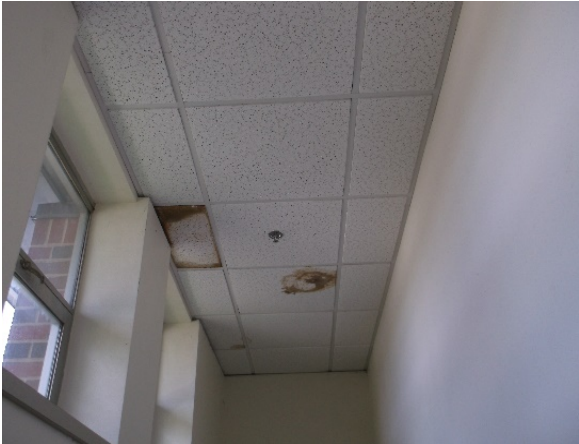
Sprinkler head in stairwell

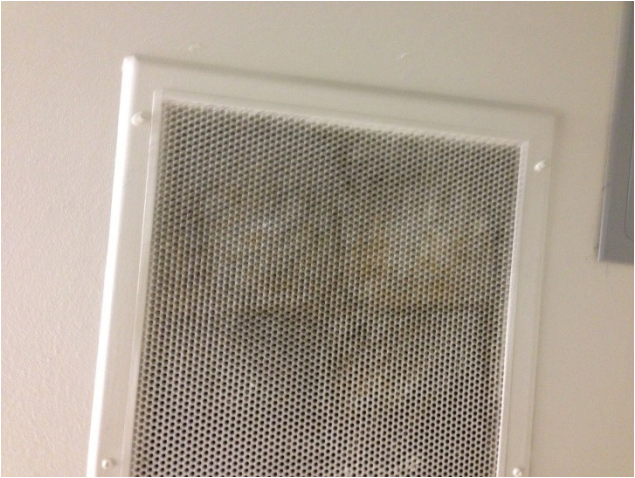
Old grille (plugged)

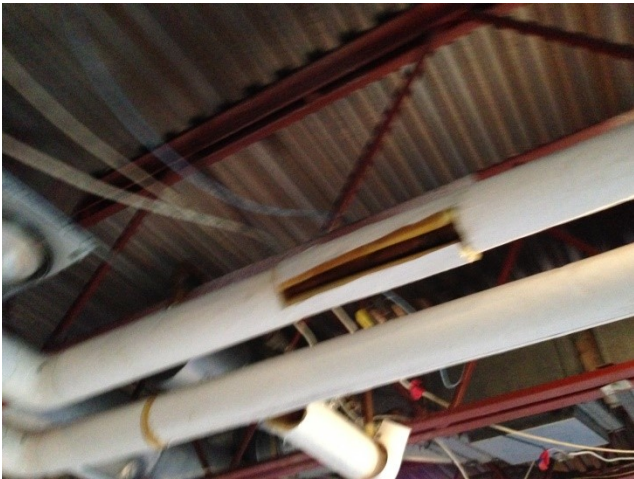
Pipe insulation is missing or in disrepair in a variety of locations around the building. The insulation is especially poor around the air unit and boiler, where maintenance work has required the removal of the insulation and it was not repaired or replaced. It is recommended to insulate this piping and repair insulation during an air unit and/or boiler replacement project.

Poor insulation (typical)
