AGENDA OF THE AD HOC FACILITIES COMMITTEE

- I. Consideration with possible action the review of the Facilities Assessment Updates for City Hall, Municipal Court, Police Station, and Fire Station #1.

An assessment of City Hall was conducted in 2015 by Berners Schober which reviewed the condition of the building's architectural, structural, mechanical, plumbing and electrical elements. This report, done in the summer of 2022, is an update to the previous assessment. Each building was re-surveyed by trade and the reports updated. Below are brief summaries of the changes to the building in the intervening 7 years.

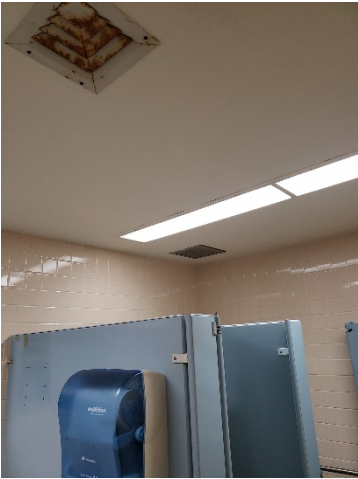
H2. The building exhaust system is served by multiple fans of various sizes and types. The ages and conditions vary greatly, as the units have been modified and replaced as necessary. Dust and lint build-up is prevalent at the lower-level grilles and ducts. Air flow within these spaces appears diminished and can be attributed to older leaking ductwork combined with the dirtying of the systems. Duct cleaning, taping, sealing, and air balancing are recommended.

Exhaust grille (degraded)

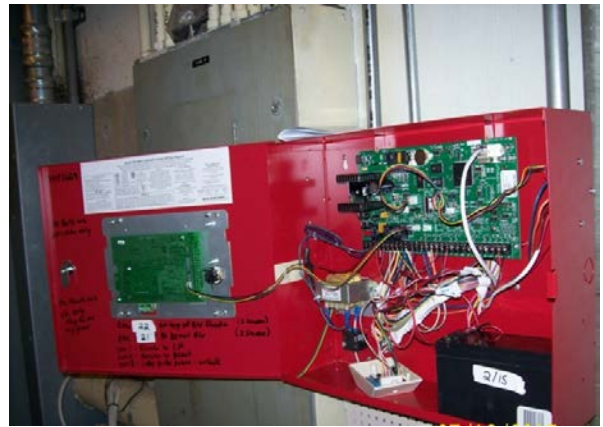
The building has a zoned fire alarm system whose control panel was reportedly replaced in 2014. The panel has six spare zones. Coverage with audible and audible/visual alarm (A/V alarm) devices is not code compliant. The elevator lobby smoke detector outside the basement elevator doors is located too close to the sidewall and is not permanently fastened. This detector is mounted on a piece of 2x4 lumber spanning, but not fastened to the building's structural members. There is no evidence of a shunt-trip mechanism to automatically disconnect power to the elevator when sprinklers are activated in the elevator machine room and/or elevator shaft. A shunt-trip operation is required by code when the machine room and elevator shaft are protected by fire sprinklers.

Fire alarm panel

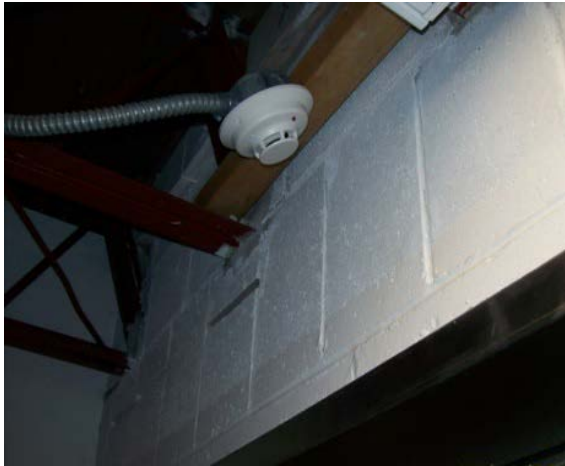
Detector not installed properly

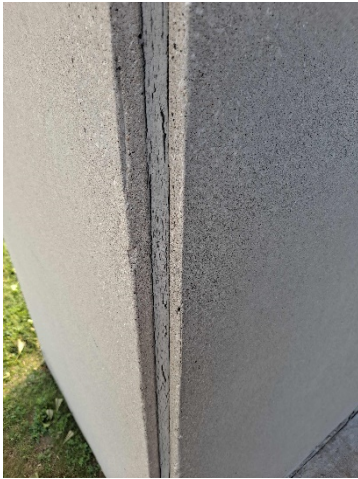
Caulking dried and brittle

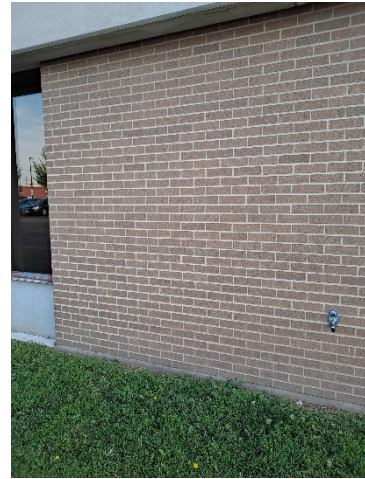
Brick in good condition

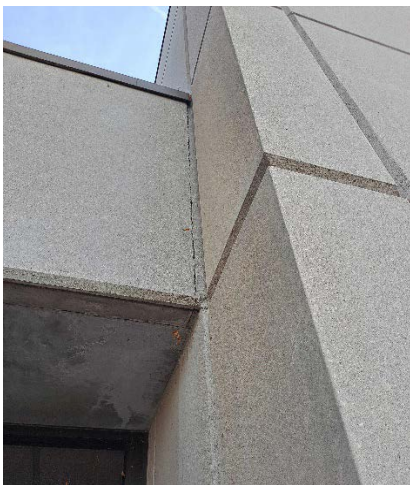
Caulking dried and brittle

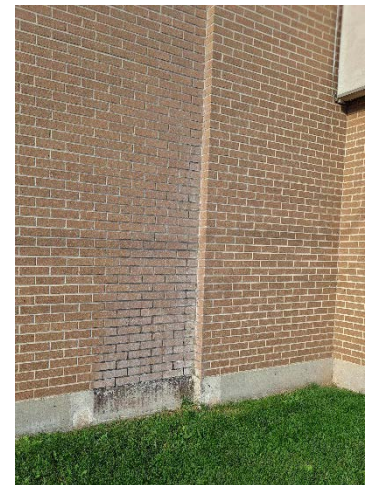
Efflorescence on brick

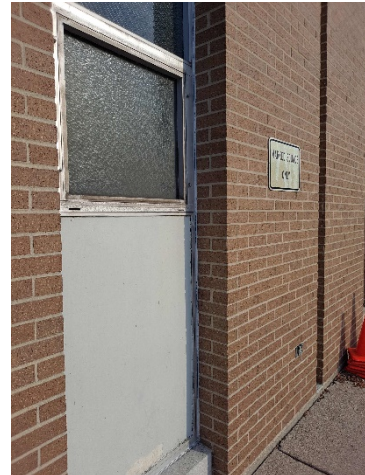
Faded window infill panels

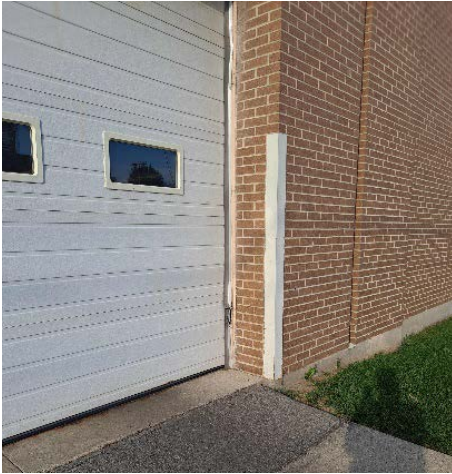
Damaged door jamb and door track

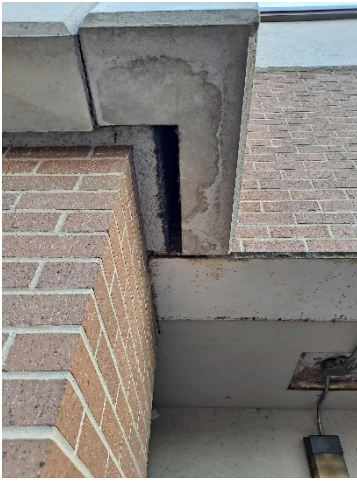
Gaps under precast concrete panels

Damaged concrete curb

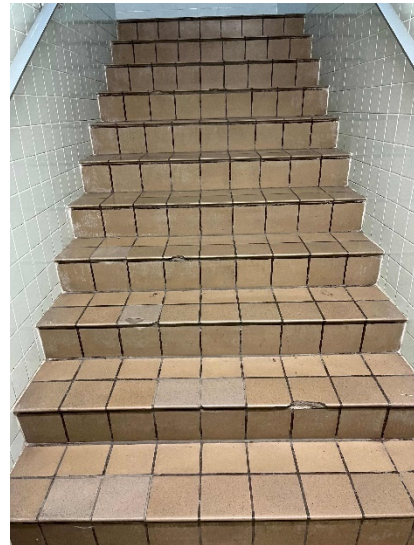
Chipped tiles at south stair

- A1. General floor maintenance: scrape and re-paint areas where floor paint has worn off (entry to shooting gallery).
- A2. Recommend replacement of cut pile carpet in office areas (Photo Processing). Most existing low-pile carpet is also very worn. Plan for replacement. Floor finish for office use areas should be either a vinyl product or low pile carpet tiles for ease of maintenance and replacement. Short term: provide transition strip at edges of carpet in lieu of duct tape. Long term: replace all carpets with appropriate flooring for use of space.
- A3. Replace chipped tiles at south stair.

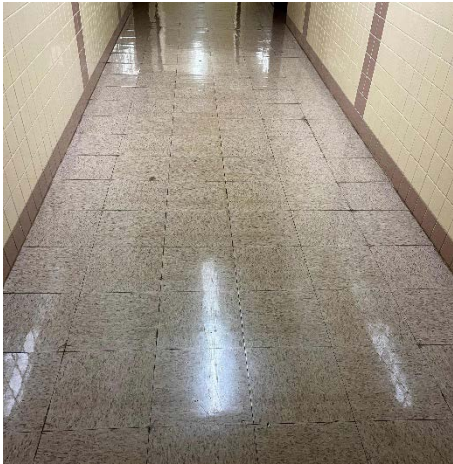
Vinyl composite tile (VCT) in basement has stains, chips, and is worn in areas under chairs. The older adhesives used on these tiles may be what is causing the dirt to collect around the seams. VCT that was in the room used for high-density evidence storage was abated due to asbestos content in the adhesive.

Dirt at center of corridor and edges of tiles

- A4. Short term: Replace areas of missing VCT (Evidence Lost & Found, High Density File Storage room). Recommend thorough mechanical cleaning of high traffic areas. An asbestos survey of the building should be done since asbestos content was previously found in the adhesive for the high-density Evidence Storage room. Long term: plan for replacement of all VCT in basement.

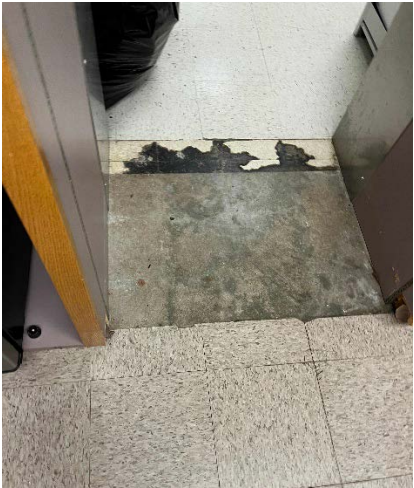
Missing VCT at basement

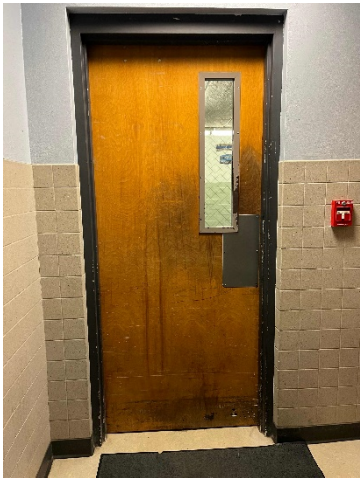
**Chipped paint at lite and damaged wood finish
Missing kick plate**

- A7. Refinish or replace doors with scratched and damaged veneer finish. Install minimum of 12" high kick plates. Estimated 4 doors; those in worst condition are in basement. See Code section of this report for recommended update of door hardware.

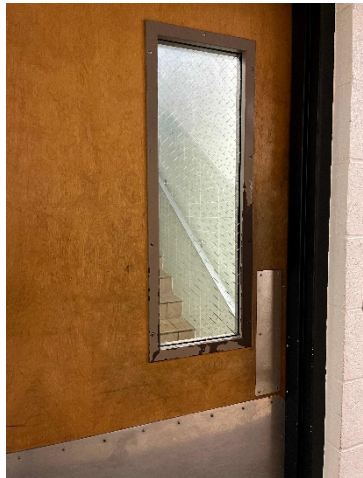
Chipped paint at lite and damaged wood finish

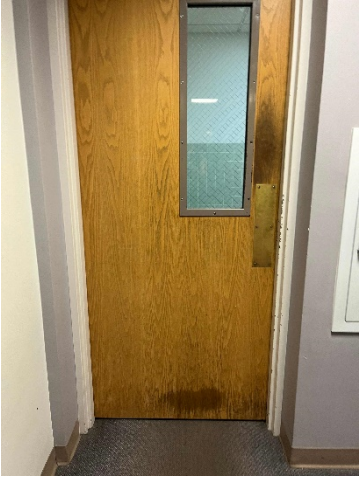
Damaged wood veneer & missing kick plate

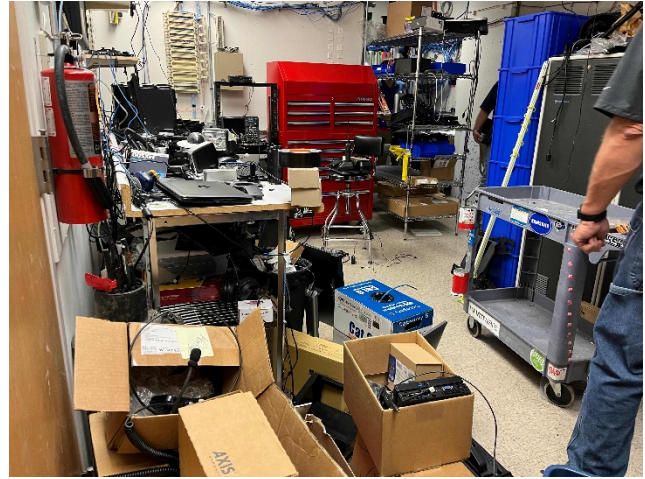
2nd floor IT room – improve egress route

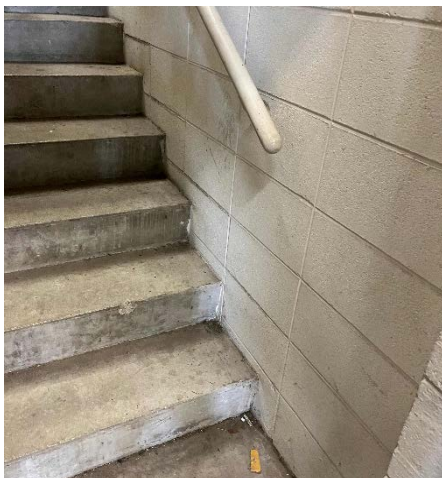
Lack of handrail extension

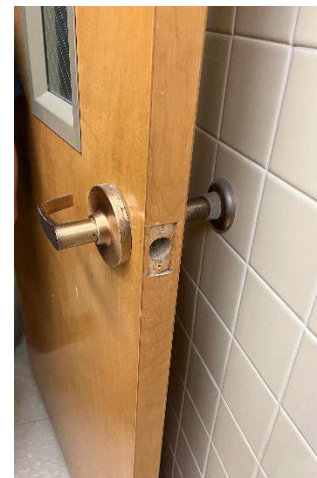
Missing latch at north stair door

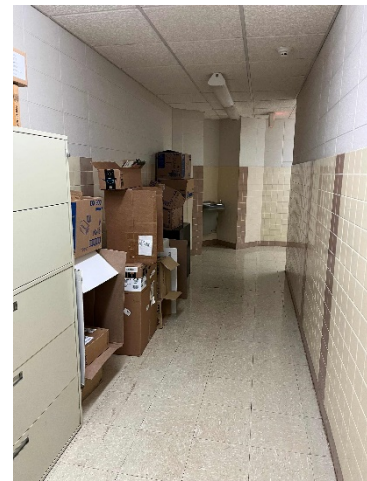
Eliminate combustible storage in corridor

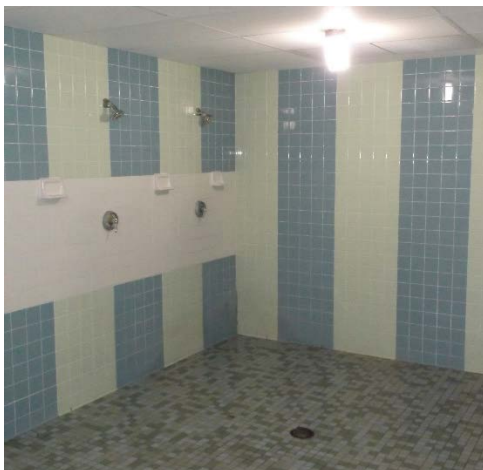
No accessible shower – men's

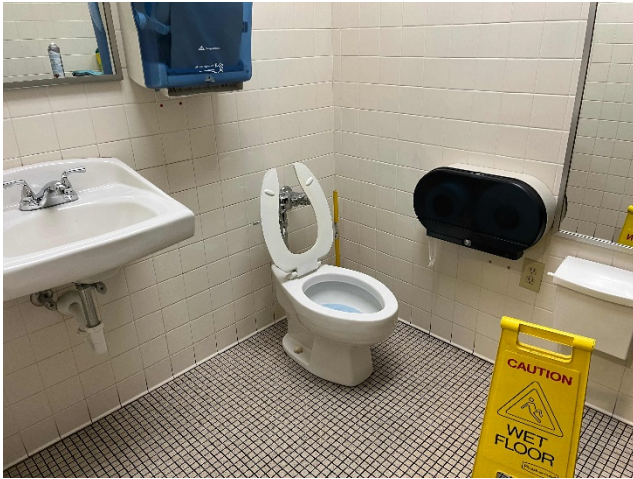
1st Floor: not accessible toilet room

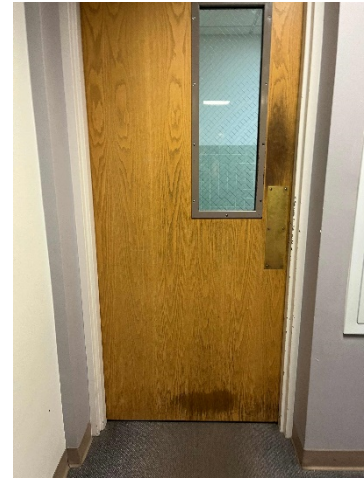
Route into 2nd floor toilets lacks clear floor space

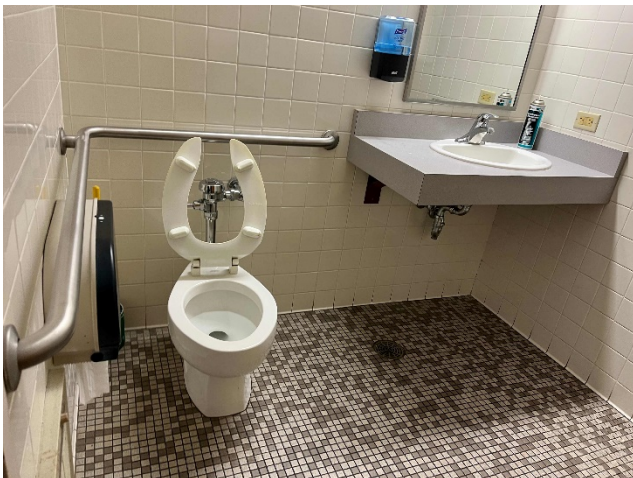
Toilet with grab bars, but lacking clear floor space

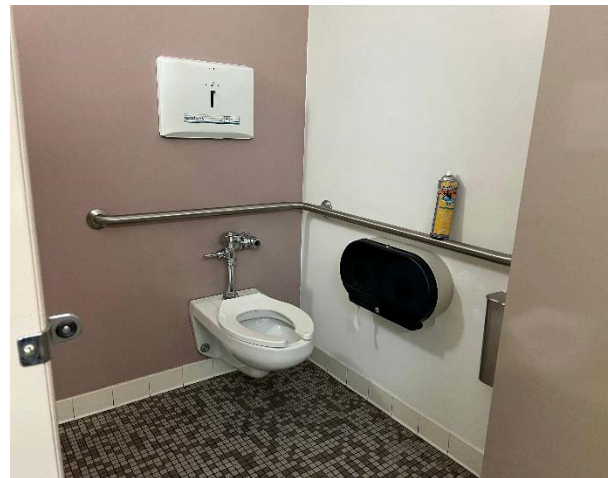
**Toilet stall accessible, but room is not
(See photo above)**

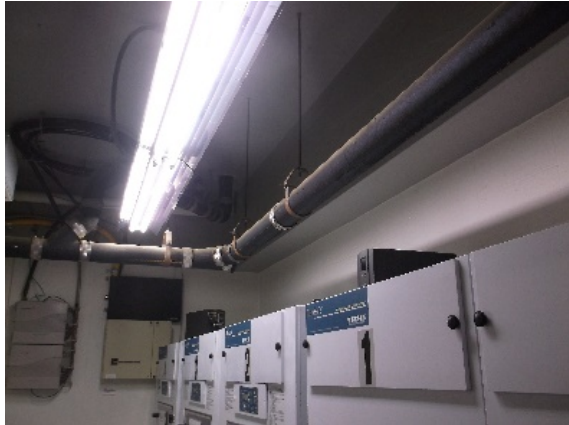
There is a sanitary pipe installed over the evidence dryers in the basement. It would be advisable to install a drain trough below the piping to protect the equipment from potential leaks.

Sanitary piping over evidence dryers

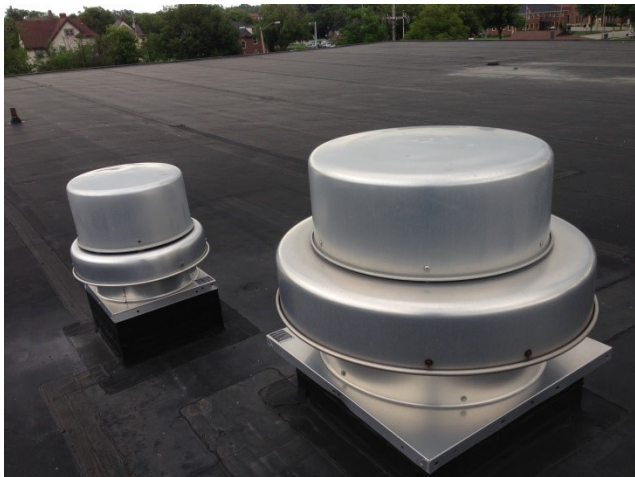
Interior exhaust fans (noisy)

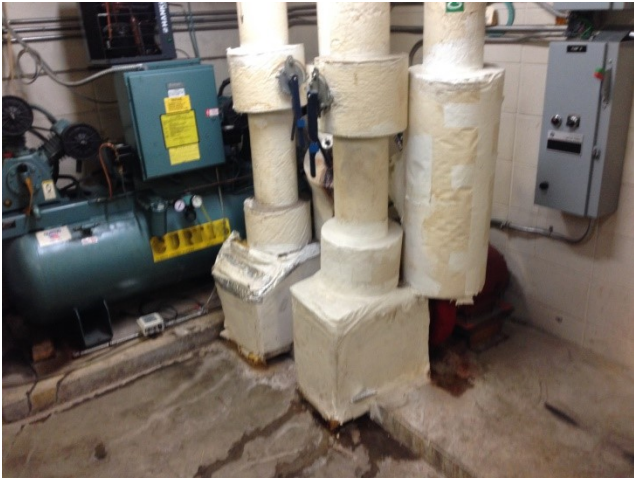
H2. The chiller was replaced in 2010. No system complaints relayed by staff. Insulation is damaged at the chilled water pump. Recommend repair to the insulation to prevent condensation and further deterioration of the insulation and piping. The insulation prevented inspection of the pump seals to determine if the water was condensation from the damaged insulation or if the pump itself was starting to leak and causing the insulation damage.

Chilled water pumps

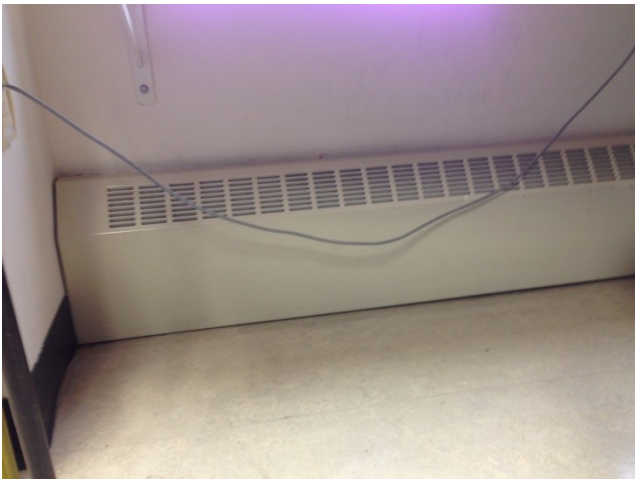
Pipe insulation	C			
Room terminal units	HP	\$15,000	H7	Convectors, VAV, cabinet heaters. Some fin tube radiation installed at floor, restricting air movement through devices.
Mechanical room ventilation	F		H8	Hot room, limited/no ventilation
controls				
Air compressor	C			Duplex, 3HP
Room control	F		H9	Original pneumatics. Replace with low voltage DDC during mechanical projects
garage ventilation				
Make-up air unit	D	\$140,000	H10	One unit has failed. The other does not keep up. Supplemental heaters installed.
Exhaust	D	\$40,000	H10	Some fans have failed. Exhaust openings not positioned correctly.
Control	D	\$20,000	H10	Time clocks. No gas detection.

Fin tube (installed at floor)

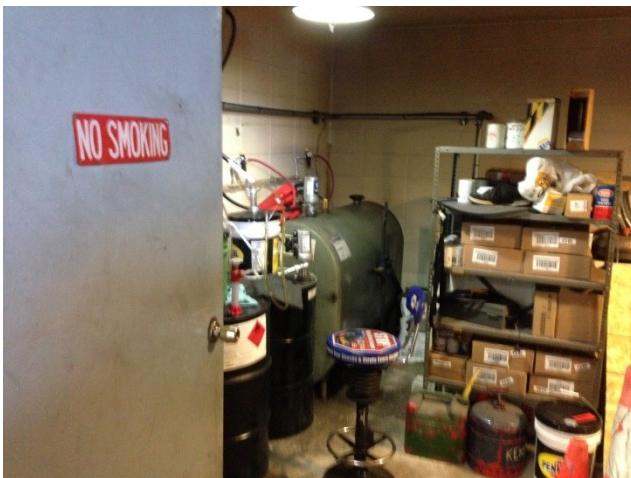
Hazardous storage room (vented tanks)

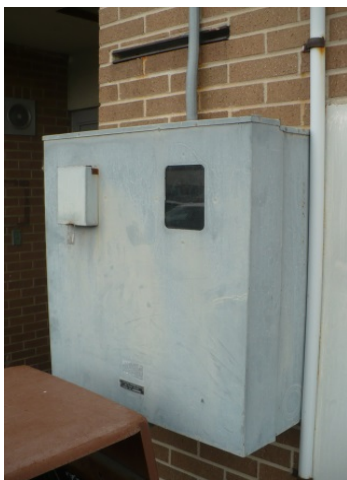
Main electrical service meter

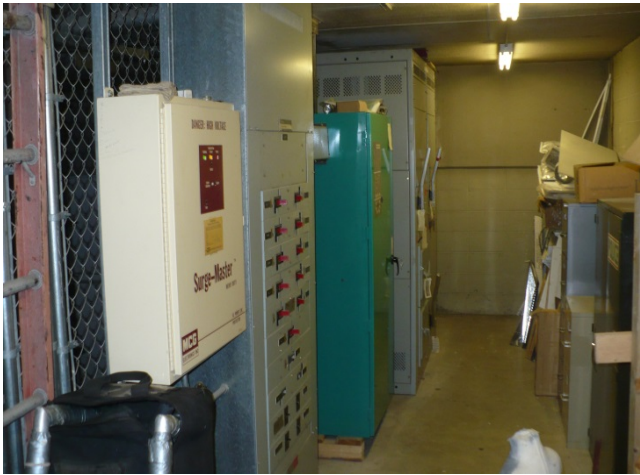
Main electrical equipment

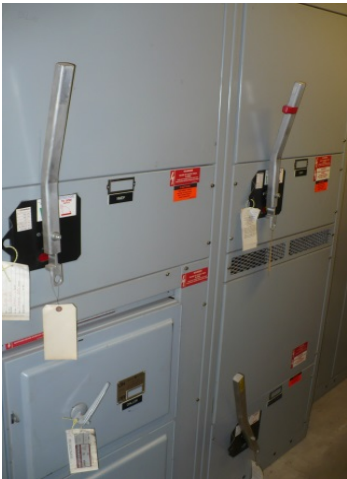
Main fused switchboard

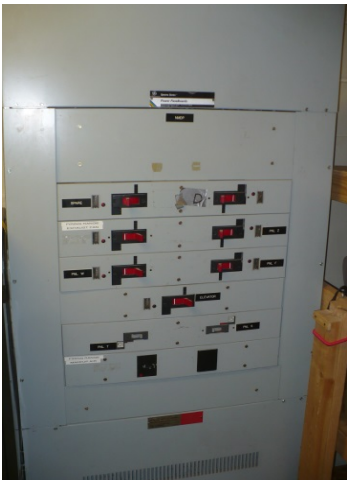
Normal main distribution panel

- E3.** Recommend providing an additional automatic transfer switch and a new distribution panel to separate the non-life safety loads from the life safety loads. Additional branch panels would be needed to transfer circuits from existing panels that have mixed loads.

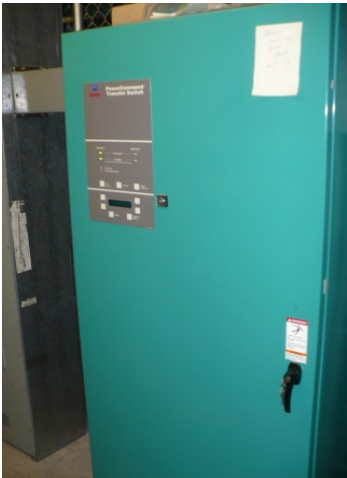
Automatic transfer switch

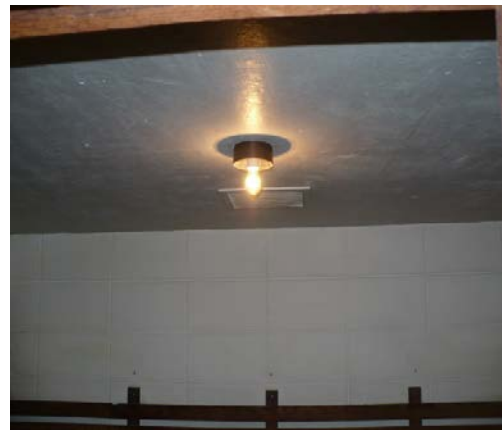
electrical systems	grade	budget cost	notes	comments
Branch panels	HP	\$25,000	E3	Original GE NLTG panels in fair condition and 1992 renovation GE A-Series panels in good condition. Panels have future capacity.
power				
Receptacles	D	\$1,500	E4	Garage outlets and outlets within 6' of sinks, and outlet in elevator equipment room needs to be GFCI. Plug strips are being used in locker rooms for charging devices.
lighting				
Garage	C			Industrial fixtures and surface mounted wraps with T-8 lamps in good condition.
Office spaces, conference rooms, gun range, and corridors	C			Recessed acrylic lens and parabolic louver troffers, surface wraps with T-8 lamps, and incandescent downlights and track heads. Fixtures are in good to fair condition.
Toilet rooms	F	\$1,000	E5, E6	Recessed troffers and surface mounted wraps in good condition. Men's shower and sauna have incandescent lamps (sauna fixture is missing lens).

Sauna light missing lens

- E5.** Replace incandescent lamps with compact fluorescent or LED type for energy savings.
- E6.** Consideration should be given to replacing older fixtures with new. Replacement or repair should be done on fixtures with broken or missing lenses.
