# **AGENDA OF THE FINANCE COMMITTEE**

**TUESDAY, NOVEMBER 29, 2022, 4:30 PM**

**F. Report of the Ad Hoc Facilities Committee (November 15, 2022).**

1. To direct Finance Staff to work with BSA on the total cost of the deficient and critical needs listed in the report in response to the review of the Facilities Assessment Updates for City Hall, Municipal Court, Police Station, and Fire Station #1.

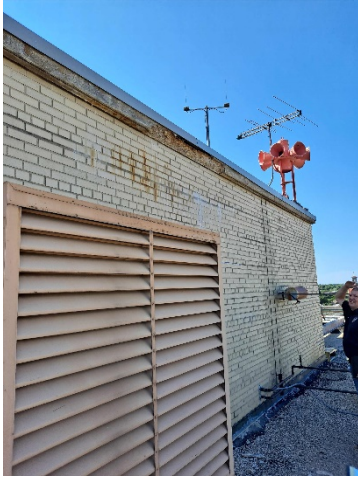
**Penthouse pre-cast coping replacement**

- A1.** Remove and replace both mechanical penthouse roof and 6<sup>th</sup> floor roof including replacement of copper flashing with stainless steel and all damaged pre-cast concrete wall caps.
- A2.** Tuck point existing main building and mechanical penthouse.
- A3.** Replace all 256 windows (various sizes) at the exterior, patch interior jambs and repaint all window jambs.

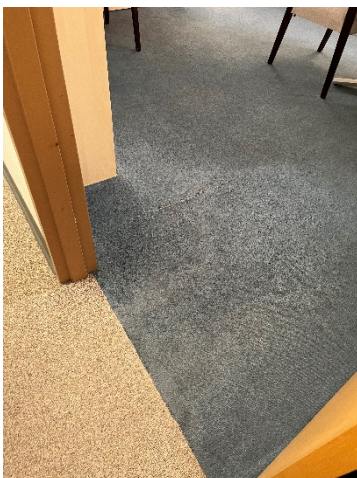
**Ripped carpet seam**

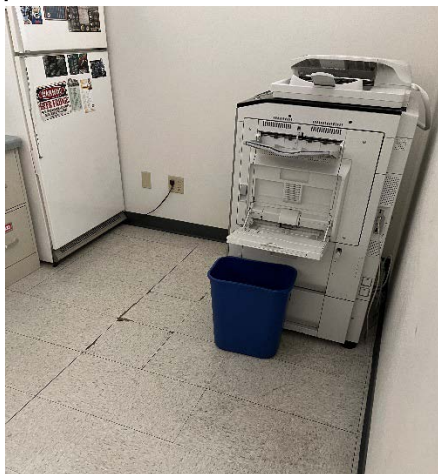
Chipped floor tiles

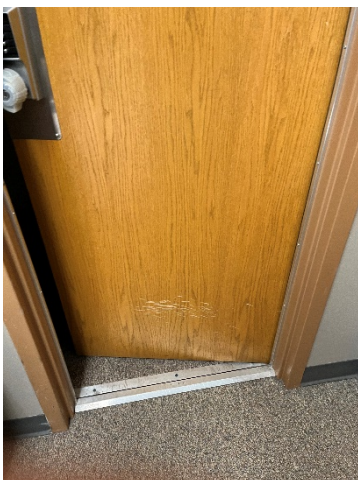
Scratched wood door

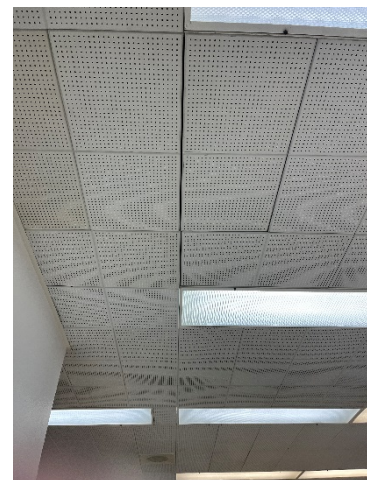
Typical spline ceiling issues

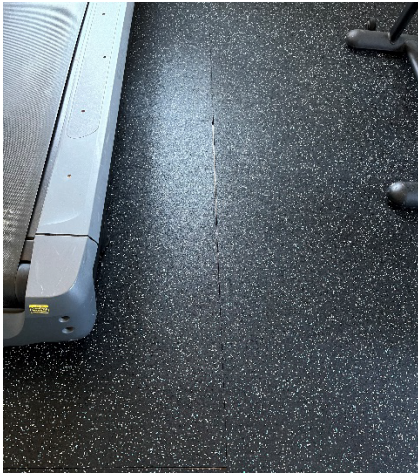
**Gap in rubber floor tile**

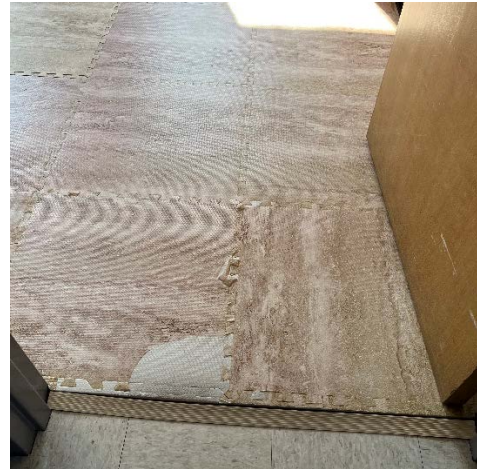
**De-laminated interlocking floor tiles**

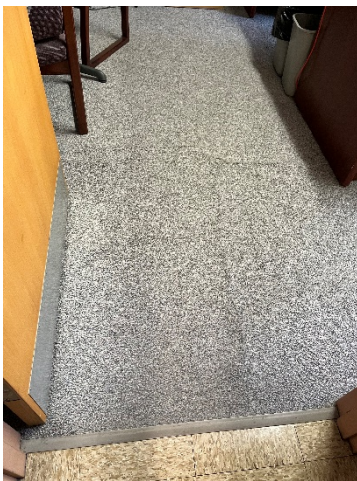
**Bubbled carpet at NE office**

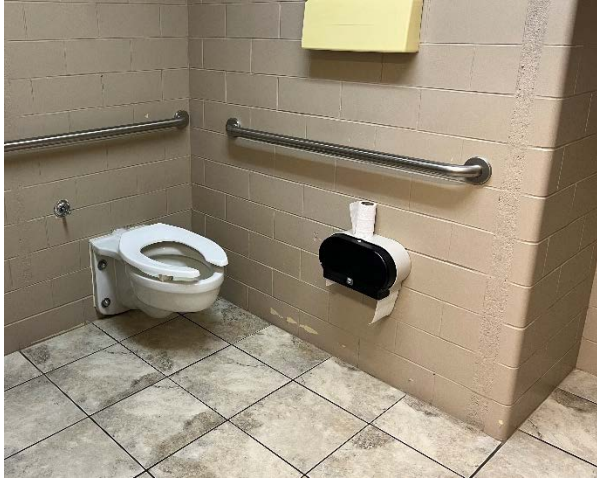
**Peeling paint from glazed block**

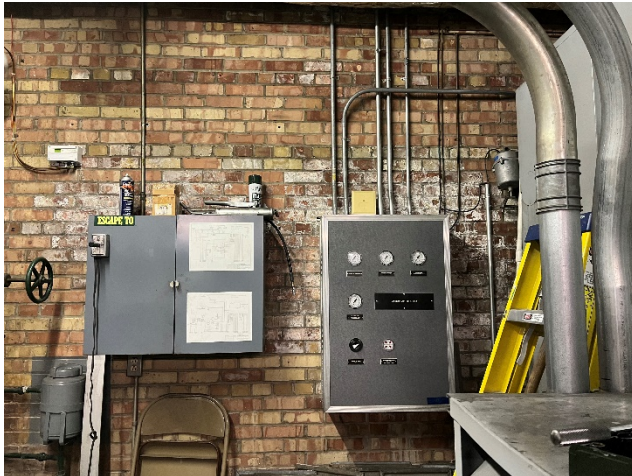
**Effervescence on west wall**

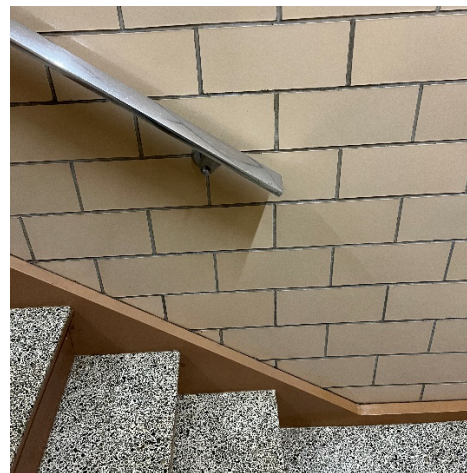
Lack of handrail extension past lowest tread

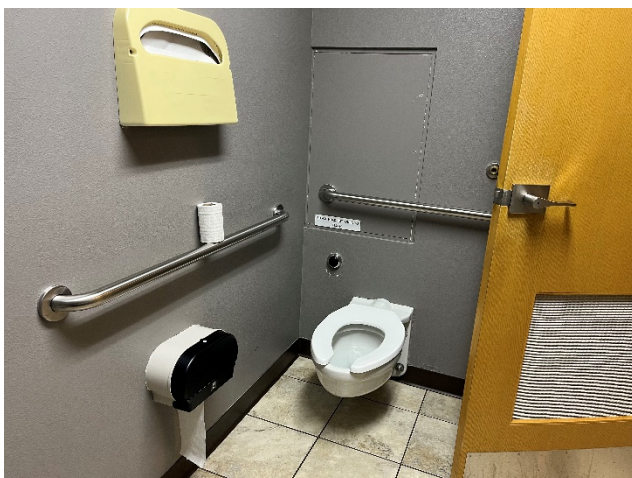
**Typical lever handled door**

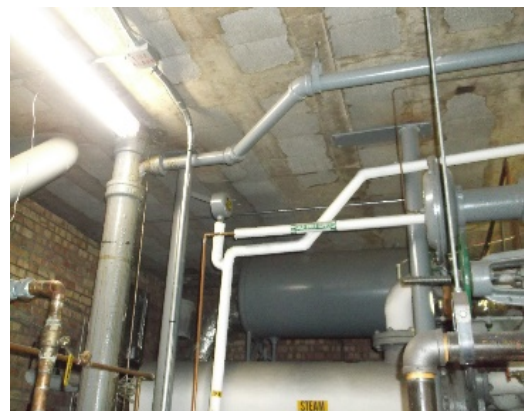
- P1. Water piping is copper, soldered joints. Original main is galvanized piping. Fair condition. Piping is missing insulation in some areas.
- P2. Original sanitary is cast iron, hub & spigot and threaded galvanized. Piping from the later remodeling(s) is cast iron no-hub or PVC.

**Cast iron vent piping**

**Recommendation:** replace sanitary waste/vent piping with new PVC as required.
- P3. Storm system has interior roof drains on the main roof. The Penthouse roof discharges over the roof edge, onto the main roof below - no roof drain(s) or scuppers. As a result, the rainwater is deteriorating the concrete and brick below the roof edge. No secondary overflow roof drainage system is installed. Storm piping within the building is not insulated.

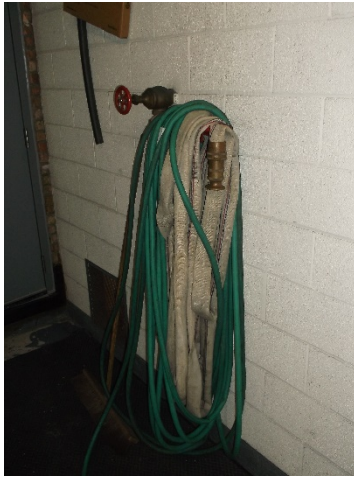
**FP6.** The existing standpipe system is a 1 ½" system. The current standard requires 2 ½" hose valves on the system. IFC 2015 also requires that hose valves on the standpipe system be installed in every required exit stairway. The valves are currently installed in the corridor on each floor. Upgrading the standpipe system would involve installing new risers in each stairway and new hose valves on each intermediate landing.

Hose valve – penthouse

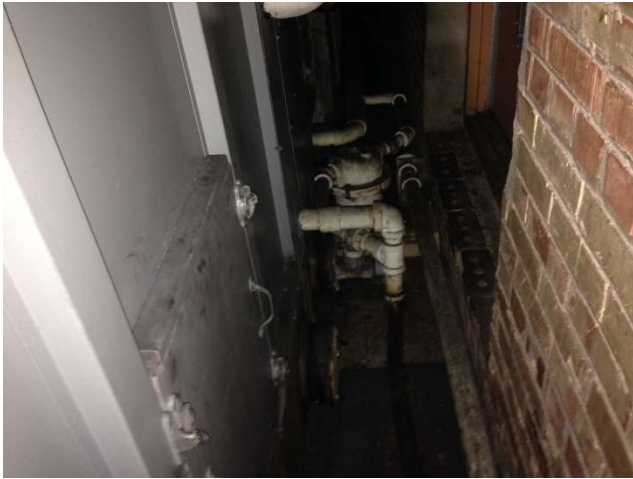
| HVAC systems | grade | budget cost | notes | comments |
|---|---|---|---|---|
| Coils | CP | (incl.) | H1 | Steam, Chilled water. Chilled water coil casing is deteriorating. |

**AHU-1 steam coil**

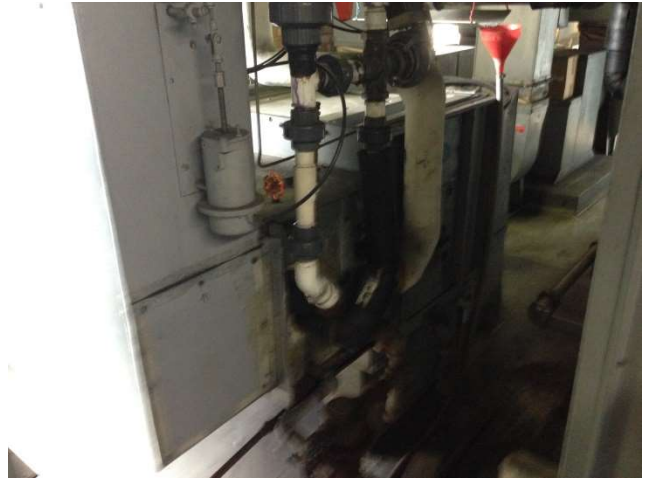
| HVAC systems | grade | budget cost | notes | comments |
|---|---|---|---|---|
| Coils | HP | (incl.) | H3 | Chilled water coil casing is deteriorating. |

**AHU-2 and 3 coils**

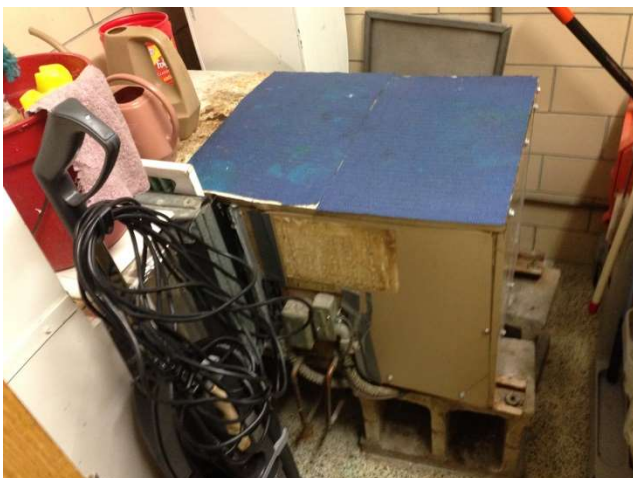
A water-cooled air unit is located in a closet on first floor and serves the reception desk and a room on second floor. The unit requires replacement, or the space should be served off a larger central system. Occupant dissatisfaction with the unit's operation has led the staff to simply turn the unit off.

**Water cooled blower coil (AHU-5)**

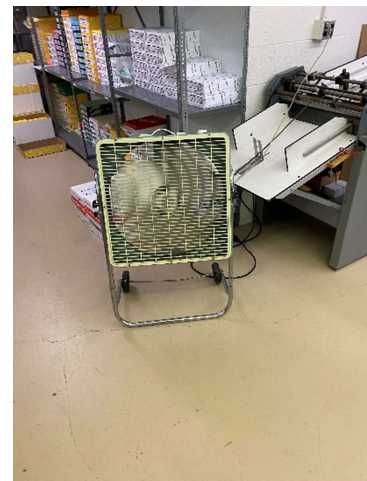
**Room circulation fan  
(temperature issues)**

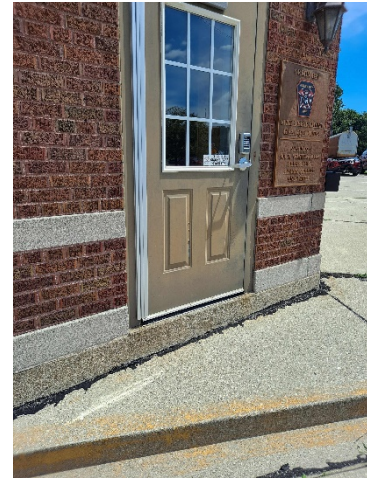
None of the exterior doors are ADA compliant due to the exterior concrete stoop settlement. See Code section of this report for additional information. The hollow metal doors are faded and could use a coat of paint. When doors are painted, it would be recommended to replace the weatherstripping around the doors. Plywood transoms over the doors are weather-damaged and should be replaced. Note that these panels were noted as Category II non-friable in the Hazardous Materials Assessment provided to the City of Green Bay.

**Door not egressing to grade**

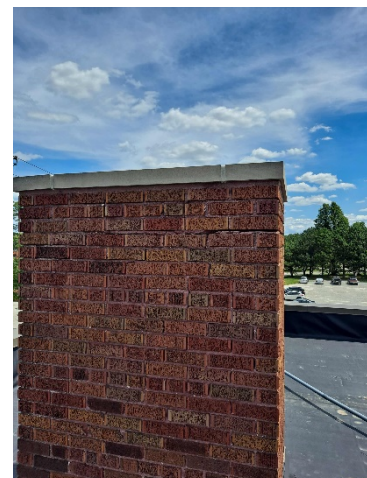
Fire Station #1 is a historic structure built in 1929 and constructed of brick with stone accent bands. The exterior brick is in very good condition for a building of this age. There only a few areas where some tuck pointing could be addressed to prevent further damage to the building. The area most in need of tuck pointing is the chimney on the roof. There are large settlement cracks that should be addressed on the chimney.

**Tuck pointing needed at chimney**

- A1.** Tuck-point as needed on few wall locations. Tuck-point and repair masonry at chimney.
- A2.** Replace plywood transom in-fill panels. Paint doors and frames. Replace weatherstripping.
- A3.** Concrete at driveways is cracked and spalling. Recommend replacement.
- A4.** Plan to continue carpet replacement of worn areas.
- A5.** Re-paint wood door frames.
- A6.** Recommend replacing missing ceiling tiles to help maintain conditioned space.
- A7.** Refer to plumbing section for notes on replacing pipe insulation at women's room.

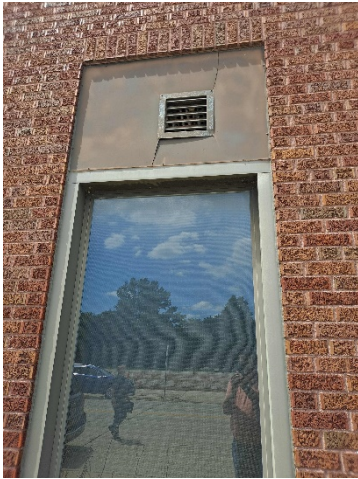
**Transom faded and broken**

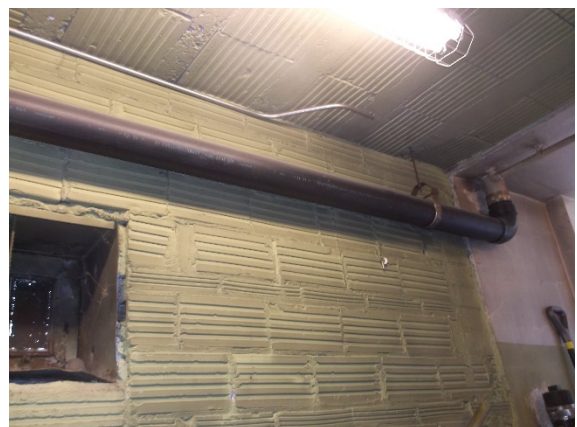
Sanitary piping – boiler room

- P17. Building is served from a 2" water main. The main routes from South Adams Street. Sanitary sewer is 6". Main routes north to Chicago Street, exits the lower boiler room at 20" aff., gravity discharge. Two 4" storm sewers route to South Washington and South Adams Streets. Parking lot/drives are pitched and discharge to the adjacent streets – no internal drainage or catch basin(s). Technically draining parking space over a public sidewalk is not allowed.

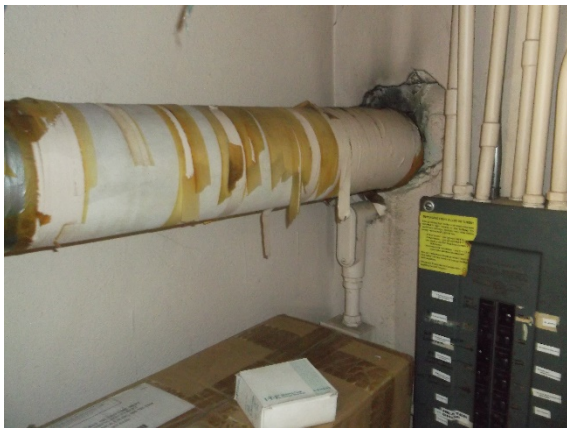
**Water piping thru electrical closet**

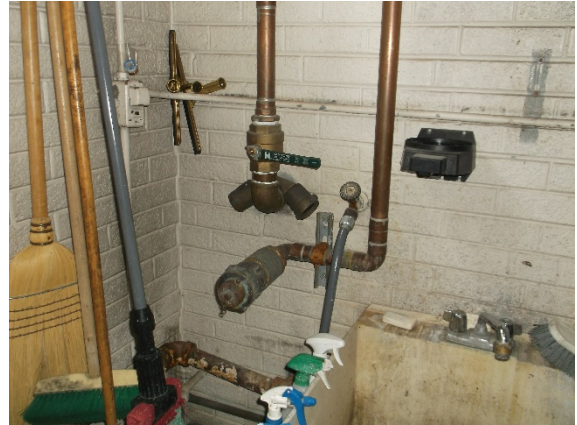
**Studor vent - garage**

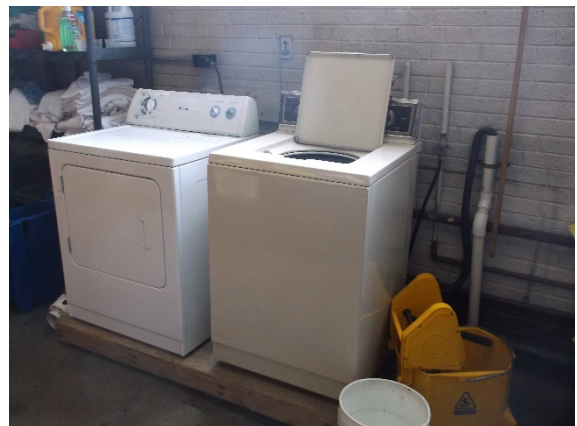
**Washer/dryer in garage bay**

- H13.** A laundry dryer is located in the apparatus garage. The dryer terminates inside the room. This termination allows warm, moist air to be vented directly into the garage. This vent should be terminated outside.

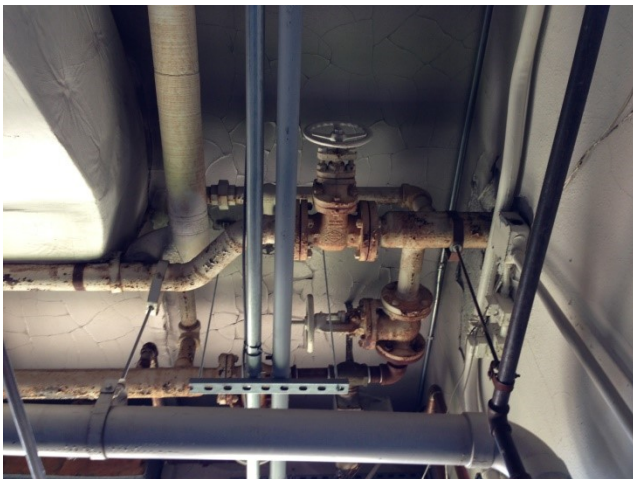
| HVAC systems | grade | budget cost | notes | comments |
|---|---|---|---|---|
| Pipe insulation | D | \$17,000 | H8 | Most of the piping is bare and uninsulated throughout the boiler room and apparatus room. Damaged insulation in multiple exposed locations. |

**Uninsulated pipe (typical)**

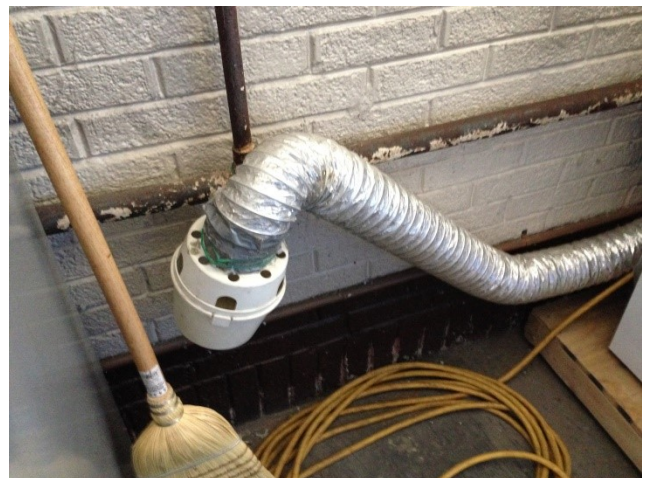
Dryer vent (indoors)

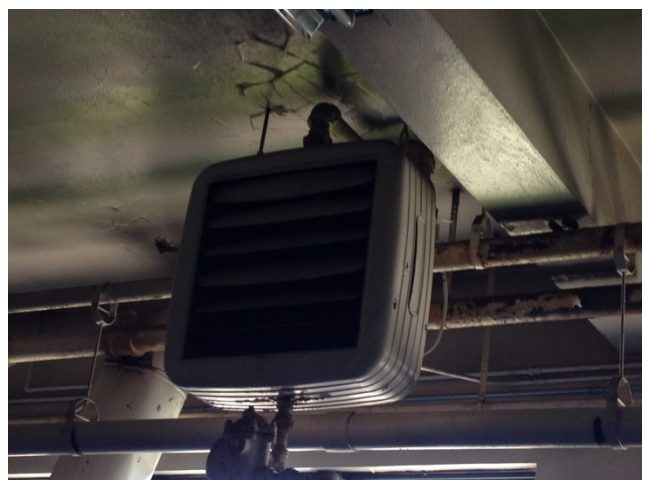
**Steam unit heater (bare piping)**

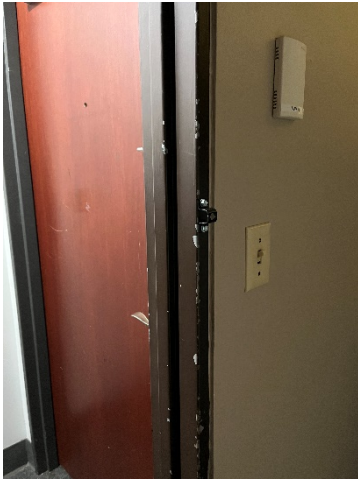
**Chipped paint at basement door frames**

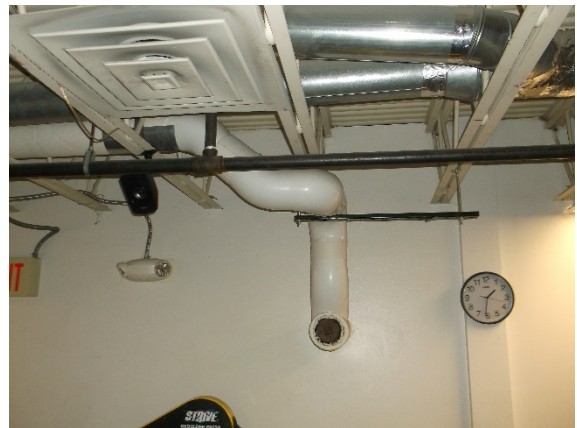
- P6.** Water and storm piping is insulated with glass fiber. Some sections of water piping are missing insulation. Repair as required.
- P7.** Code issues: water temperature is set at 120° Fahrenheit - maximum temperature to be 110-115 degrees Fahrenheit. No thermostatic mixing valve (TMV) at the heater. Add TMV per code. Fire protection drain discharges to a janitor's sink in the basement, which is not allowed per code for in-direct waste discharge. Re-route drain piping to a nearby floor drain. Install hose end vacuum breaker on the hose bib at the water main.

**Storm piping - insulated**

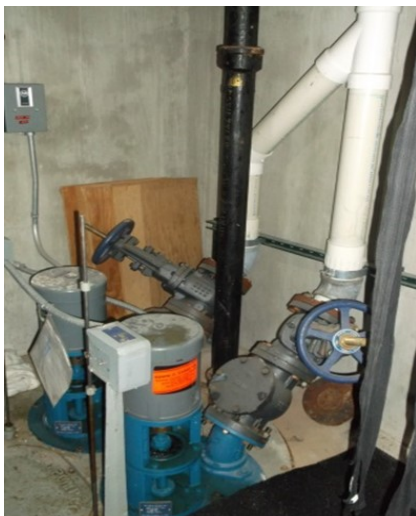
- P15.** Sanitary ejector pumps are duplex top-mount. Pumps are 1 ½ hp, 208Volt, 3-phase.
- P16.** Building is served by four 3" roof drains with 4" roof leaders to below grade. Piping is insulated with glass fiber. There is no secondary roof drainage installed, which is a code issue. (International Plumbing Code 1108.1) Secondary drainage could have been added during the last re-roofing project.

**Sanitary ejector – duplex pumps**

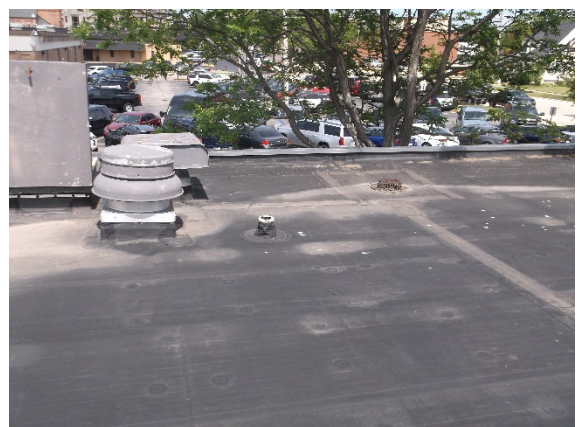
**Sanitary vent & roof drain**

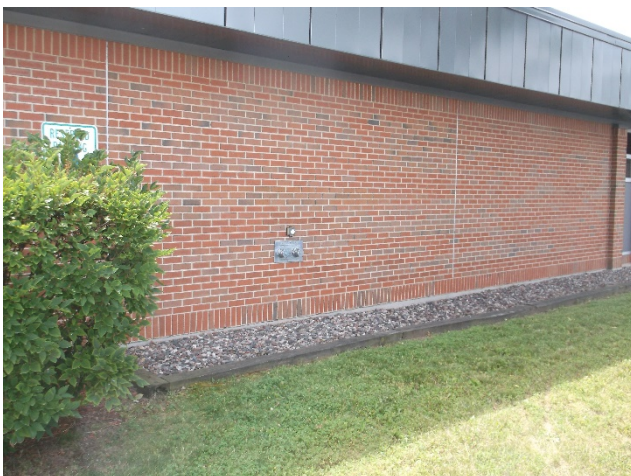
- FP3.** The basement level and the stairwells are fully sprinkled. The deficiencies on the fire sprinkler system include the following. The sprinkler flow indicator stickers installed on the piping to the fire department connection are pointing in the wrong direction. The automatic ball drip valve on the fire department connection check valve is capped. This drip valve is meant to allow water in the check valve to drip out to prevent freezing. A pendent sprinkler head was discovered that was not replaced with an upright head when the ceiling was removed. The inspector's test drain is piped to a sink. There are a few upright sprinkler heads that are not piped to within 6" of the bottom of the metal deck – minor deficiency. All valves, piping, and sprinkler heads appear to be in good condition. The piping shows no indication of corrosion and the valves appear to be in good condition.

**Fire department connection**

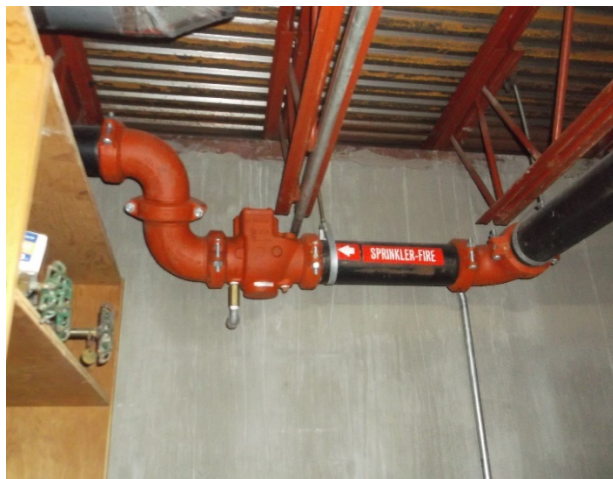
**Flow direction points the wrong direction**

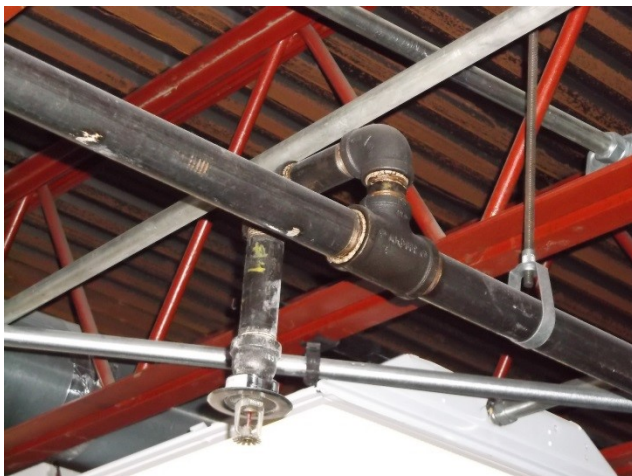
**Pendent sprinkler head too far from ceiling**

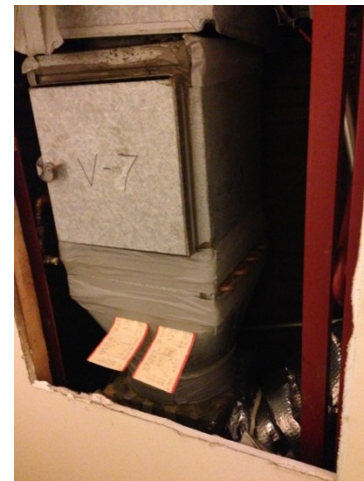
**Older VAV terminal**

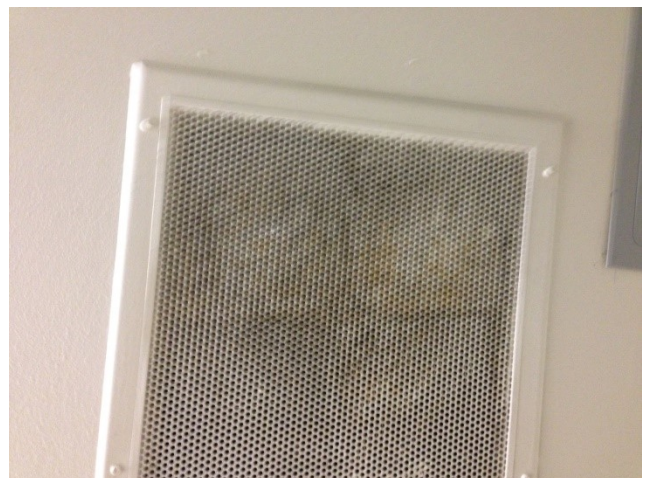
| HVAC systems | grade | budget cost | notes | Comments |
|---|---|---|---|---|
| Exhaust ductwork | HP | \$16,000 | H2 | Mostly original. Minimal replacement during renovation projects. Lint/dust is coating the grilles and ductwork in the basement, less on first floor. Recommend cleaning, sealing, and rebalance. |

**Old grille (plugged)**

- H2.** The building exhaust system is served by multiple fans of various sizes and types. The ages and conditions vary greatly, as the units have been modified and replaced as necessary. Dust and lint build-up is prevalent at the lower-level grilles and ducts. Air flow within these spaces appears diminished and can be attributed to older leaking ductwork combined with the dirtying of the systems. Duct cleaning, taping, sealing, and air balancing are recommended.

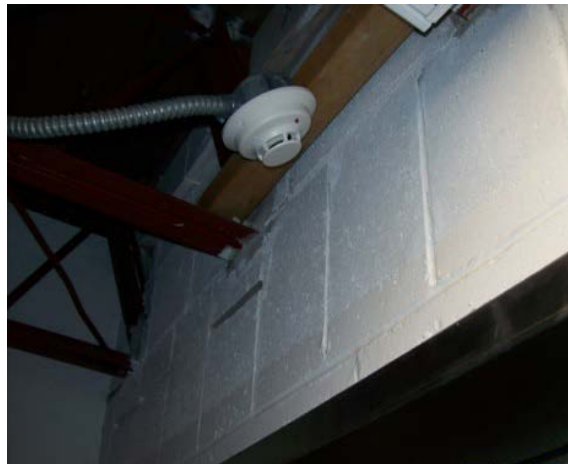
Detector not installed properly

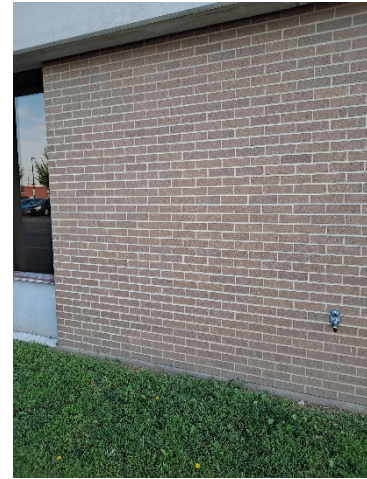
**Brick in good condition**

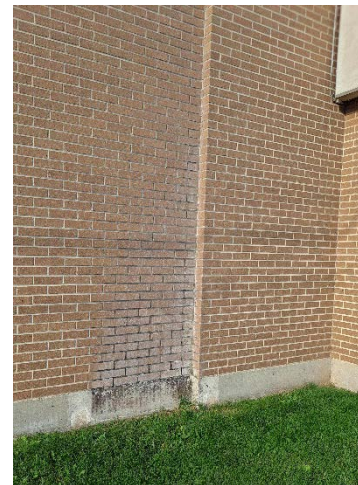
Portions of the exterior walls are brick, which is in fair condition. There are a few spots where tuck-pointing would be recommended as part of a typical maintenance program. One area near an inside corner shows effervescence that starts approximately 6' up on an inside corner and extends diagonally down. The mortar is compromised, and the exposed portion of foundation wall is stained.

**Efflorescence on brick**

- A1. Tuckpoint approximately 10% of brick joints. Note especially triangular area in north corner at juncture of garage and office.
- A2. Remove dried and brittle caulk in precast joints. Re-seal with backer rod and sealant. Patch/repair cracks at vertical concrete between west windows. Power wash panels to remove stains under windows and wall-mounted equipment.

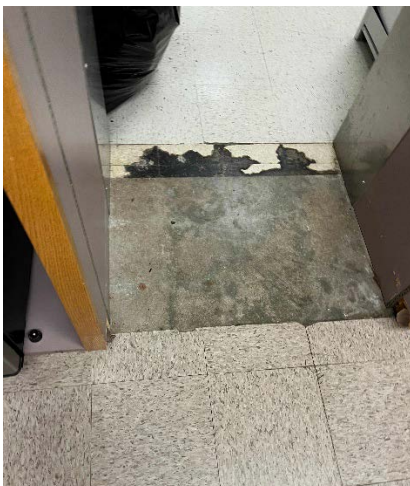
**Missing VCT at basement**

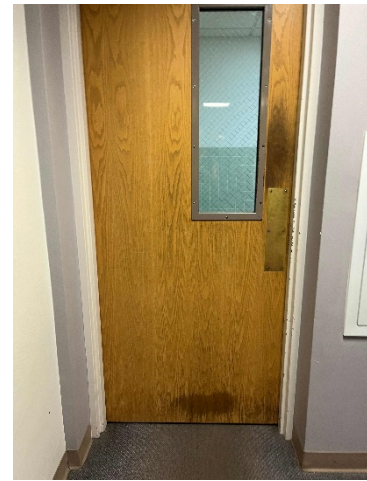
**Damaged wood veneer & missing kick plate**

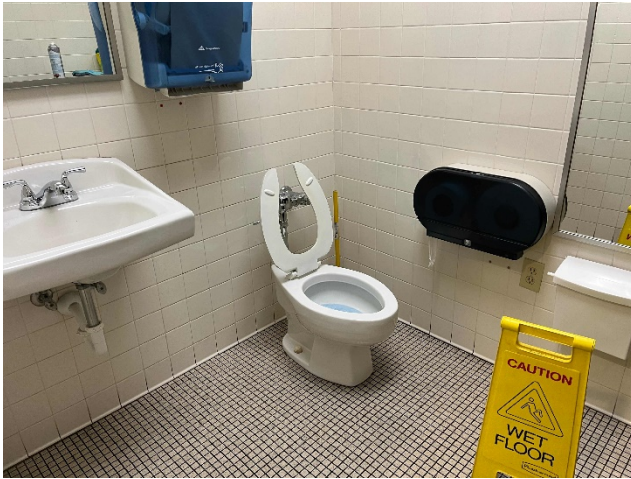
**1<sup>st</sup> Floor: not accessible toilet room**

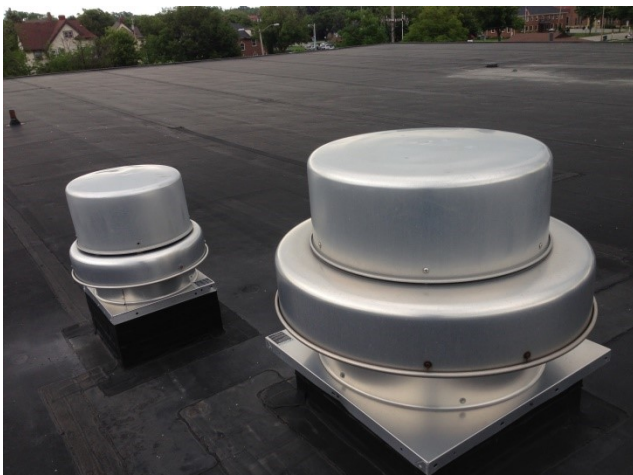
| hvac systems | grade | budget cost | notes | comments |
|---|---|---|---|---|
| Toilet/locker room exhaust | F | | | Multiple power roof ventilators. Ages and condition vary. Ceiling fan in single fixture toilet rooms – light switch operated. |

**Power roof ventilators (typical)**

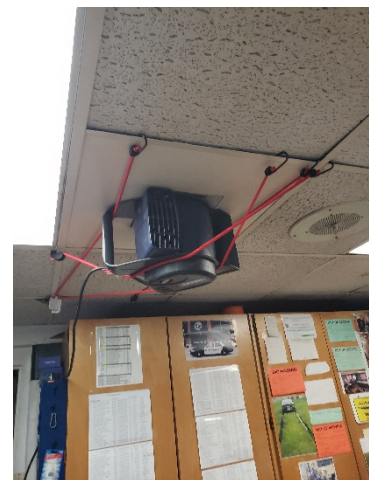
**Makeshift room ventilation unit**

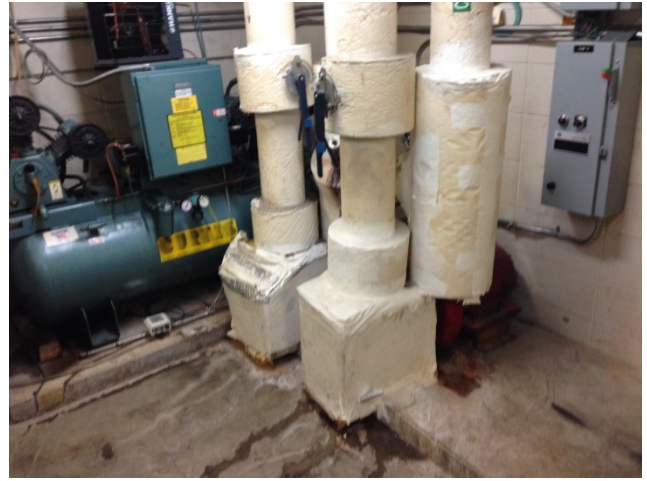
| hvac systems | grade | budget cost | notes | comments |
|---|---|---|---|---|
| Insulation | CP | \$1,500 | H2 | Insulation has failed at one pump (or pump is leaking). Condensation on pump and across floor. |

**H2.** The chiller was replaced in 2010. No system complaints relayed by staff. Insulation is damaged at the chilled water pump. Recommend repair to the insulation to prevent condensation and further deterioration of the insulation and piping. The insulation prevented inspection of the pump seals to determine if the water was condensation from the damaged insulation or if the pump itself was starting to leak and causing the insulation damage.

Chilled water pumps

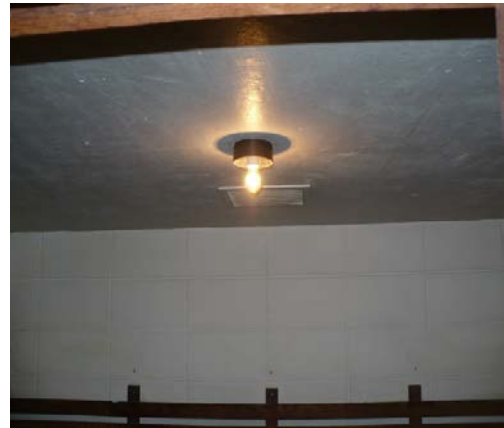
| electrical systems | grade | budget cost | notes | comments |
|---|---|---|---|---|
| Toilet rooms | F | \$1,000 | E5, E6 | Recessed troffers and surface mounted wraps in good condition. Men's shower and sauna have incandescent lamps (sauna fixture is missing lens). |

**Sauna light missing lens**

- E5.** Replace incandescent lamps with compact fluorescent or LED type for energy savings.
- E6.** Consideration should be given to replacing older fixtures with new. Replacement or repair should be done on fixtures with broken or missing lenses.

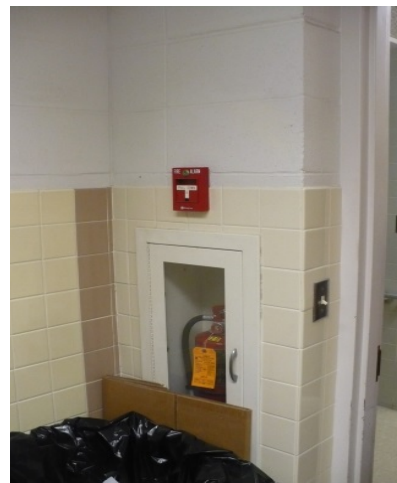
| electrical systems | grade | budget cost | notes | comments |
|---|---|---|---|---|
| Zoned system | F | \$50,000 | E9 | Simplex 4002 zoned system in fair condition, coverage does not meet code. Some pull stations are not ADA compliant for mounting height. |

**Non-ADA height of pull station**

- E9.** Recommend upgrading the fire alarm system to an addressable system with device locations that meet current code requirements.
