AGENDA OF THE AD HOC FACILITIES COMMITTEE

Report to the
Ad Hoc Facilities Committee
of the City of Green Bay

■ Existing Flow Analysis - City Hall | Green Bay, WI

Existing Flow Analysis - Police Department | Green Bay, WI

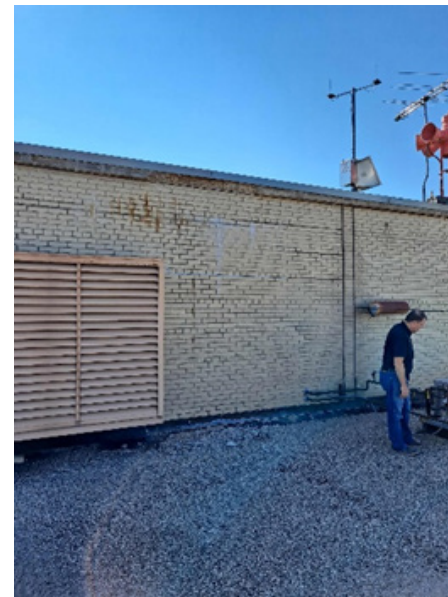
Mechanical penthouse - tuck pointing

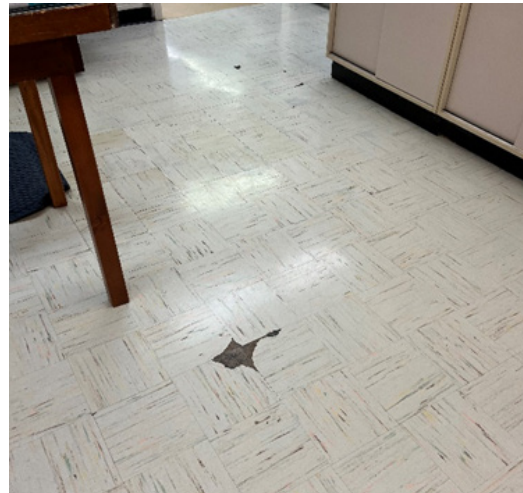
•9” composite tile in print shop area has cracked and missing tile at multiple locations throughout the space. Staff reports that a previous asbestos survey found asbestos in the adhesive for the tiles, but not the tiles themselves. Areas of missing or damaged tile should be addressed in order to prevent old adhesive from becoming airborne.

Chipped floor tile

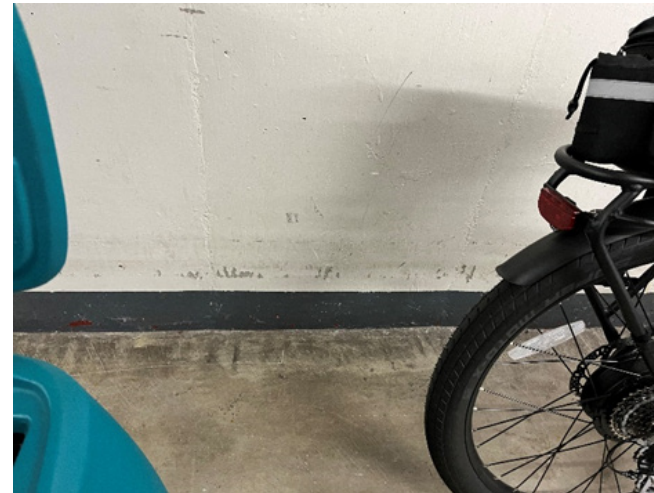
Chipped paint at wall

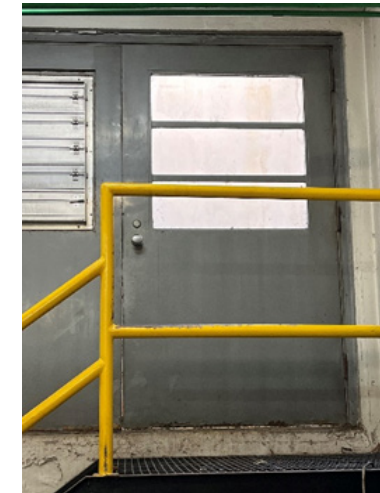
•Paint at frames is worn and chipped in multiple locations.
•Metal door from boiler room to exterior is rusted at sill. Weatherstripping is missing at door. Daylight visible at door perimeter.

Missing weatherstripping
at rusted door

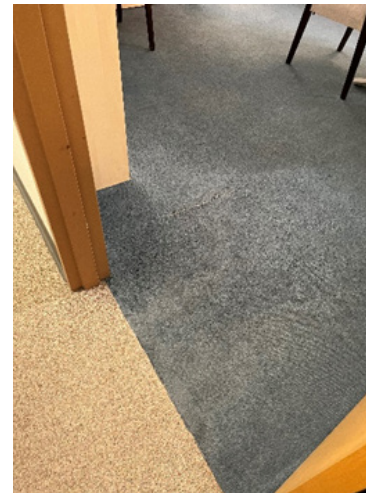
Ripped carpet seam

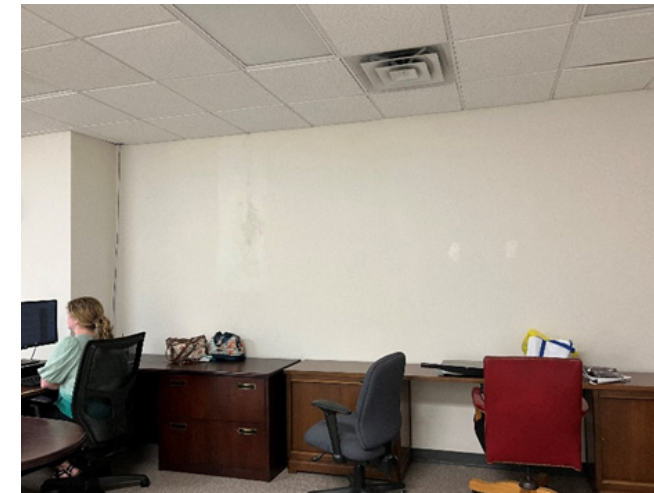
Visible wall patches

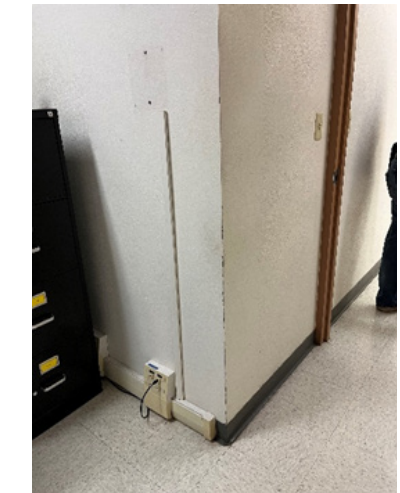
2nd & 3rd floors: typical
chipped paint at exterior
corner

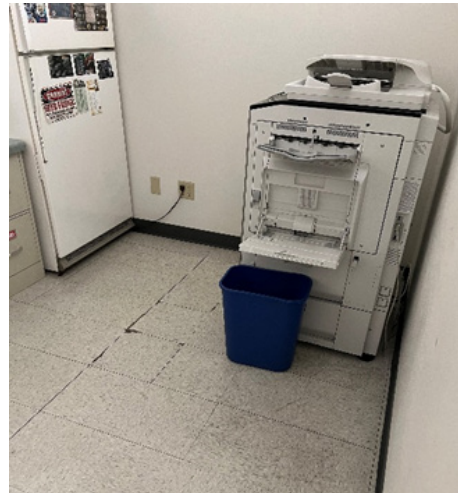
Chipped floor tile

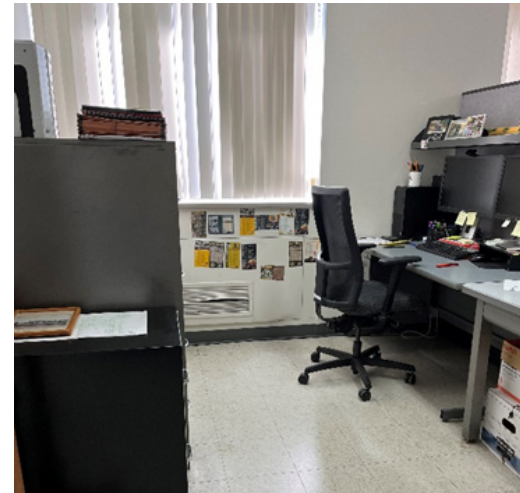
Bent louver blades

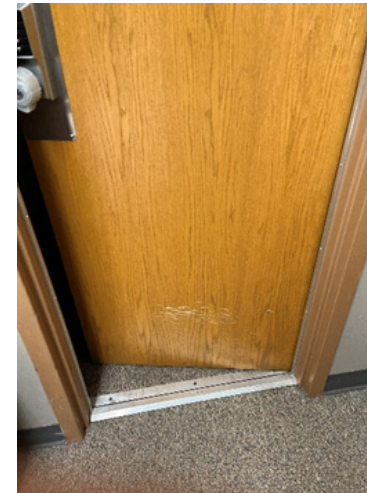
Scratched wood door

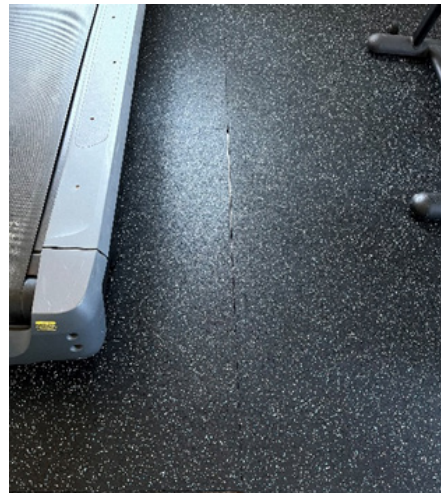
•Athletic flooring is shifting, causing gaps between floor tiles.
•Older athletic flooring with interlocking edges has de-laminating surface at several tiles.
•Bubbled carpet at NE office. Long-term condition. Carpet is worn at traffic areas.

Gap in rubber floor tile

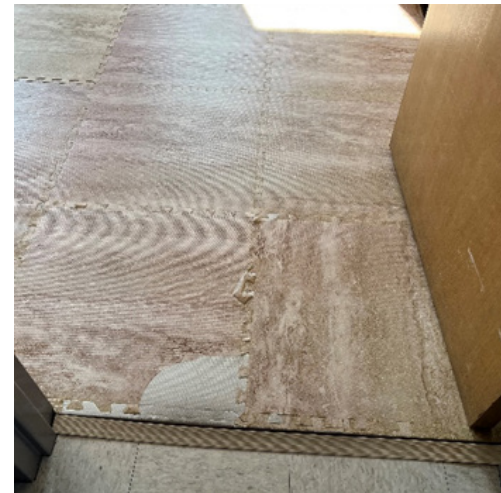
De-laminated interlocking floor tiles

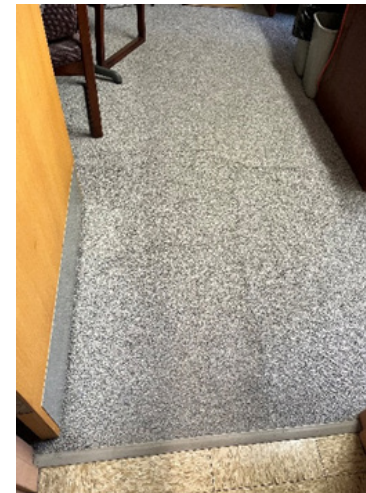
Bubbled carpet at NE office

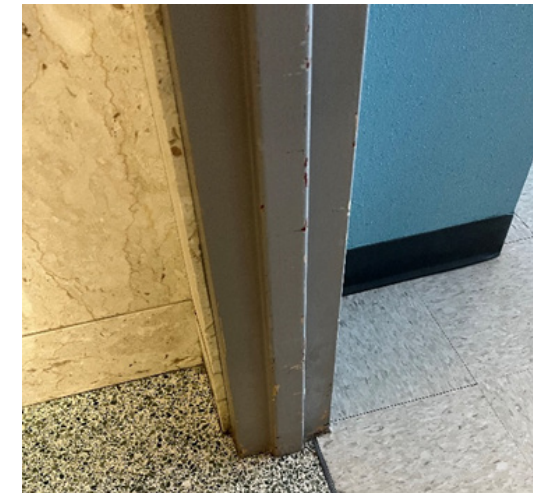
Chipped paint at HM frames

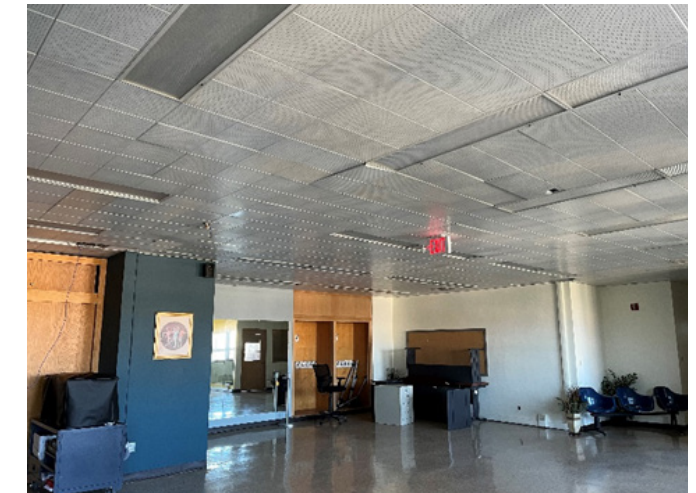
Typical spline ceiling issues

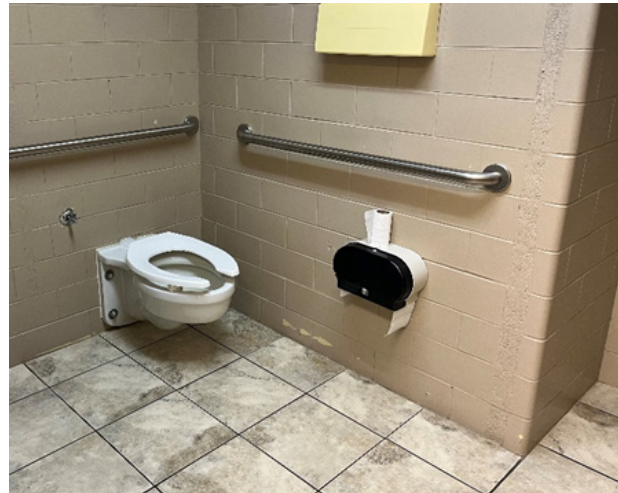
Peeling paint from glazed block

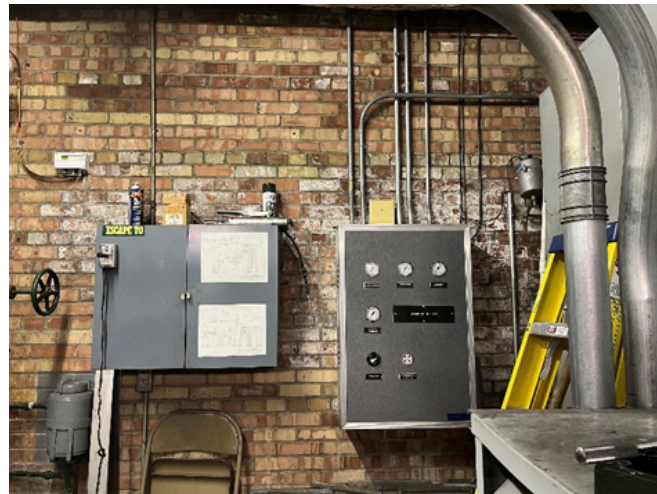
Efflorescence on west wall

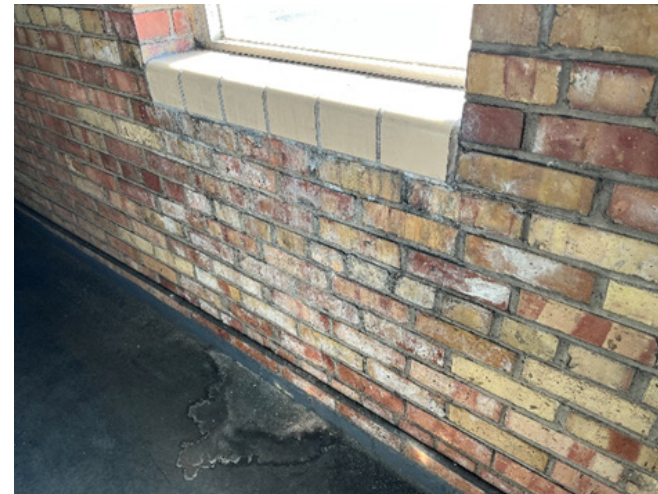
Efflorescence on east wall

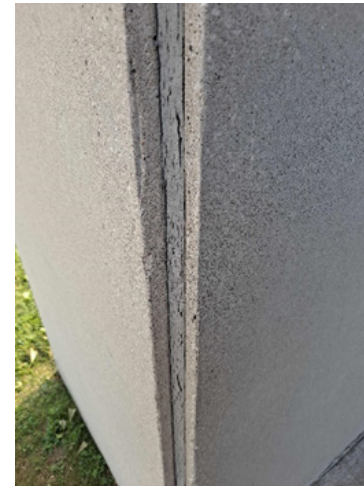
The remainder of the exterior walls are precast concrete panels. At the panel joints, there is dried and brittle caulking which should be replaced. There are also several locations where the panels are stained from the window frames or other wall-mounted equipment. Large gaps are present in the soffit areas of the precast panels. There is also some damage to the upper portion of the precast concrete wall panel at the southeast corner where a previous patch was made. There are some settlement cracks in the vertical concrete elements between the large west-facing windows.

Caulking dried and brittle

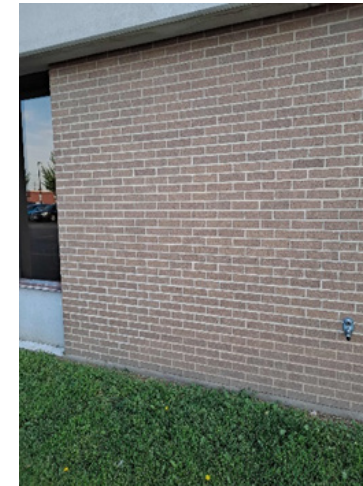
Brick in good condition

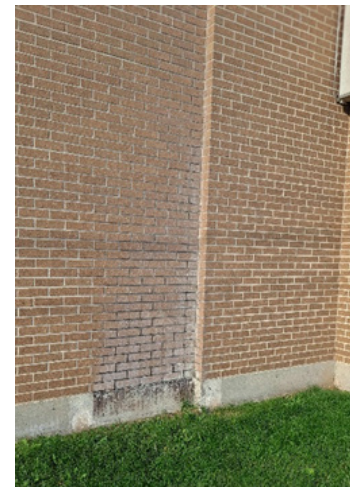
exterior walls
Portions of the exterior walls are brick, which is in fair condition. There are a few spots where tuck-pointing would be recommended as part of a typical maintenance program. One area near an inside corner shows efflorescence that starts approximately 6' up on an inside corner and extends diagonally down. The mortar is compromised, and the exposed portion of foundation wall is stained.

Efflorescence on brick

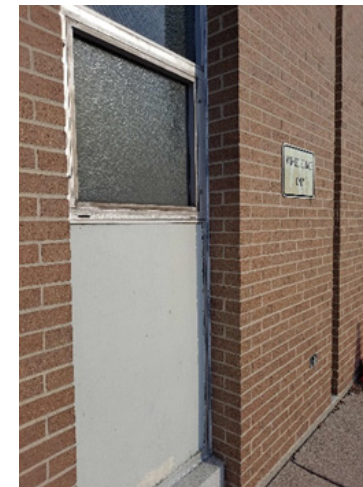
The windows appear to be thermally broken with insulated glass. The windows do not appear to have broken seals as no signs of moisture were noted during this review. The exterior window jambs and infill panels along the east side of the building are faded. The housing around the window covers need to be painted to prevent further damage from rusting on the west side of the building. There are a few empty conduits that could be removed.

Faded window infill panels

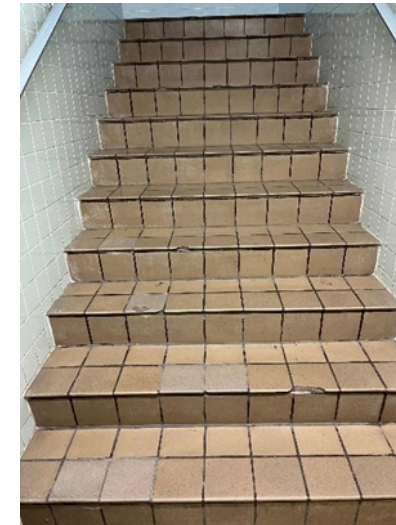
Minor chipping of concrete block corners and glazed wall tiles. Bottom of walls in the high-density file storage room has deteriorated. Lack of flooring and wall base has contributed to this situation.

Chipped tiles at south stair

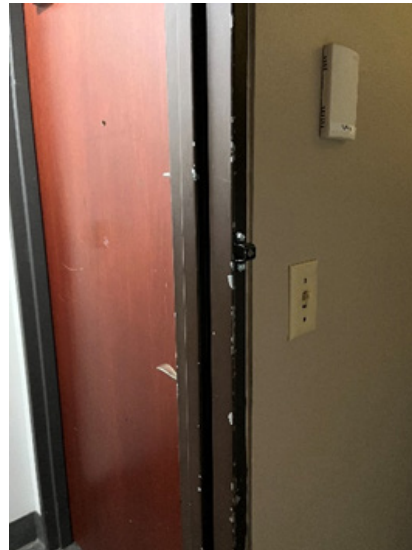
Chipped paint at basement door frames
