# AGENDA OF THE FINANCE COMMITTEE

**TUESDAY, NOVEMBER 28, 2023, 4:30 PM**

An assessment of City Hall was conducted in 2015 by Berners Schober with an update in 2022, which reviewed the condition of the building’s architectural, structural, mechanical, plumbing, and electrical elements. This report is a flow analysis, studying and noting the observed deficiencies.

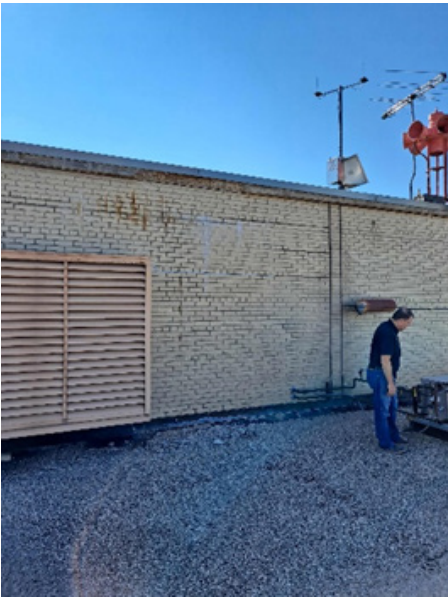
Mechanical penthouse - tuck pointing

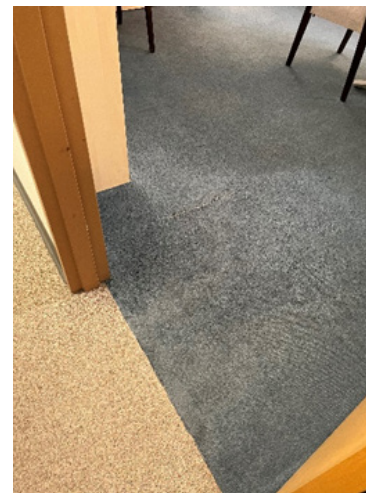
Ripped carpet seam

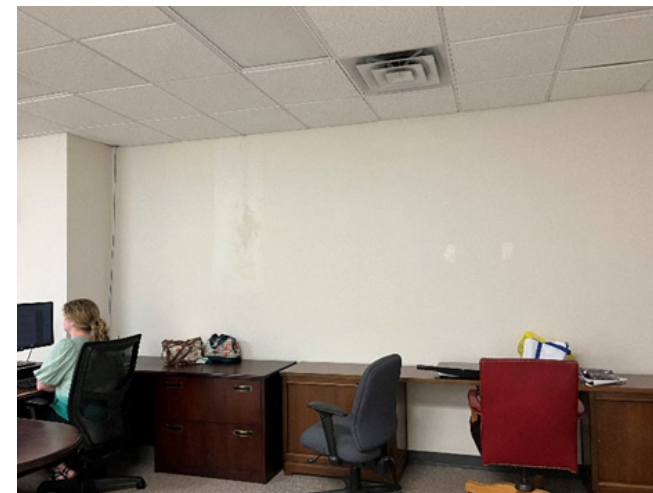
Visible wall patches

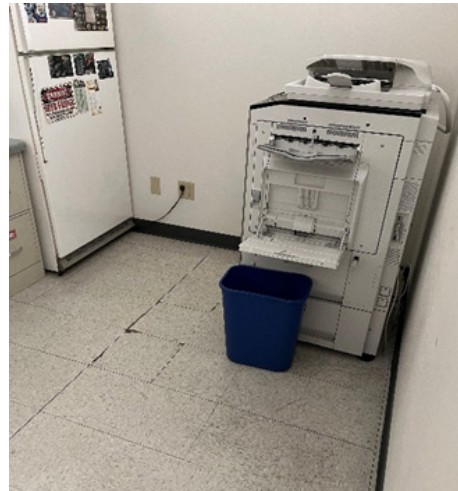
Chipped floor tile

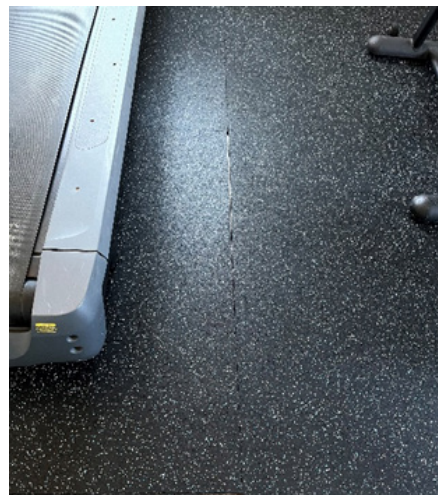
•Athletic flooring is shifting, causing gaps between floor tiles.  
•Older athletic flooring with interlocking edges has de-laminating surface at several tiles.  
•Bubbled carpet at NE office. Long-term condition. Carpet is worn at traffic areas.

Gap in rubber floor tile

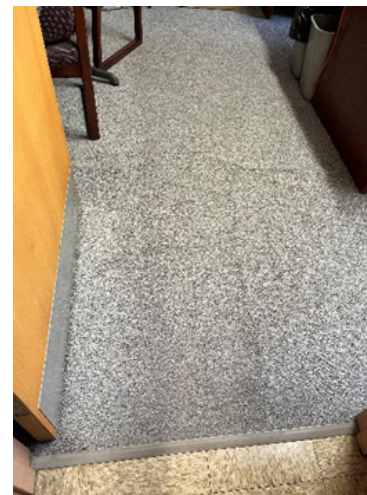
Bubbled carpet at NE  
office

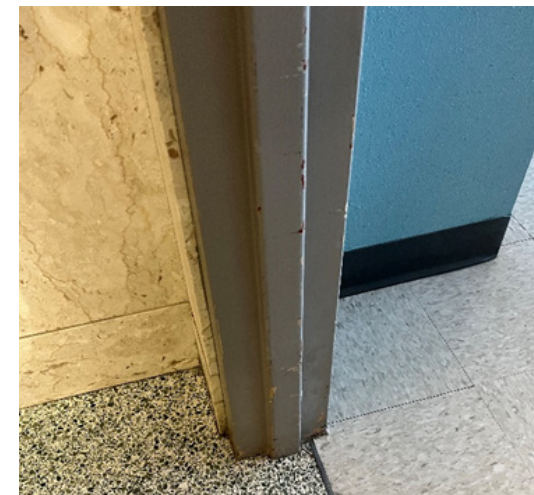
Chipped paint at HM frames

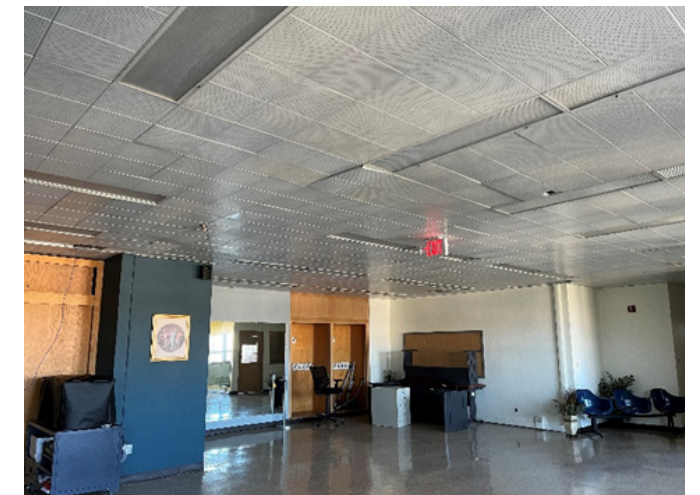
Typical spline ceiling  
issues

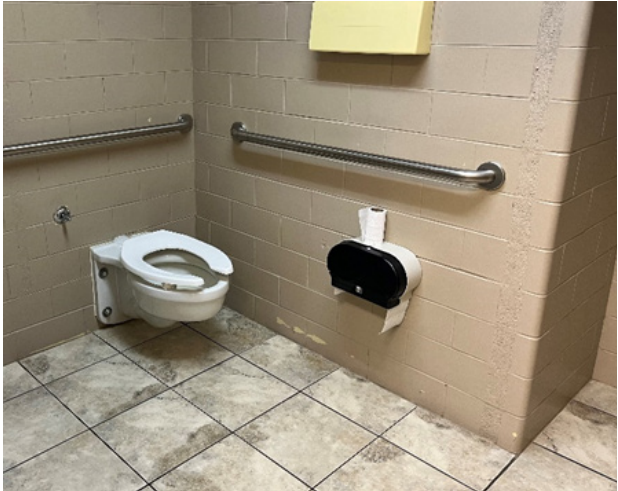
Sixth Floor

Peeling paint from glazed block

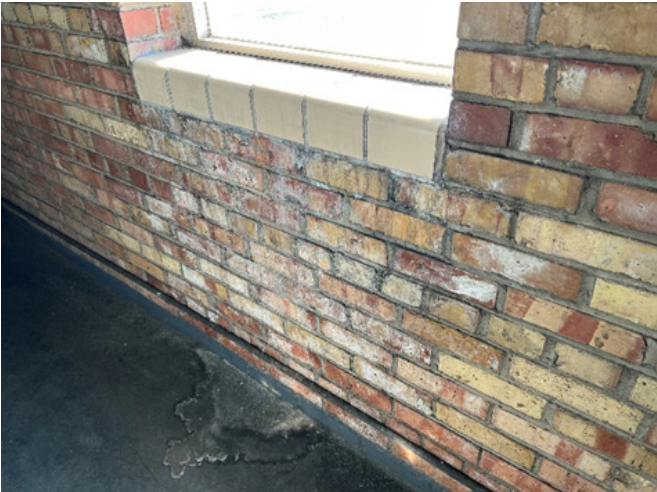
Efflorescence on east wall

**Efflorescence of Brick** - The presence of efflorescence on the brickwork indicates moisture-related issues that need to be addressed promptly to prevent further damage.

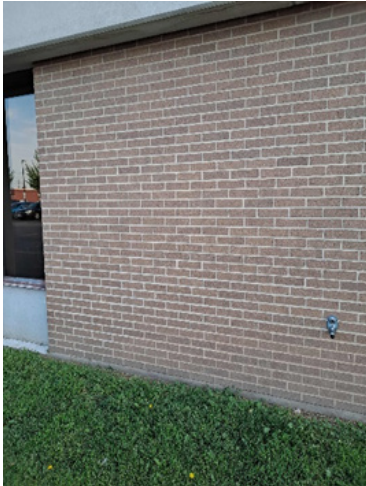
Brick in good condition

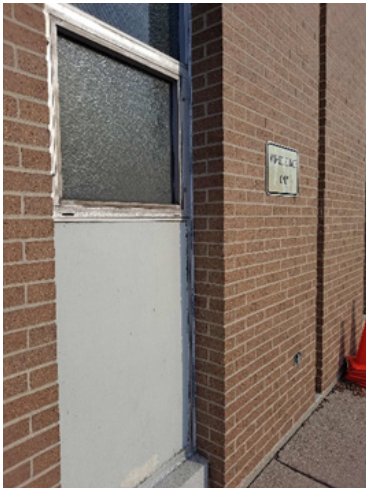
The windows appear to be thermally broken with insulated glass. The windows do not appear to have broken seals as no signs of moisture were noted during this review. The exterior window jambs and infill panels along the east side of the building are faded. The housing around the window covers need to be painted to prevent further damage from rusting on the west side of the building. There are a few empty conduits that could be removed.

Faded window infill panels

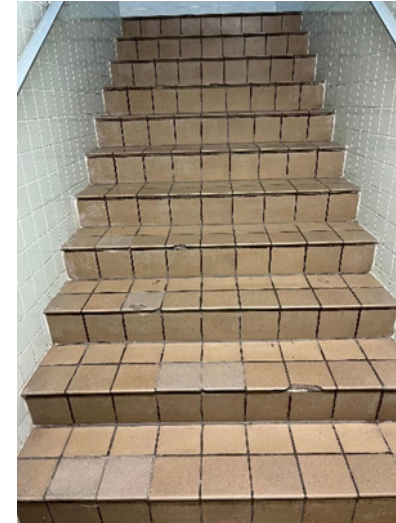
Chipped tiles at south stair

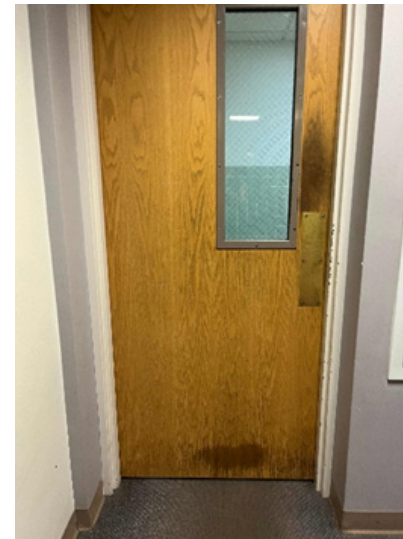
Scratched wood veneer

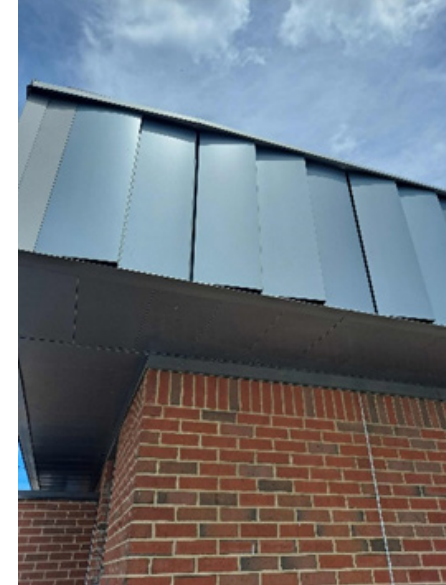
Brick wall are in generally good condition. Sealant at expansion joints is beginning to show signs of cracking. The fascia panels at the southwest corner of the building are out of alignment with the rest of the fascia. Building maintenance personnel report that this area was hit last winter by a payloader plowing snow. The structure itself was not damaged.

Aluminum fascia panels
