# **AGENDA OF THE LANDMARKS COMMISSION**

**WEDNESDAY, MARCH 20, 2024, 4:30 PM**  
**City Hall, Room 604 - The Harry Maier Room.**  
**Virtual attendance is also available via Zoom.**

- I. (COA 24-12) Consideration with possible action on a design review for replacement garage side door and window located at 1011 S Van Buren Street.

2. (COA 24-13) Consideration with possible action on a design review for basement window size change and replacement located at 840 S Jackson Street.

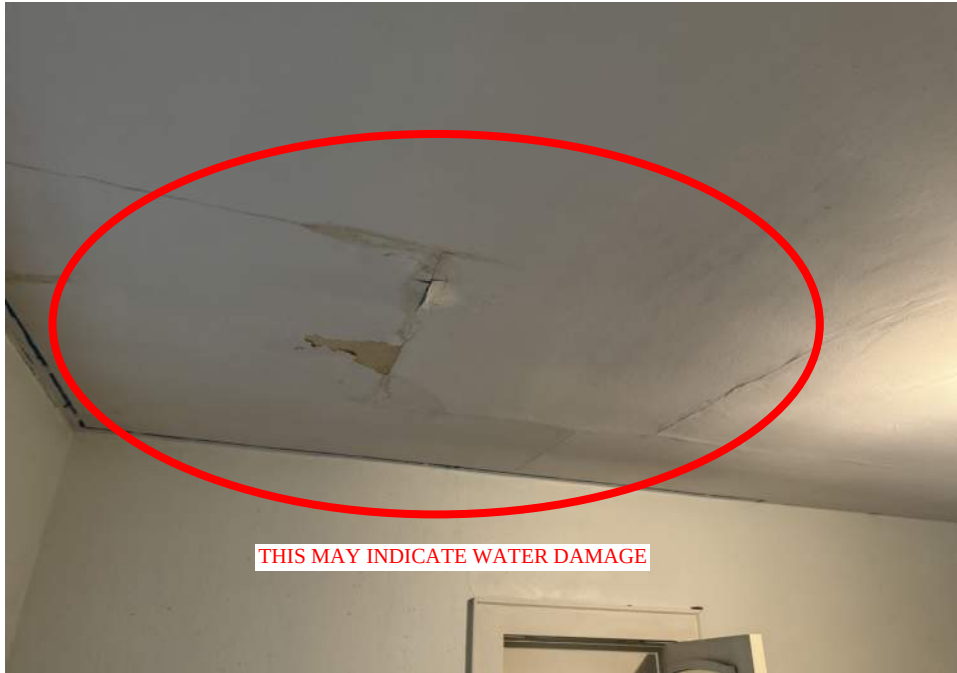
THIS MAY INDICATE WATER DAMAGE

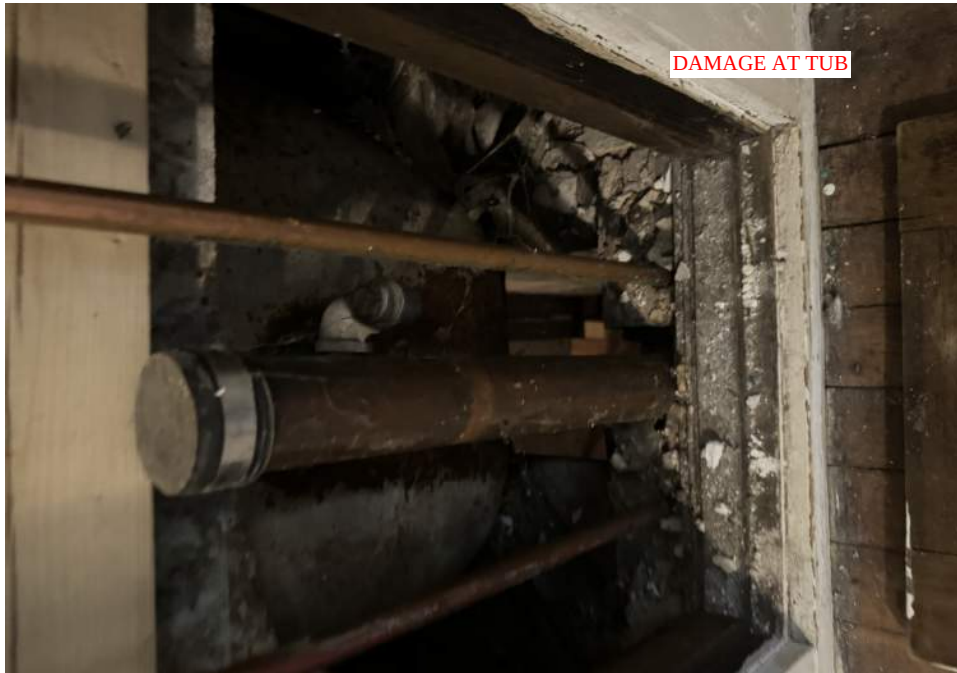
DAMAGE AT TUB
