AGENDA OF THE AD HOC FACILITIES COMMITTEE

- I. Consideration with possible action the review of the Facilities Assessment Updates for City Hall, Municipal Court, Police Station, and Fire Station #1.

An assessment of City Hall was conducted in 2015 by Berners Schober which reviewed the condition of the building's architectural, structural, mechanical, plumbing and electrical elements. This report, done in the summer of 2022, is an update to the previous assessment. Each building was re-surveyed by trade and the reports updated. Below are brief summaries of the changes to the building in the intervening 7 years.

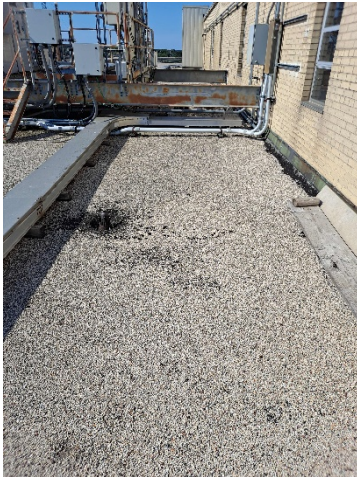
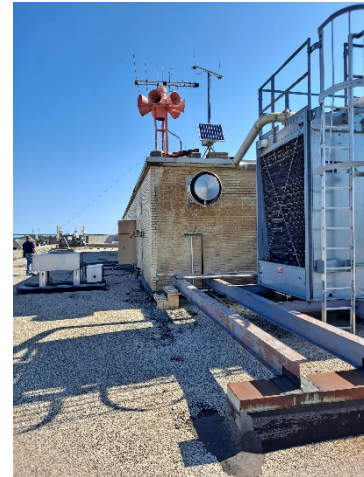
Existing roof

- A1.** Remove and replace both mechanical penthouse roof and 6th floor roof including replacement of copper flashing with stainless steel and all damaged pre-cast concrete wall caps.
- A2.** Tuck point existing main building and mechanical penthouse.
- A3.** Replace all 256 windows (various sizes) at the exterior, patch interior jambs and repaint all window jambs.

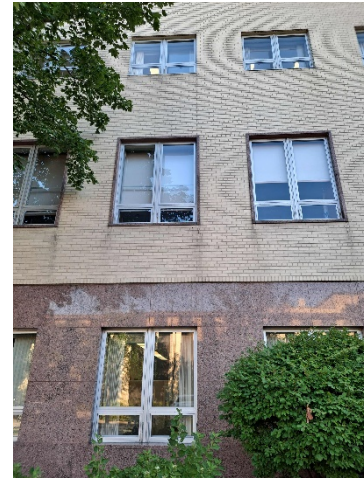
Replace exterior windows

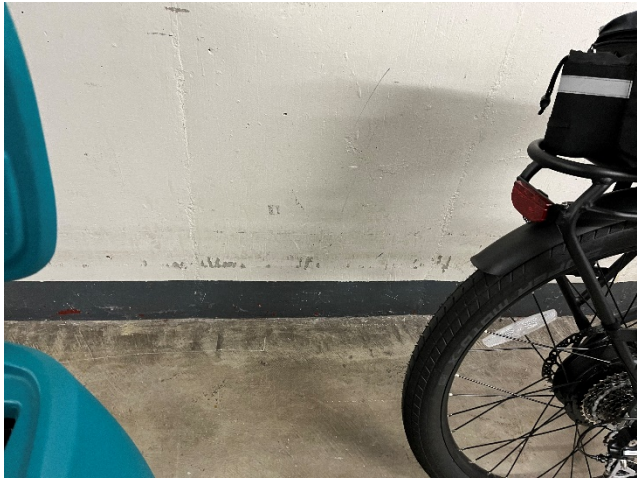
Chipped paint at wall

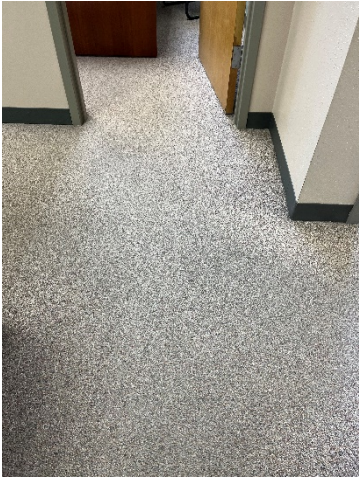
- Carpet at high traffic areas (legal suite, reception areas) is showing wear.

Worn carpet – legal area

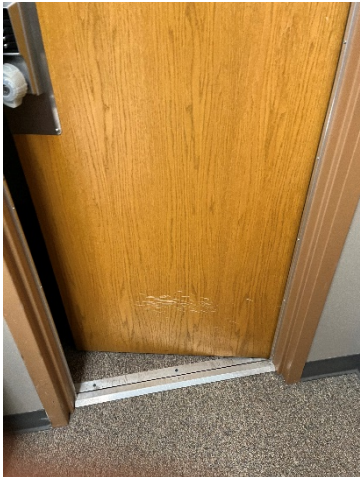
Scratched wood door

- A8.** Clean effervescence off brick in penthouse and monitor for reoccurrence after exterior conditions are corrected.
- A9.** Lightly sand and re-finish scratched wood doors and wood frames.

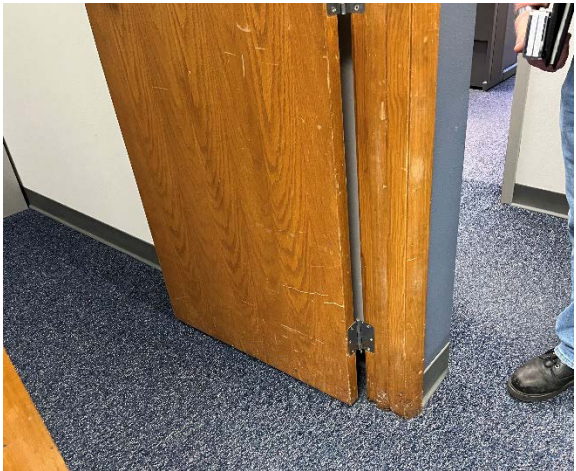
Scratched wood finish

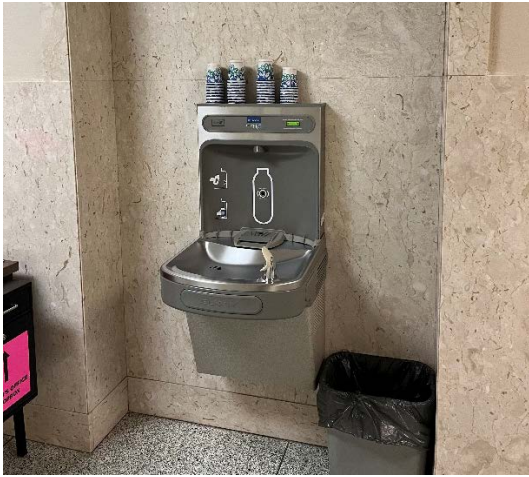
Drinking cups provided at water fountain

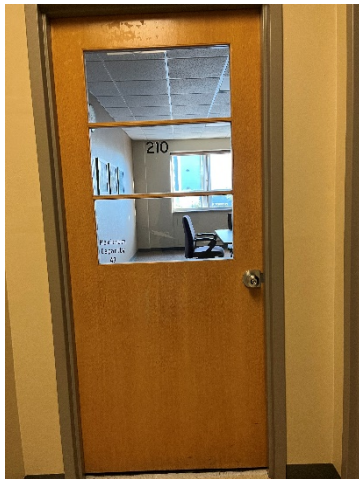
Knob handle on door

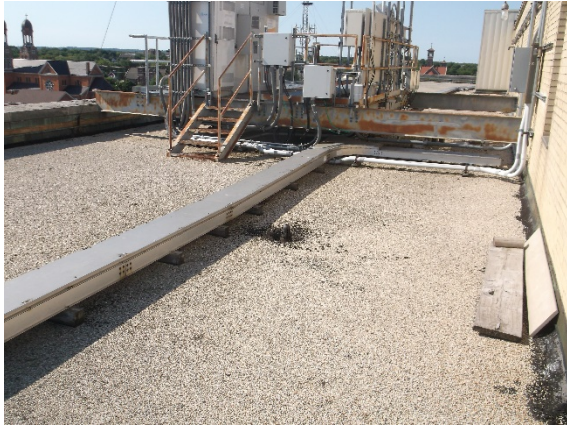
Roof drain

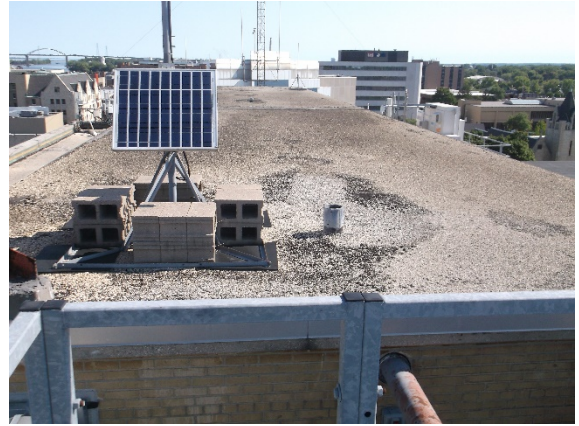
- P3. Storm system has interior roof drains on the main roof. The Penthouse roof discharges over the roof edge, onto the main roof below - no roof drain(s) or scuppers. As a result, the rainwater is deteriorating the concrete and brick below the roof edge. No secondary overflow roof drainage system is installed. Storm piping within the building is not insulated.
Note: Secondary drainage needs to be addressed per code and the Penthouse roof needs roof drains or scuppers installed for proper drainage. Existing roof drains should be replaced in the next roofing project, as they are in poor condition.

P18. The upper Penthouse does not have roof drainage, rainwater discharges over the roof edge to drains on the main roof. This discharge pattern is deteriorating the concrete and brick walls of the Penthouse. The main building roof has interior cast iron roof drains, that are in poor condition and should be replaced. There is no secondary overflow roof drainage system installed, which would be required by today's code. Areaways have a drain(s) installed, which connects to the drain tile system for discharge. West entrance canopies discharge to grade, over the roof flashing edge.

Penthouse roof

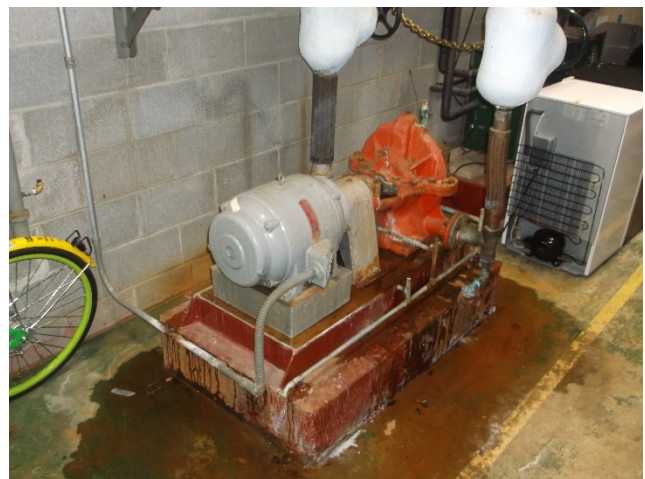
Based on its condition the fire pump appears to be the original pump. The fire pump is showing signs of severe corrosion and leaking and is not located within its own rated enclosure as required by the current edition of NFPA 20. If the fire pump is replaced it will required to be brought up to the current adopted standards.

FP3. Based on its condition the fire pump is believed to be the original fire pump installed in 1955 although it appears to have been relocated at some point in time. No nameplate was found on the fire pump, but the test card attached to the piping indicates that it is a 200 GPM 40 PSI fire pump. The fire pump does not have a jockey pump installed that is required to maintain pressure in the system.

The fire pump is in poor condition; it is leaking and shows signs of severe corrosion. The pump, located in the mechanical room, is not in a dedicated two-hour enclosure. The current installation meets the installation standards when the pump was installed, but any changes or updates to the fire pump system will be required to meet the current adopted standards. NFPA 20 2013 Edition requires that a fire pump in a non-sprinkled building shall be separated from the rest of the building by two-hour construction. Upgrading the fire pump will also require adding jockey pump and controller.

Fire pump

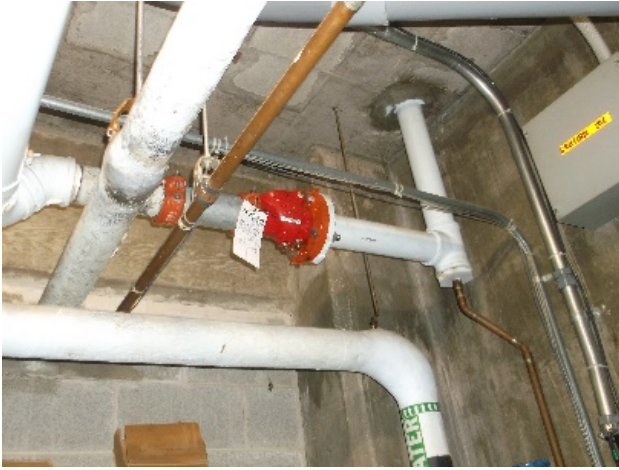
FDC check valve

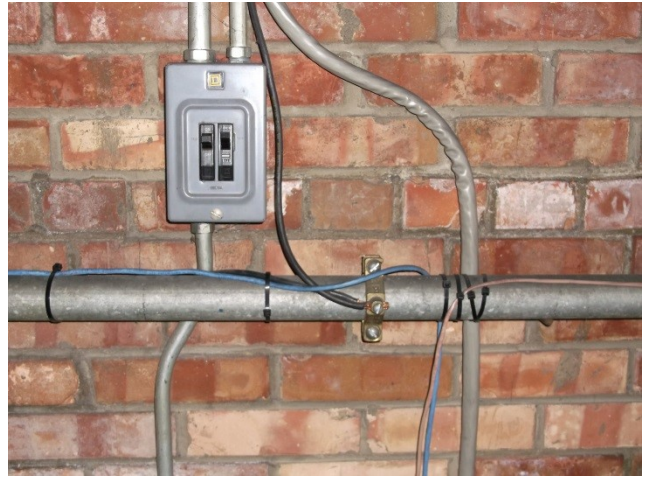
Cable attached to standpipe

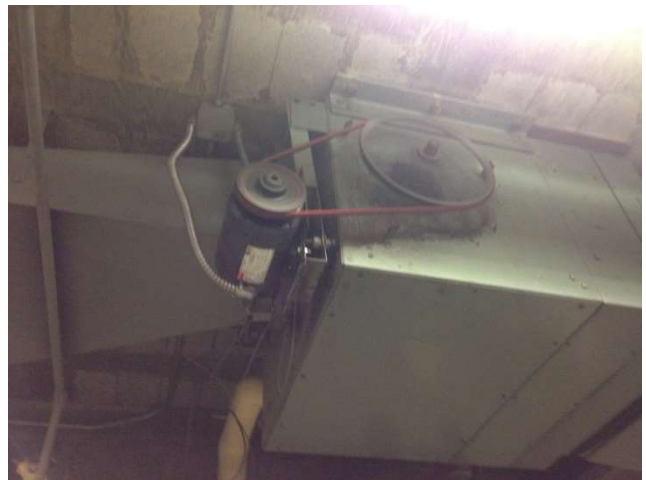
A water-cooled air unit is located in a closet on first floor and serves the reception desk and a room on second floor. The unit requires replacement, or the space should be served off a larger central system. Occupant dissatisfaction with the unit's operation has led the staff to simply turn the unit off.

Water cooled blower coil (AHU-5)

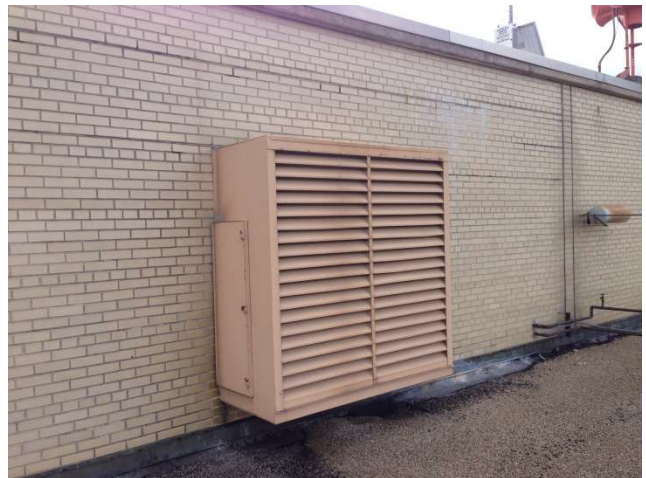
Four main exhaust fans serve the building's exhaust ventilation requirements. The fans are in poor condition, and the ducts, mostly original to the building, are dirty and leak. Exhaust ventilation is reduced significantly at the lower levels. A fan, that previously served a blueprint machine, is believed to still be abandoned in the areaway. The fan is powered with the manual on/off/auto switch located in a break room.

Typical exhaust fan

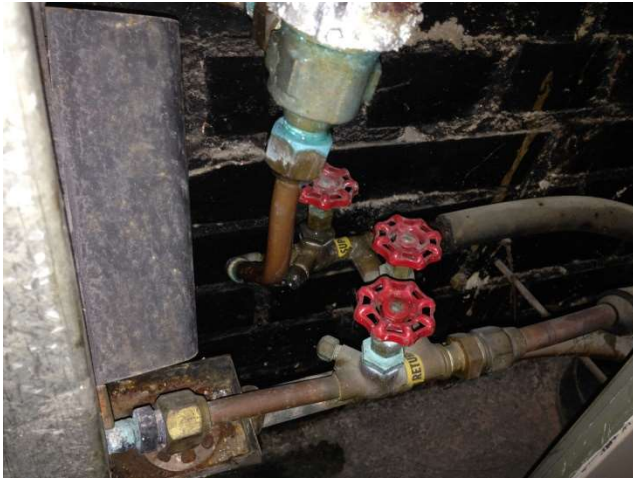
The chiller was replaced in 2008 and the cooling tower in 2011. The pumps have also been replaced. The piping, in general, is in fair condition. Pipe insulation is missing or has deteriorated around the air unit coils and is causing rust and deterioration of the piping. The lack of insulation at the induction unit coils allows condensation to form and drip into the building's envelope cavity.

Condensation below induction unit (in wall)

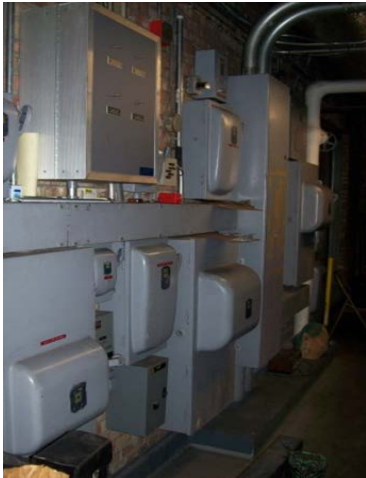
Understanding how power is distributed in the penthouse could be improved by installing a motor control center. Currently the feeder serving the penthouse is tapped several times to serve numerous disconnect switches. There is a project waiting for funding which replaces all the distribution equipment.

Penthouse distribution

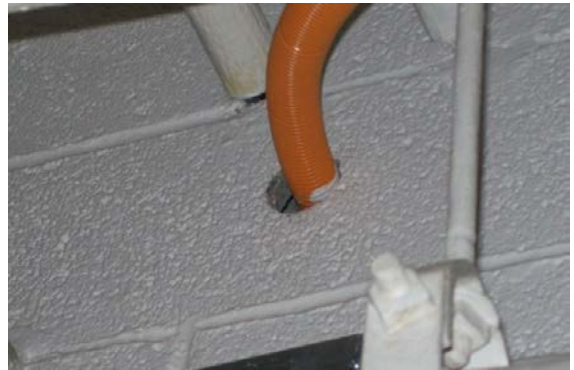
Various unsealed corridor wall penetrations were observed throughout the building. Most of these penetrations appear to be due to distribution of fiber optic cabling or other communications cabling.

Unsealed penetration

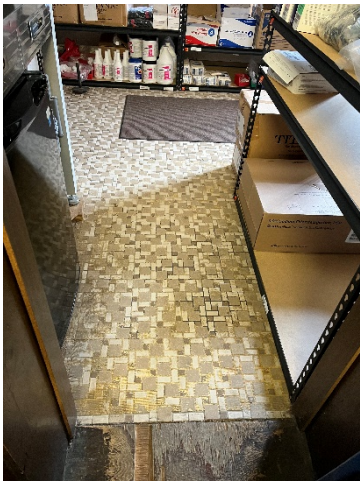
Tile with adhesive on it

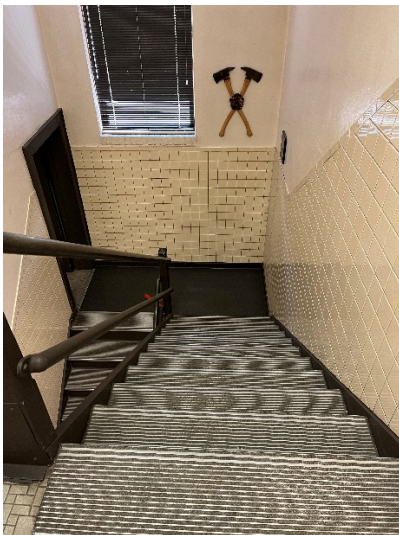
Recommend 2nd handrail

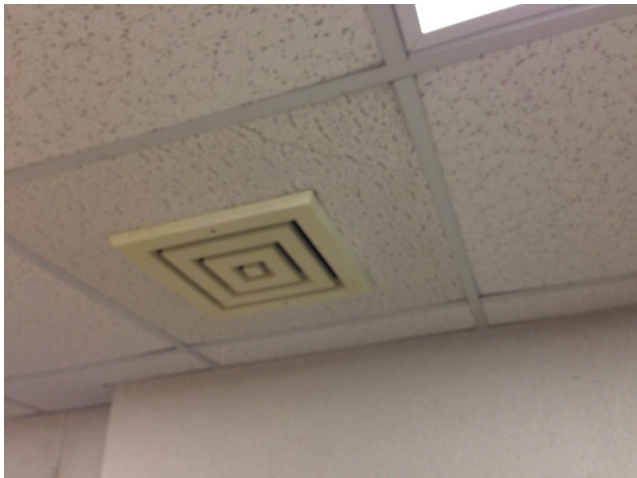
- H4.** The men's toilet fan is ventilated with timer switch operated ceiling fan. The Women's toilet fan is interlocked with the rooms light switch. The type of fan and physical size indicate that they do not provide enough ventilation to properly exhaust the room. In addition, the number of toilet fixtures and showers require that the ventilation be continuous when the building is occupied. Replacement of the fans and interlocking them with the air unit operation is recommended.

Ceiling mount fan (typical)

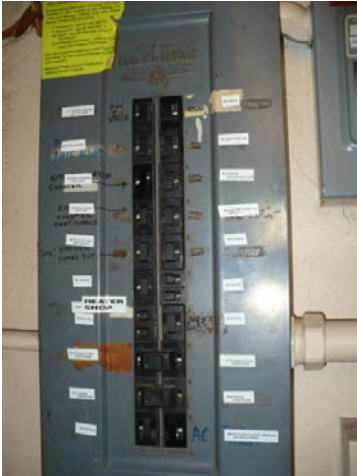
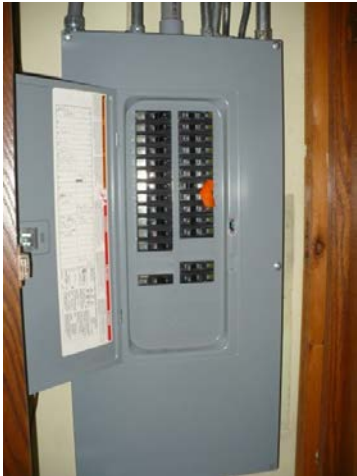
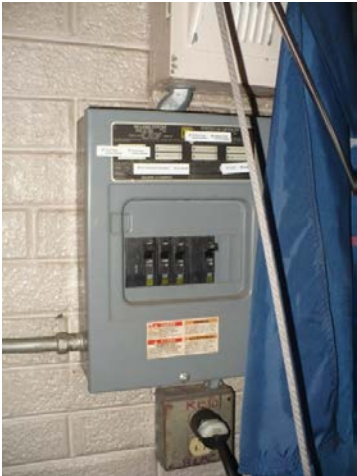
electrical systems	grade	budget cost	notes	comments
electrical service				
Utility service entrance	C			Two overhead utility services, one 200 Amp, one 100 Amp enter the building on the north side into the 2 nd floor electrical closet. Water main over panels is a code violation.
normal power distribution equipment				
Main disconnect(s)	F			200A Bulldog Electric disconnect in fair condition. MCB in fair condition.
Branch panels	HP	\$6000	E1	Two panels on 2nd floor, two panels on 1 st floor. Bulldog Electric panel on 2 nd floor in poor condition, Square D load centers in good condition.
emergency power distribution equipment				
Generator	F			10 KW Kohler natural gas generator in fair condition.
Transfer switch	HP	\$6,000	E2	Kohler 50 Amp ATS in fair condition.
Disconnect switch	C			50A/2P Square D disconnect on incoming generator feed to the ATS in the boiler room in good condition.
Branch panel	HP	\$18,000	E2	Three small Square D load centers in fair condition with limited future capacity. Mixed loads.

Existing panel

- E1. Consideration should be given to replacing the existing Bulldog Electric panel (that is in poor condition and will have limited parts available) with a new panel.
- E2. Recommend providing an additional automatic transfer switch and panel board to separate the critical and equipment branch loads from the life safety loads. The existing panels have several circuits listed as "unknown". These circuits should be traced and identified to get a better idea of available capacity.

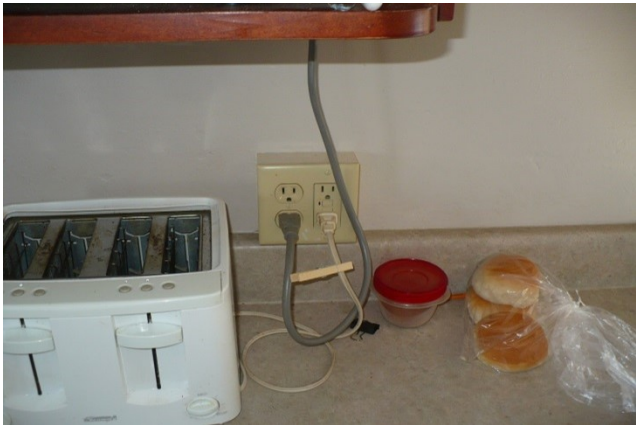
electrical systems	grade	budget cost	notes	comments
Receptacles	D	\$1500	E3	Garage outlets need to be GFCI. Outlets within 6' of sinks need to be GFCI.
lighting				
Garage	C		E4	Industrial fixtures with T-8 lamps in good condition.
Office spaces, conference rooms, and corridors	F	\$2,000	E4	Recessed acrylic lens troffers with T-8 lamps in good to fair condition.
Sleep rooms and toilet rooms	C		E4	Recessed acrylic lens troffers in good condition.
Mechanical spaces, storage rooms, utility areas	F	\$3,000	E4	Ceramic lamp holders with screw-in compact fluorescent lamps, surface mounted wraps and industrial strips with T-8 lamps, in fair condition.
Exterior	F	\$6,000	E4	Decorative wall mounted fixtures are in fair condition. Fixtures are utilizing screw-in compact fluorescent lamps.
lighting controls				
Conference or meeting rooms	C		E5	Existing occupancy sensors
Offices	HP	\$4,000	E5	Add occupancy sensors.

Kitchen receptacles

- E3.** Replace all outlets located in the garage area with GFCI type device. Replace existing kitchen outlets with GFCI type device unless they are currently protected from the adjacent GFCI outlet. If this is the case, the outlet should be labeled per NEC requirements.
- E4.** Consideration should be given to replacing older non-LED fixtures with new LED ones.
- E5.** Occupancy sensors should be installed in the offices, storage rooms, and janitor's closets to provide additional energy savings. If areas are renovated, controls will be required to be updated to meet current energy code.

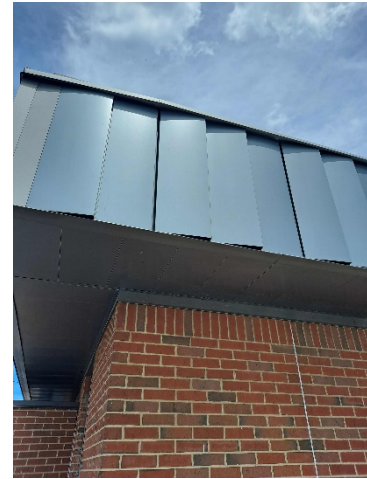
Brick wall are in generally good condition. Sealant at expansion joints is beginning to show signs of cracking. The fascia panels at the southwest corner of the building are out of alignment with the rest of the fascia. Building maintenance personnel report that this area was hit last winter by a payloader plowing snow. The structure itself was not damaged.

Aluminum fascia panels

- A1.** Replace dried or cracked sealant at expansion joints.
- A2.** Replace or repair loose aluminum fascia panels at southwest corner of building.
- A3.** Plan for future replacement of metal spandrel panels at windows.
- A4.** Replace missing vinyl composite tiles in back stair. Repair ripped carpet at Cardio room.
- A5.** Repaint door frames in basement.
- A6.** Touch up stain and re-seal finish at reception counter.
- A7.** Short-term maintenance: remove rust and re-paint toilet partitions at basement. Long-term planning: coordinate new partitions with accessibility upgrades. See Code report.
- A8.** Replace all missing or stained ceiling tiles. At back (west) entry, provide hold-down clips to prevent tiles from being dislodged by winter winds and pressure changes.
- A9.** Replace rusted ceiling diffuser in toilet rooms.

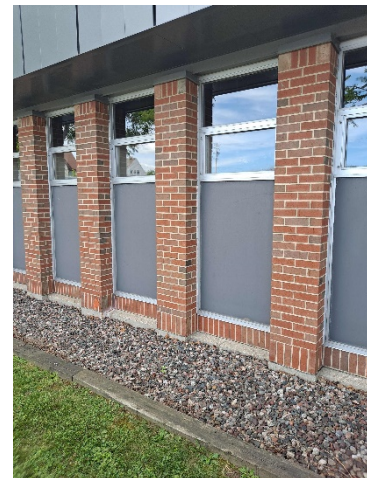
The composite panel portion of the windows has faded but is in otherwise serviceable condition.

Transom panels at windows

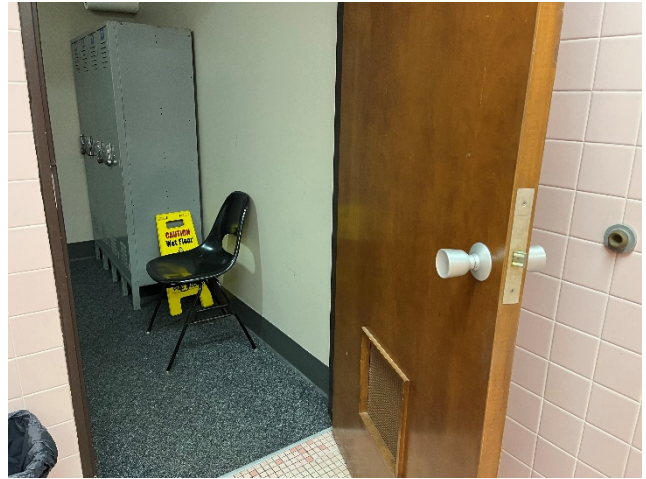
Knob hardware at basement Women's room

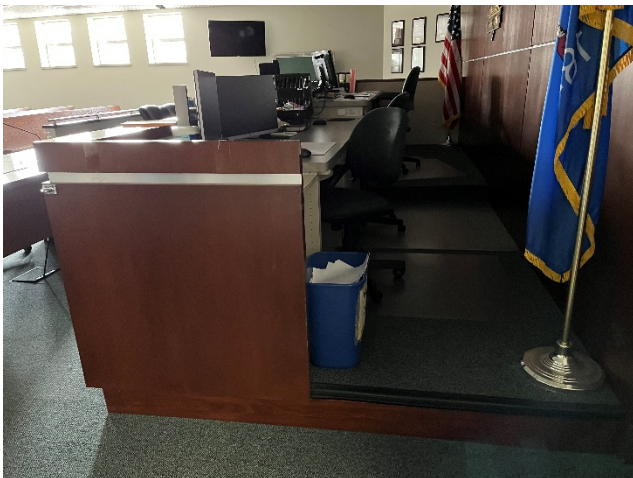
Step up to judge's platform

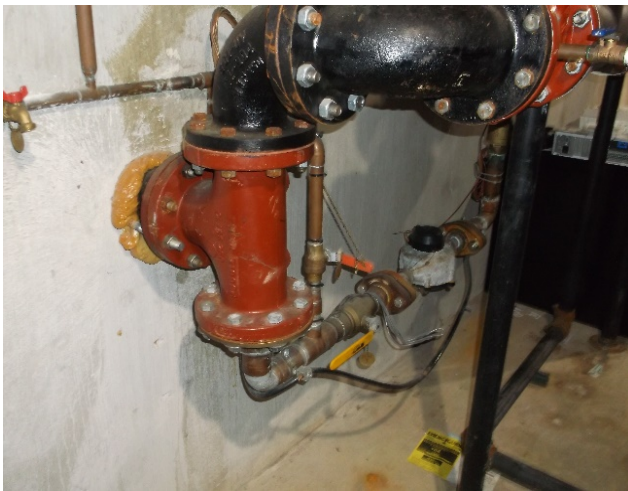
- P17.** Utilities are fed from Jefferson Street. 4" water main to the building serves the domestic water and fire protection systems combined. 4" sanitary sewer. 4" and 6" storm sewers combined, route to a 6" storm main to the street. Parking lot has internal storm drainage with catch basin(s).

4" water service

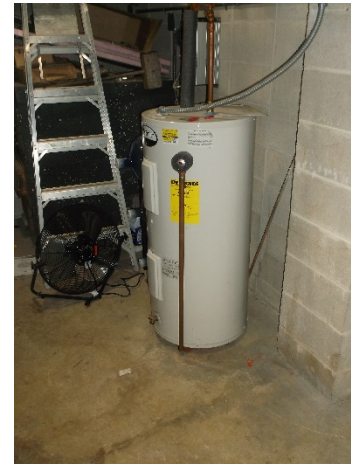
- P8.** Water heater is electric, AO Smith model #ECS 40 200, 208/240Volt, 40-gallon unit. Piping has pro-press connections, also missing insulation. Repair as required. 1" HCW connections.

Electric water heater

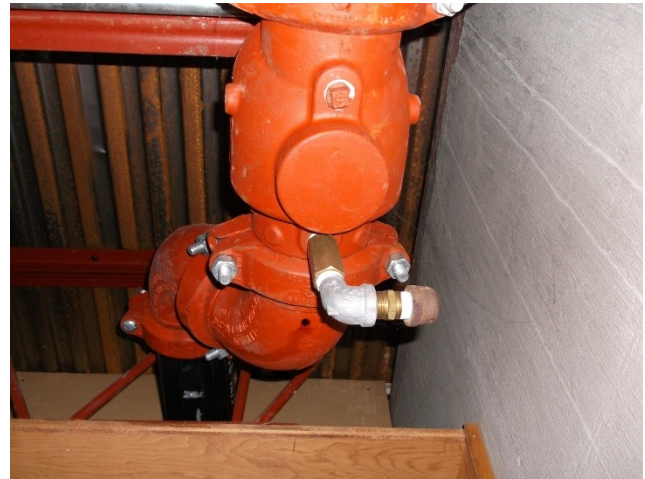
Automatic ball drip capped

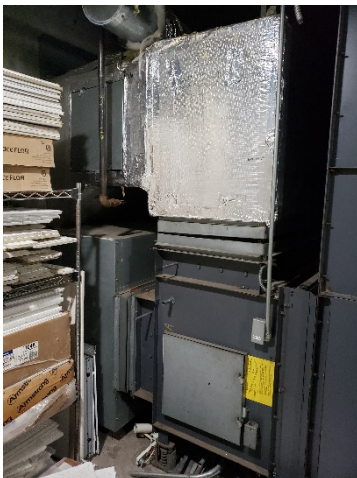
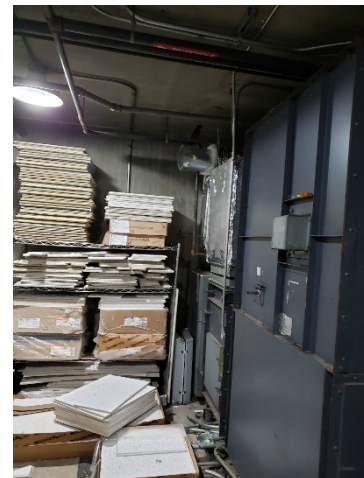
H1. The unit is an indoor modular unit with hot water heating coil, refrigerant cooling coil and VAV control. The unit appears to be at least 35 years old, which exceeds the units expected useful life. The condensing unit was replaced approximately 8 years ago as the old one had failed. Maintenance staff has replaced components on this unit as they have failed, which has allowed the unit to maintain operation to this point. Eventually, corrosion, tube erosion, and metal fatigue will cause major failure of the coils and/or fans. The mechanical room is extremely tight and a replacement will require an extended period of downtime. The unit is undersized to adequately ventilate the building and temperature and humidity issues require the use of supplemental systems and dehumidifiers to maintain comfort. A project to replace the air handling unit, possibly with an outdoor, on-grade unit, is recommended.

Air unit

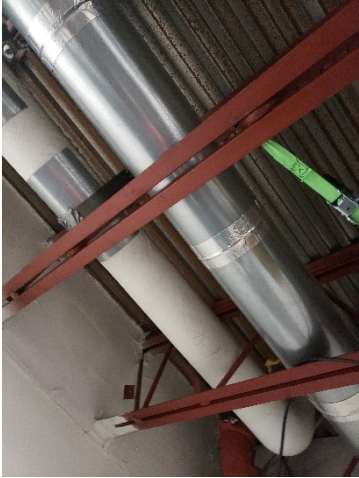
The supply ducts are lined. Duct liner erodes over time. This will lead to system inefficiency and condensation which will damage building material. It is recommended to seal the ductwork and install duct wrap insulation during renovation projects.

Duct (sealed)

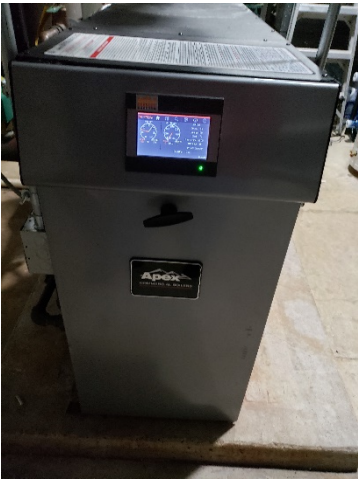
H3. The boiler system has been replaced since the last evaluation. No operational issues were noted during the building walk-through.

Boiler

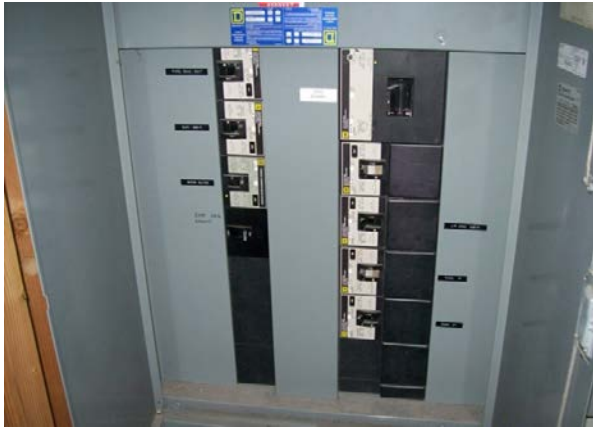
The electric service is rated 600-Amps at 120/208-Volt, 3-Phase, and is fed underground from pole-mounted transformers located west of the building. The main distribution panel (MDP) is in the basement. It was installed during a renovation project in 2000. There is a spare 4" conduit routed from the MDP to the CT cabinet located on the building's west elevation. The MDP was manufactured by Square D, is in good condition, and has a total of 19.5-inches of unused space available for new circuit breakers. New and replacement circuit breakers are still available. There are three branch circuit panels. Two were added with the 2000 project and are manufactured by Square D (type NQOD); the other is manufactured by Westinghouse. The Square D panels are in good condition. New and replacement parts are available for the Square D panels; however, Westinghouse no longer manufactures electric panel boards or circuit breakers. All circuit breaker positions in all branch circuit panelboards are occupied.

MDP panel

- E1.** Availability of new and replacement parts will eventually become an issue for the obsolete Westinghouse panels.
- E2.** Consideration should be given to replacing older non-LED fixtures with new LED ones.
- E3.** Keeping emergency egress lighting operational is important to limit liability exposure.
- E4.** When non-code required devices are voluntarily added to a fire alarm system, code requires the entire installation shall comply with code. There are several rooms without audible or audible/visual alarms. Smoke detector at elevator in basement requires attention.
- E5.** Code requires the power to the elevator be disconnected if fire sprinklers in the elevator machine room and/or elevator shaft are activated. Releasing water on energized electrical circuits could result in a passenger in the elevator being electrocuted.

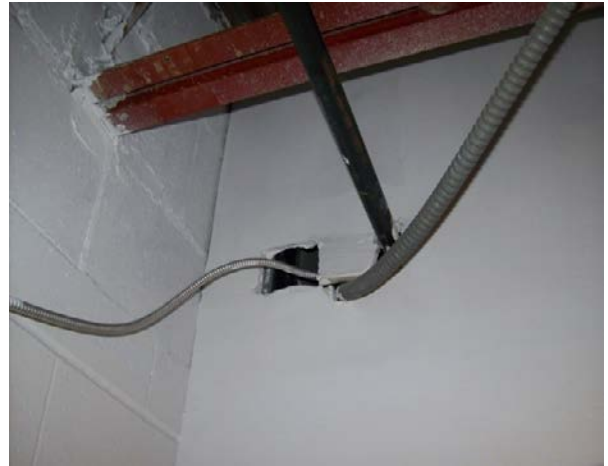
Opening through wall common with stairway

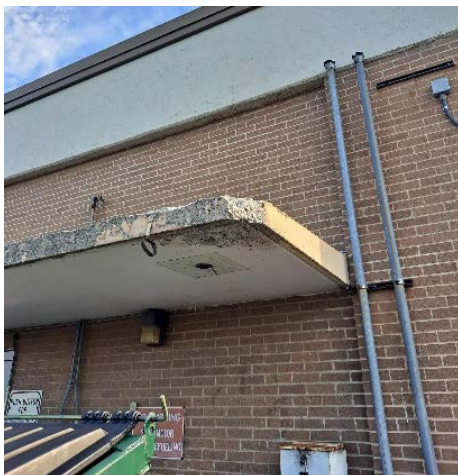
Damaged canopy

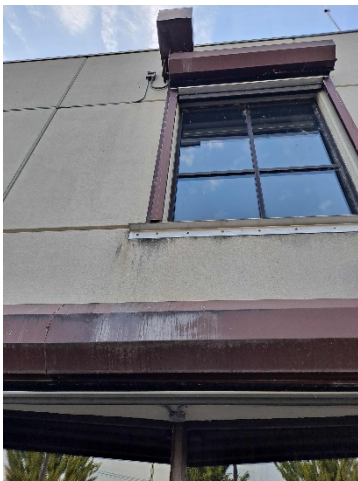
Window housing faded and rusting

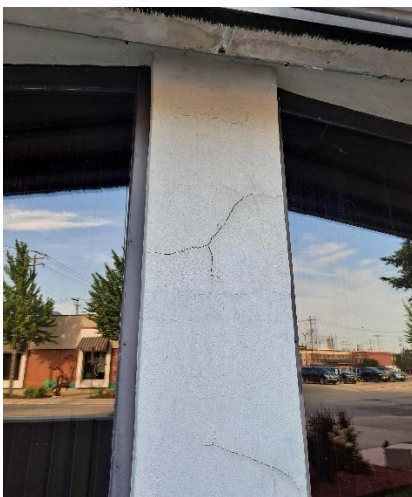
Cracked concrete between windows

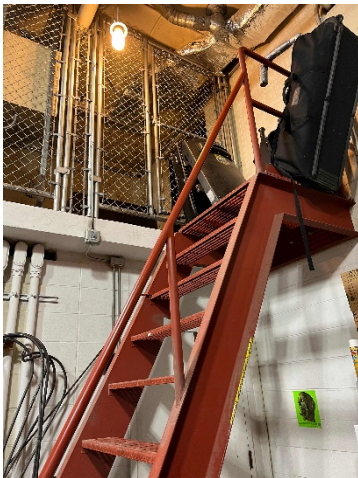
SWAT Team storage mezz – no legal egress

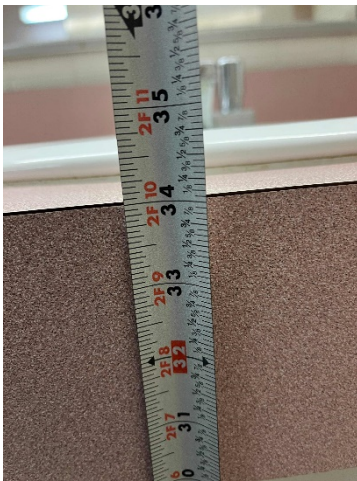
Women's Locker Rm. Lav – above 34" height

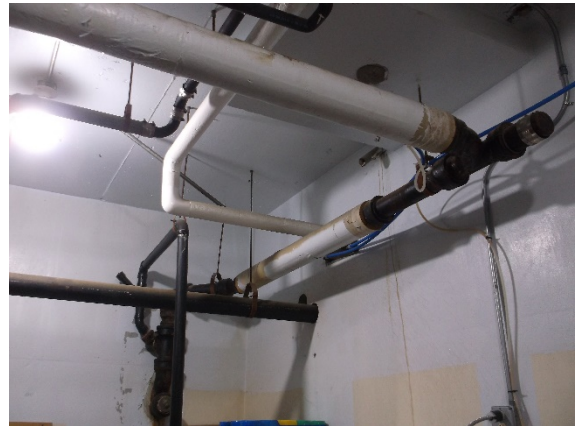
- P6. Water piping is insulated with glass fiber and elastomeric insulation. 1969 insulation probably contains asbestos and needs verification. No insulation on the storm piping is causing condensation on the piping and is resulting in ceiling tiles being stained.

Storm piping

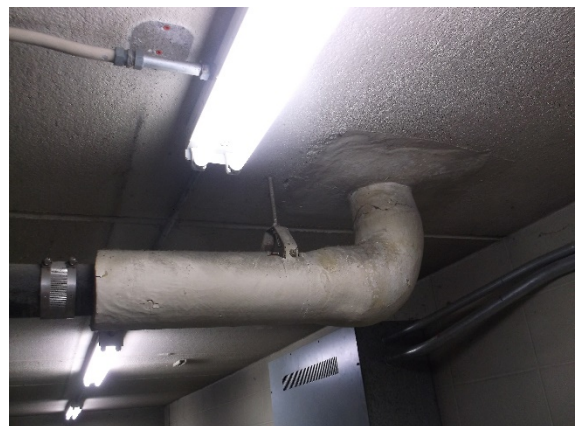
Storm piping

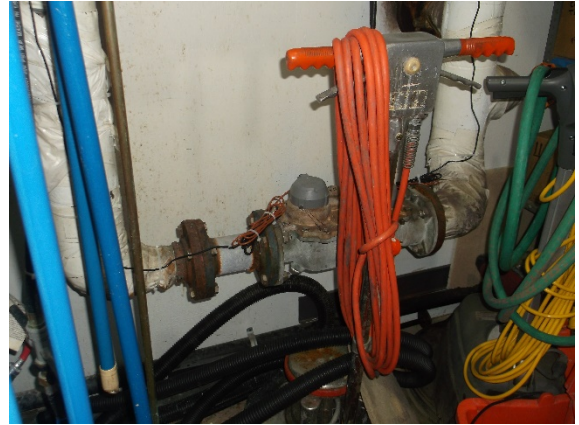
- P1. Water piping is mainly copper, soldered joints. Fair condition. Some galvanized piping at the water meter. Some PEX piping also installed. Most of the piping is insulated.

Water meter

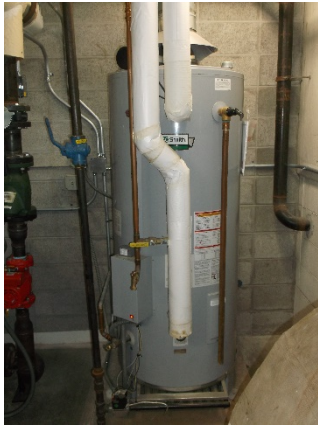
- P8. Water heater is a single gas fired, AO Smith model BTR-365 series 118, 365,000 BTU/HR, 85 gallon with atmospheric gas venting. No expansion tank installed.
Recommendation: add expansion tank at the water heater.

Water heater

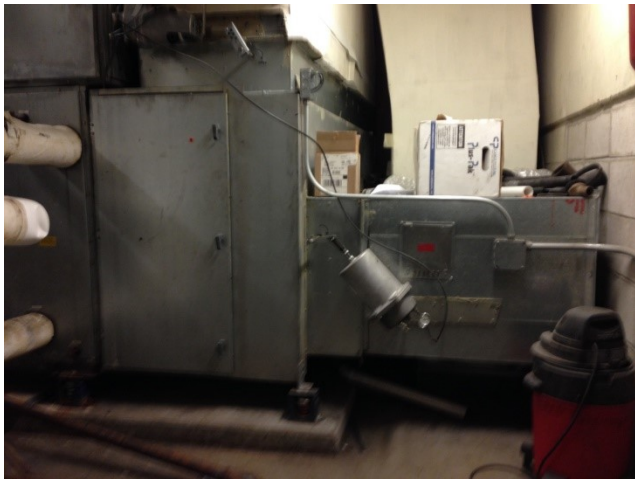
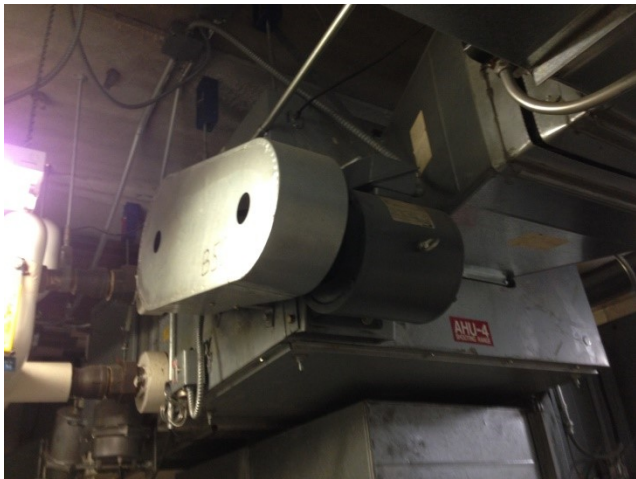
hvac systems	grade	budget cost	notes	comments
Air Units – office area, three total			H1	Installed 1992.
Housing	CP	\$435,000	H1	Showing signs of 30 years of operation. Minor rust.
Air intake	C			Roof hood
Coils	HP			Hot water, chilled water.
Fan	HP			(2) 10,000 CFM-10HP, (1) 8,000 CFM-7.5HP
Filters	F			
Controls	HP

H1. These units are original to the 1992 project. Units are 30 years old with an expected useful life of 25 years depending on maintenance and operation of the unit. Overall, the units have been maintained well but are showing signs of age and continuing to rust. The coils appear to be in fair condition, however most deterioration occurs from the inside out and won't be visible until leaks occur. The unit grade is mainly based on the unit's age and expected useful life. The estimated replacement cost assumes many factors, including ability for extended unit outage during construction, and combining of multiple units into one. The actual cost could widely vary depending on the project specifics.

Air unit (typical)

The units are indoor modular units with hot water heating coil, chilled water-cooling coil and VAV control. The supply ducts are lined. Duct liner erodes over time, and this will lead to system inefficiency and condensation which will damage building material. It is recommended to seal the ductwork and install duct wrap insulation during renovation projects.

Low voltage DDC actuation/controls is being phased in as budgets allow. When the units are replaced, it is recommended to provide all new DDC controls as this will allow for more in-depth monitoring and remote monitoring.

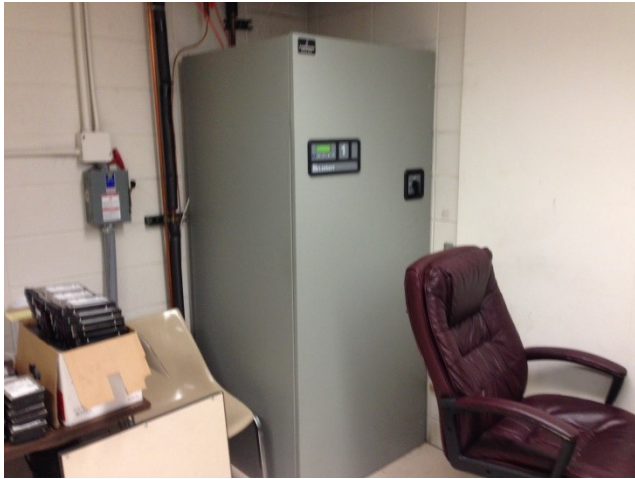
Makeshift room ventilation unit

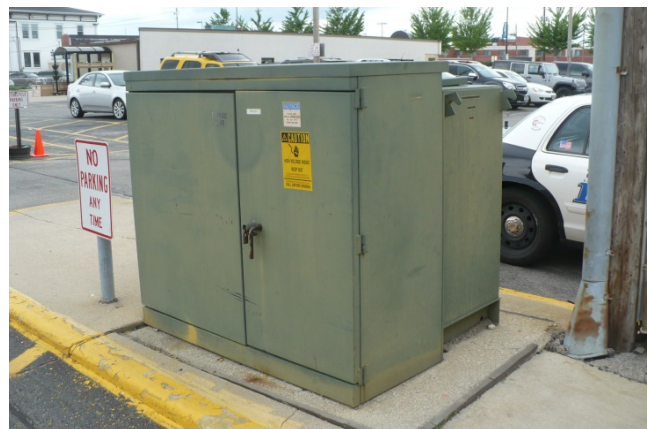
Utility transformer

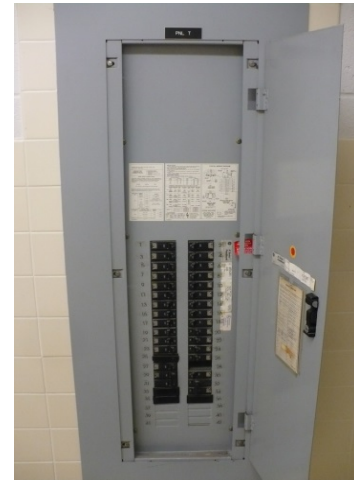
electrical systems	grade	budget cost	notes	comments
Branch panels	HP	\$25,000	E3	Original GE NLTG panels in fair condition and 1992 renovation GE A-Series panels in good condition. Panels have future capacity.
power				
Receptacles	D	\$1,500	E4	Garage outlets and outlets within 6' of sinks, and outlet in elevator equipment room needs to be GFCI. Plug strips are being used in locker rooms for charging devices.
lighting				
Garage	C			Industrial fixtures and surface mounted wraps with T-8 lamps in good condition.
Office spaces, conference rooms, gun range, and corridors	C			Recessed acrylic lens and parabolic louver troffers, surface wraps with T-8 lamps, and incandescent downlights and track heads. Fixtures are in good to fair condition.
Toilet rooms	F	\$1,000	E5, E6	Recessed troffers and surface mounted wraps in good condition. Men's shower and sauna have incandescent lamps (sauna fixture is missing lens).

1992 renovation panel

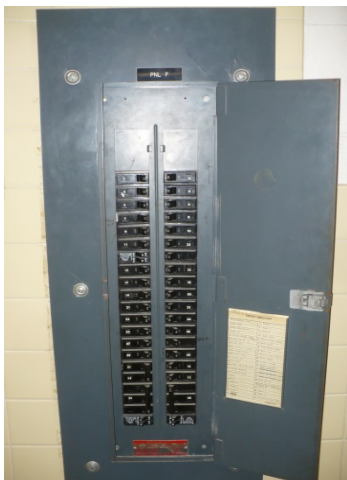
Original panel

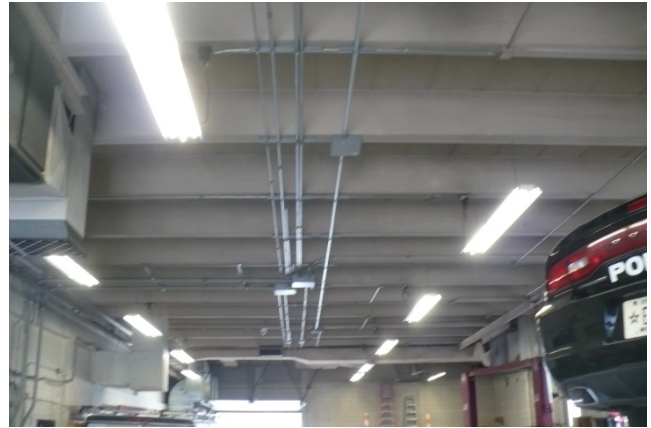
Garage lighting

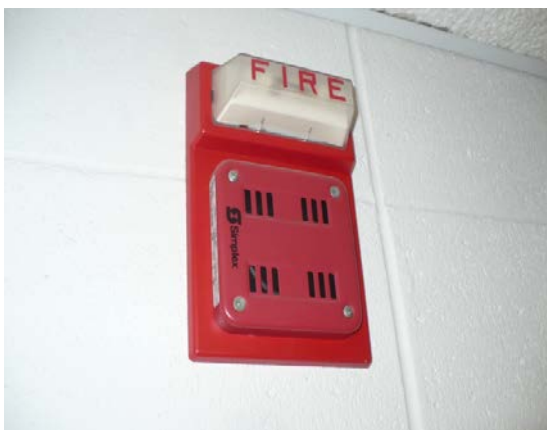
The server equipment is in good condition and the facility is pulling Cat 5 and Cat 6 data and voice cabling from data racks on each floor and coax for CATV. The fire alarm system is a zoned system with smoke detectors, pull stations, and notification devices located around the building. Coverage does not comply with current code; a new addressable fire alarm system upgrade is recommended with additional devices provided to meet code.

Fire alarm horn/strobe

- E9.** Recommend upgrading the fire alarm system to an addressable system with device locations that meet current code requirements.

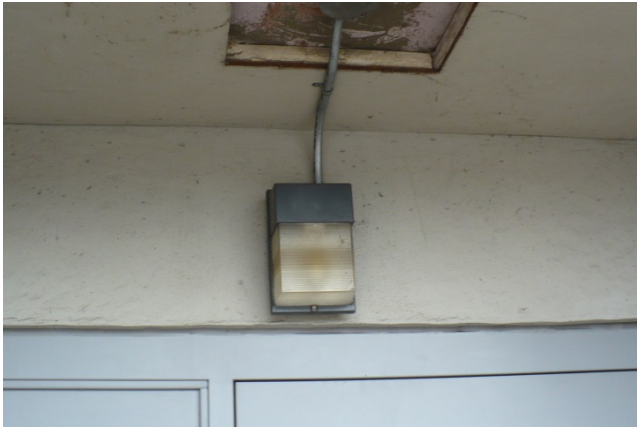
HID wall pack light

- E7.** Consider replacing all HID fixtures with more efficient LED in the future.
- E8.** Occupancy sensors should be installed in the meeting room, conference rooms, offices, storage rooms, and janitor's closets, etc. to provide additional energy savings. If areas are renovated, controls will be required to be updated to meet current energy code.

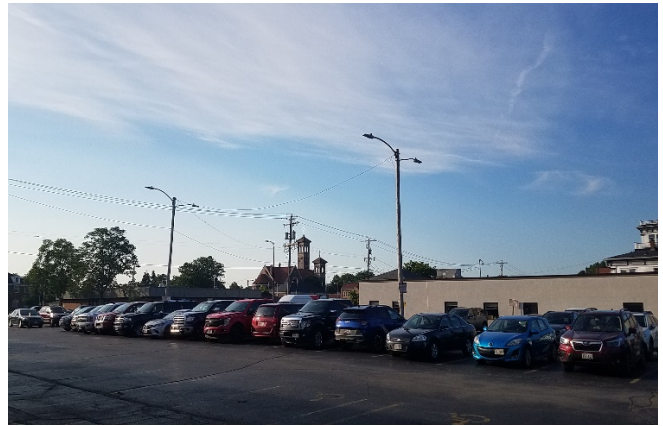
There are numerous outlets around the building that need to be GFCI protected. Lighting fixtures are in fair to good condition and utilize T8 lamps and ballasts, incandescent and compact fluorescent lamps. There are several fixtures with broken, miscolored or missing lenses. These should be replaced or repaired. There are a few occupancy sensors located in office areas, but the facility should install occupancy sensors in all offices, meeting rooms, break room, storage rooms and janitor's closets. HID building mounted fixtures are in fair condition; consideration should be given to replacing the HID fixtures with more efficient and lower maintenance LED fixtures in the future. The parking lot lighting and flagpole lighting have been upgraded to LED.

LED pole light
