# **AGENDA OF THE FINANCE COMMITTEE**

**TUESDAY, NOVEMBER 29, 2022, 4:30 PM**

**F. Report of the Ad Hoc Facilities Committee (November 15, 2022).**

1. To direct Finance Staff to work with BSA on the total cost of the deficient and critical needs listed in the report in response to the review of the Facilities Assessment Updates for City Hall, Municipal Court, Police Station, and Fire Station #1.

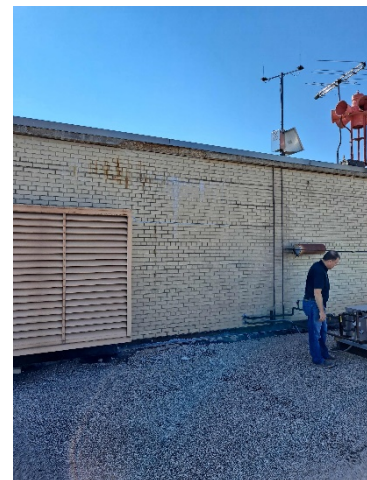
**Mechanical penthouse - tuck pointing**

- A1.** Remove and replace both mechanical penthouse roof and 6<sup>th</sup> floor roof including replacement of copper flashing with stainless steel and all damaged pre-cast concrete wall caps.
- A2.** Tuck point existing main building and mechanical penthouse.
- A3.** Replace all 256 windows (various sizes) at the exterior, patch interior jambs and repaint all window jambs.

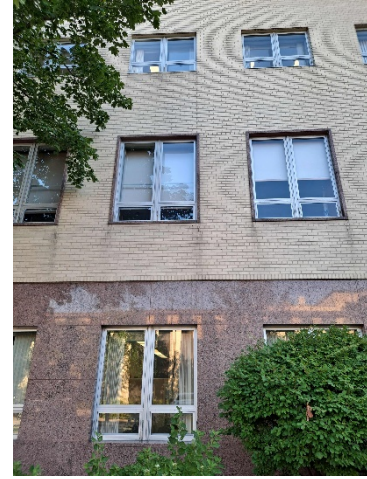
**Replace exterior windows**

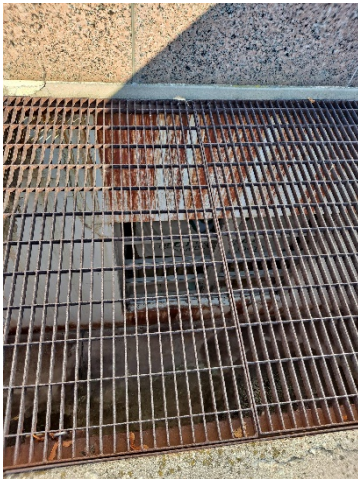
**Rust on window well walls**

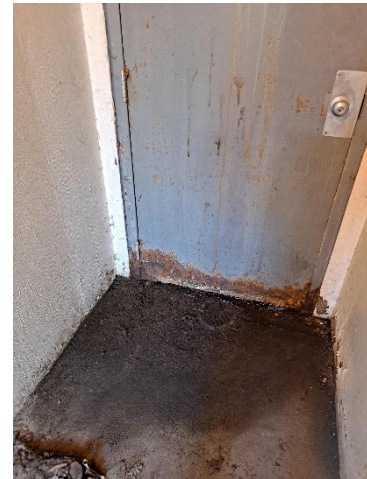
**Rusted door to window well**

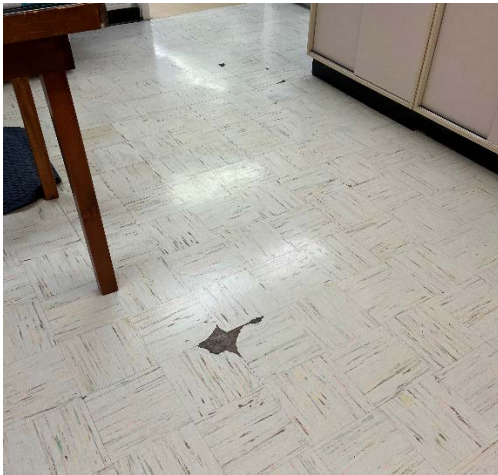
**Chipped floor tile**

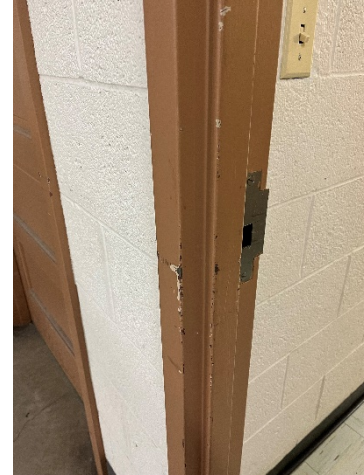
**Chipped paint**

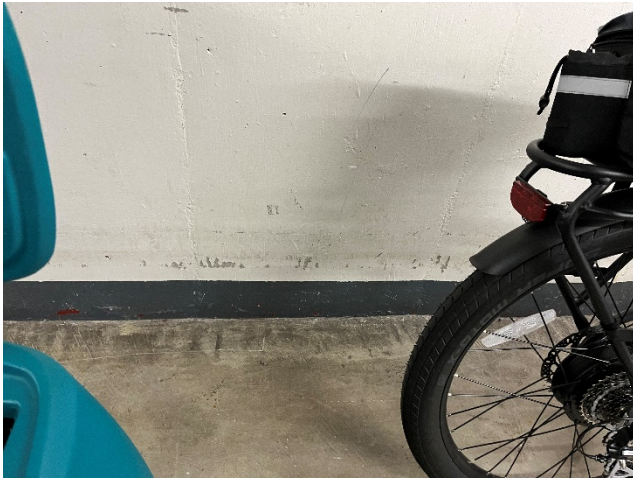
**Chipped paint at wall**

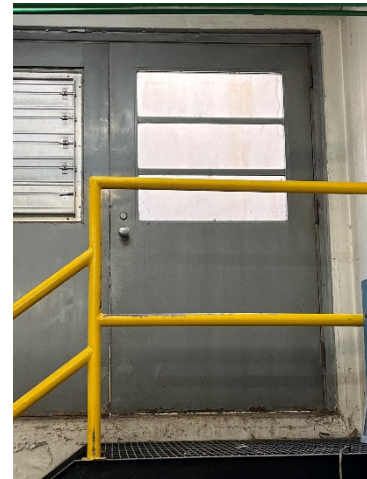
**Missing weatherstripping at rusted door**

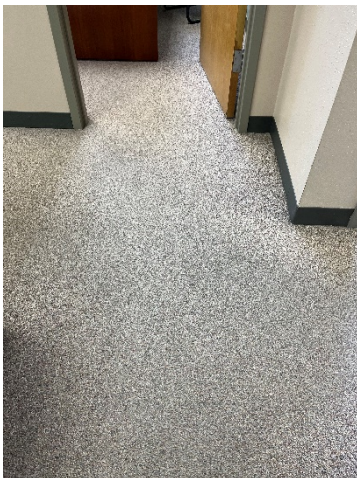
**Worn carpet – legal area**

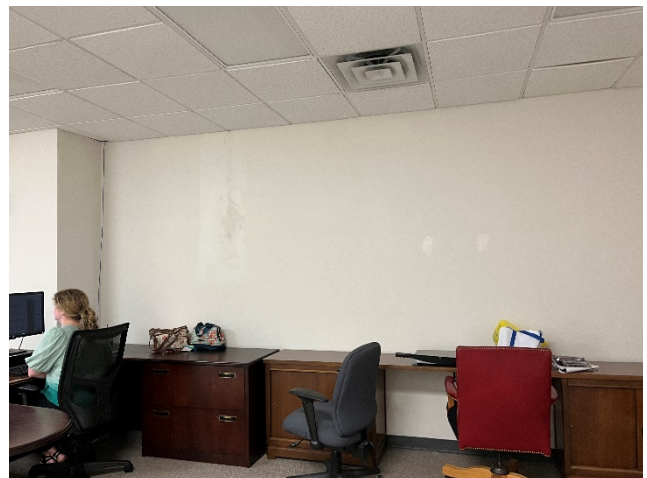
**Visible wall patches**

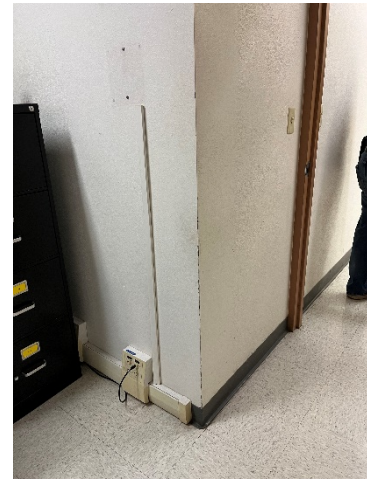
2<sup>nd</sup> & 3<sup>rd</sup> floors: typical chipped paint at exterior corner

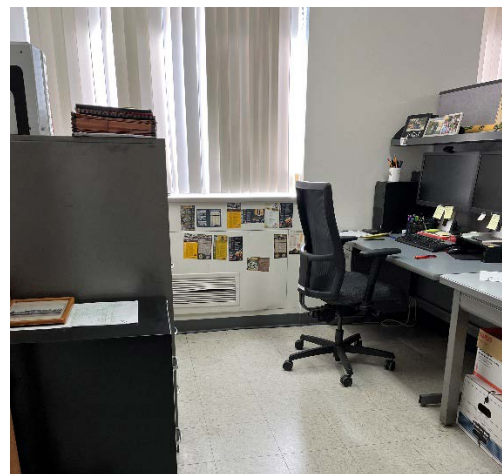
Bent louver blades

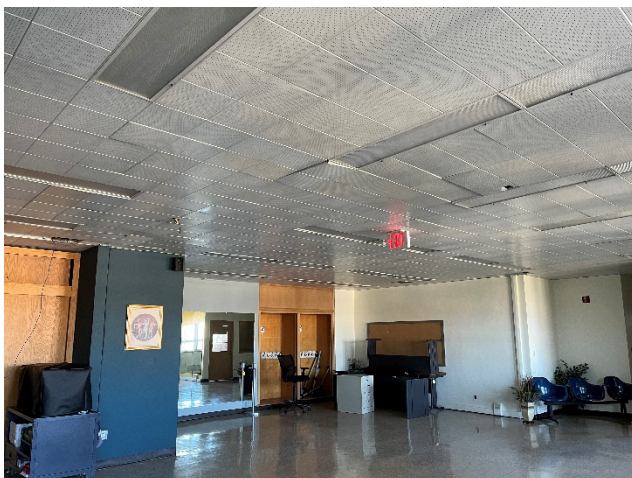
**Typical spline ceiling issues**

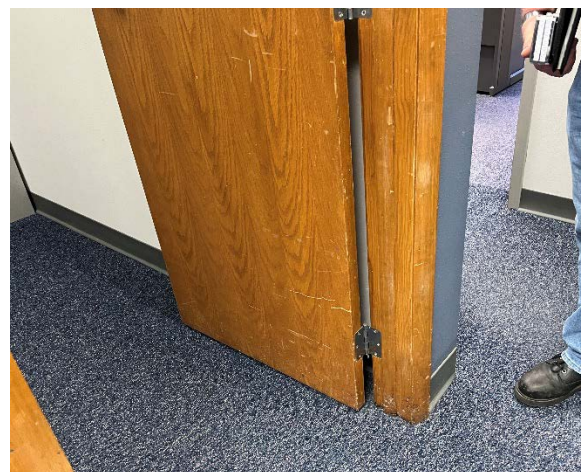
**Scratched wood finish**

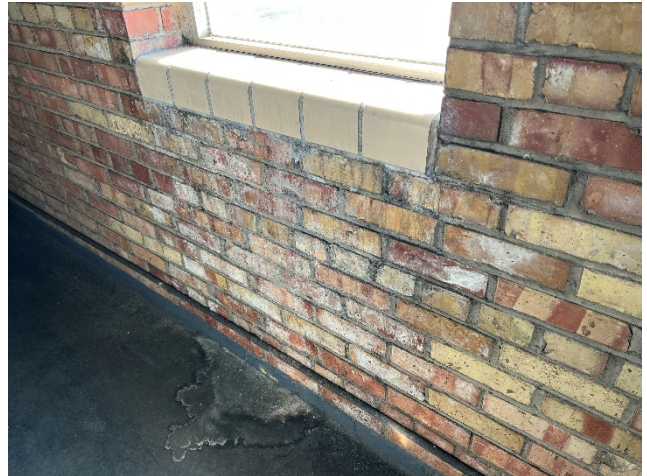
**Effervescence on east wall**

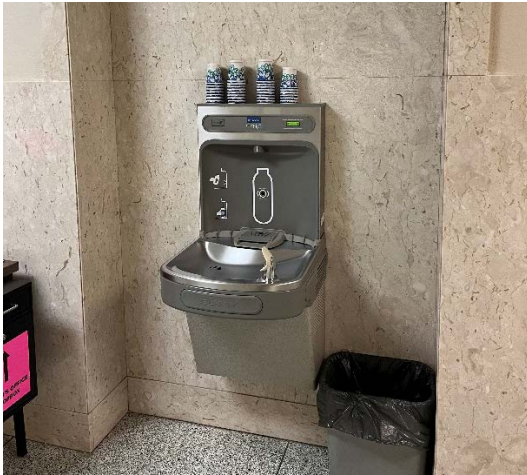
**Drinking cups provided at water fountain**

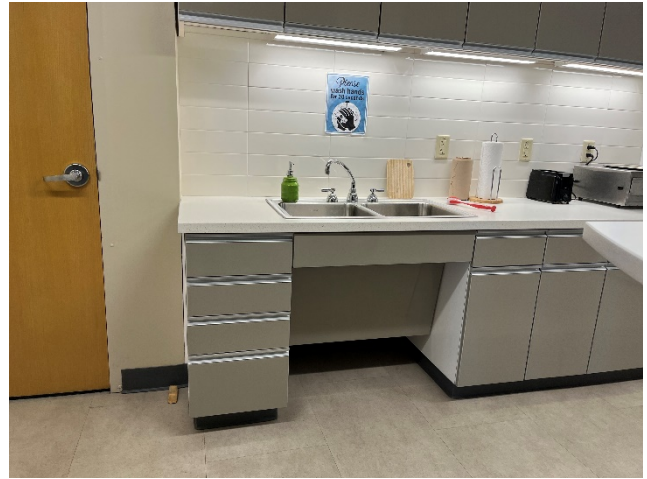
**Sink with front-approach accessibility**

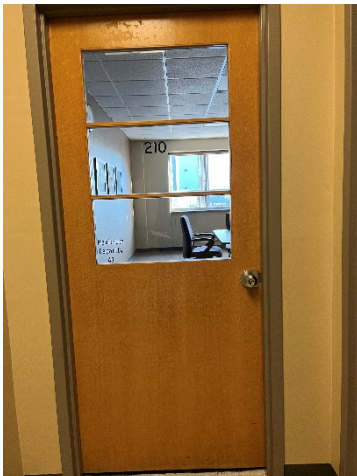
**Knob handle on door**

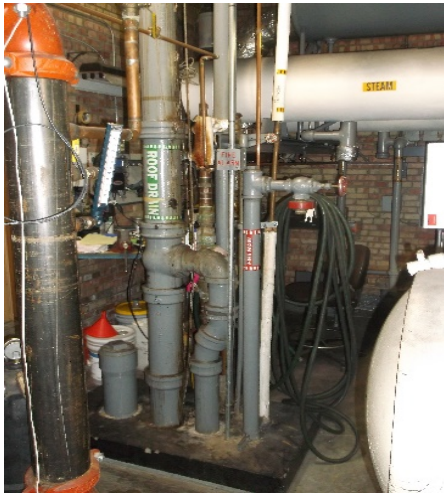
Vent, water piping in penthouse

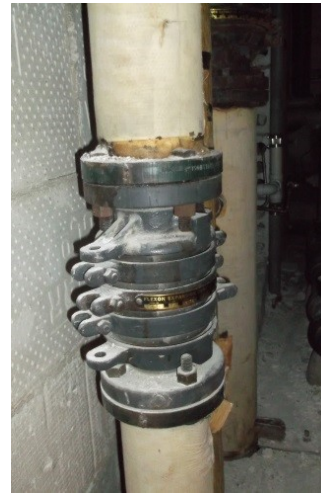
Expansion joint (4th floor) toilet chase

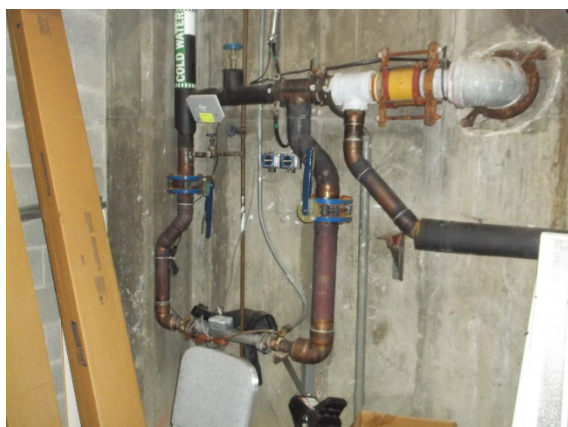
- P19.** Building is served by a 4" water main, 3" for domestic water and 3" boosted main for the fire protection standpipe system. Sanitary sewer is 6" routed to Walnut Street. Several 6" storm sewers routes to Walnut and Jefferson Streets. Parking lots have interior catch basin(s). The north parking lots pitch west to catch basins located at the drives. The east parking lot pitches south to catch basins and a curb inlet.

2" water meter, 4" water main

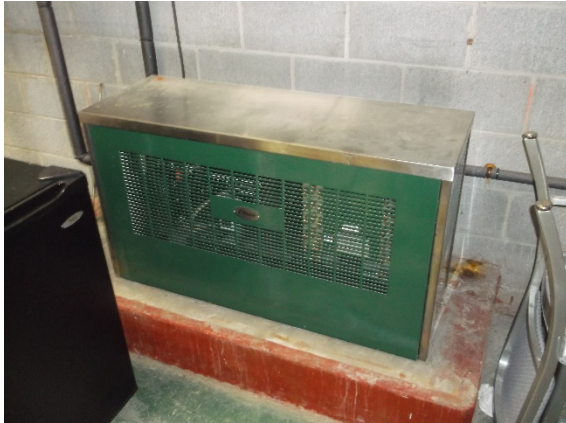
- P17.** There is a Filtrine chiller in the basement with a dedicated piping system that serves the drinking fountain in the basement and the newer electric water coolers on each floor. Presently the chiller is serving electric water coolers that already have a cooler on them. If the last remaining drinking fountain in the basement was replaced, the chiller unit in the basement could be removed.

**Chiller for drinking fountain(s)**

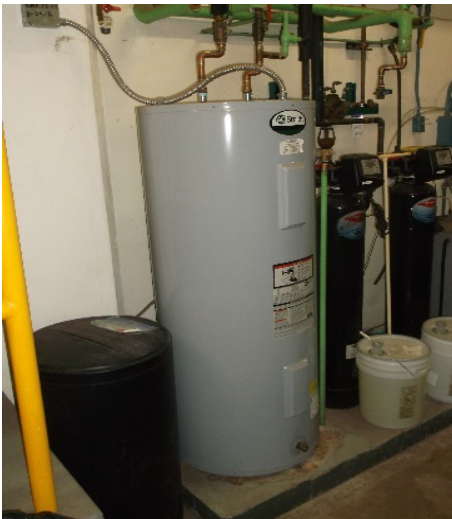
| plumbing systems | grade | budget cost | notes | comments |
|---|---|---|---|---|
| Domestic water heater | F | | P8 | Electric unit replaced since last assessment |

**Electric water heater**

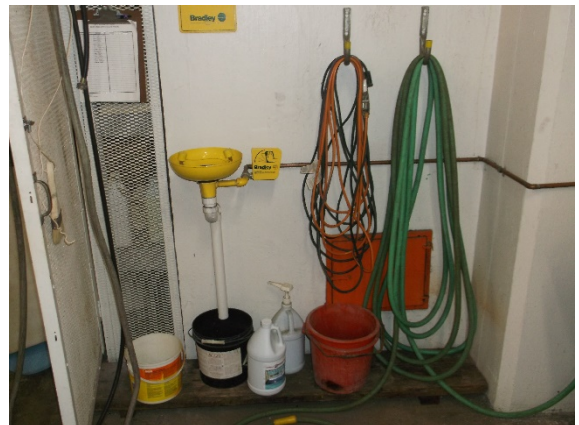
City Hall was constructed in 1956. The original piping is in fair condition and can be replaced as needed. Insulation could be added to the hot water piping for energy savings. Thermostatic mixing valves (TMV's) should be added to correct code issues. Eyewashes require tempered water – add TMV's.

**Eyewash – boiler room**

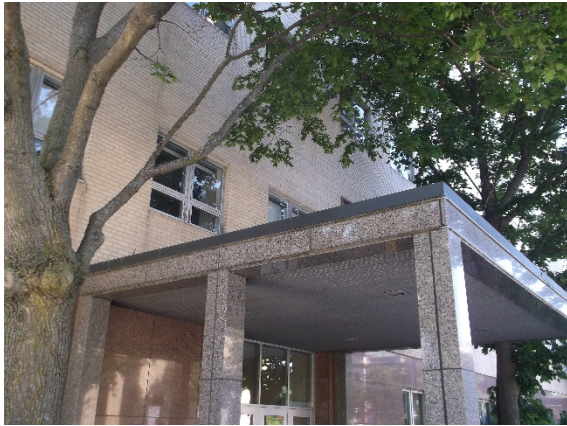
- P18.** The upper Penthouse does not have roof drainage, rainwater discharges over the roof edge to drains on the main roof. This discharge pattern is deteriorating the concrete and brick walls of the Penthouse. The main building roof has interior cast iron roof drains, that are in poor condition and should be replaced. There is no secondary overflow roof drainage system installed, which would be required by today's code. Areaways have a drain(s) installed, which connects to the drain tile system for discharge. West entrance canopies discharge to grade, over the roof flashing edge.

**Canopy roof(s)**

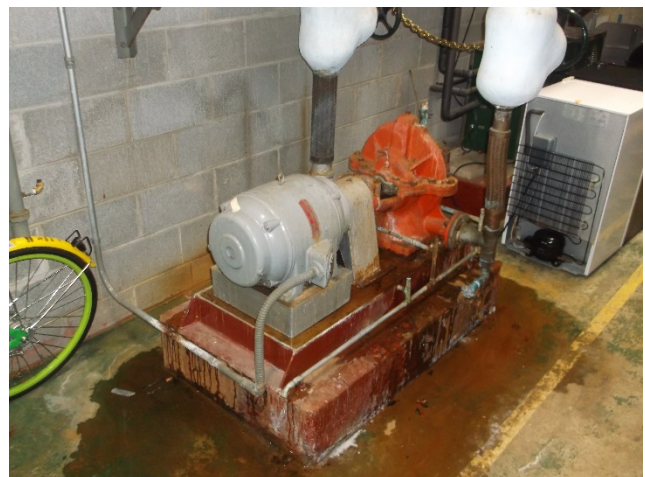
Based on its condition the fire pump appears to be the original pump. The fire pump is showing signs of severe corrosion and leaking and is not located within its own rated enclosure as required by the current edition of NFPA 20. If the fire pump is replaced it will required to be brought up to the current adopted standards.

**FP3.** Based on its condition the fire pump is believed to be the original fire pump installed in 1955 although it appears to have been relocated at some point in time. No nameplate was found on the fire pump, but the test card attached to the piping indicates that it is a 200 GPM 40 PSI fire pump. The fire pump does not have a jockey pump installed that is required to maintain pressure in the system.

The fire pump is in poor condition; it is leaking and shows signs of severe corrosion. The pump, located in the mechanical room, is not in a dedicated two-hour enclosure. The current installation meets the installation standards when the pump was installed, but any changes or updates to the fire pump system will be required to meet the current adopted standards. NFPA 20 2013 Edition requires that a fire pump in a non-sprinkled building shall be separated from the rest of the building by two-hour construction. Upgrading the fire pump will also require adding jockey pump and controller.

Fire pump

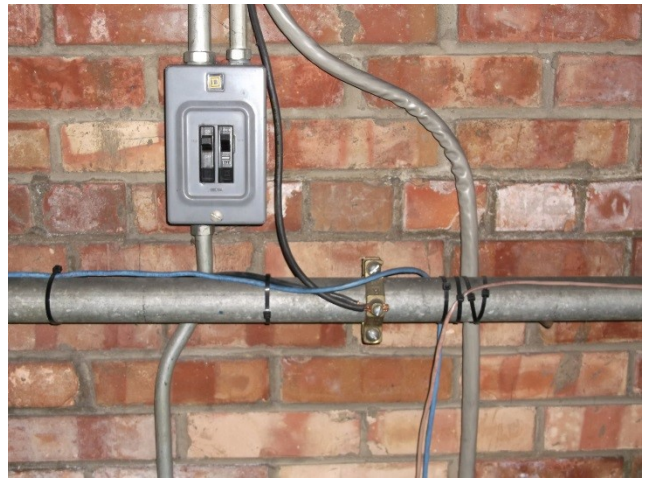
**Cable attached to standpipe**

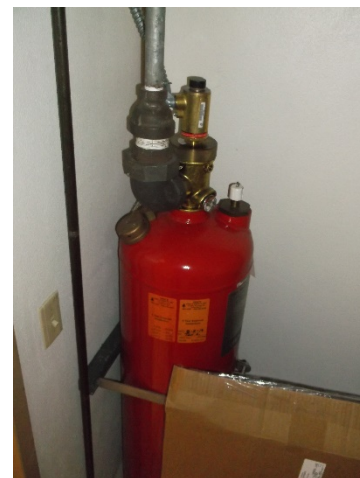
**FP5.** The IT room (4<sup>th</sup> floor) has a Ansul Halon 1301 fire suppression system and nozzle installed in the room. The system is controlled by a AutoPulse Z-10 agent release control panel.

**Ansul Halon 1301 – IT room**

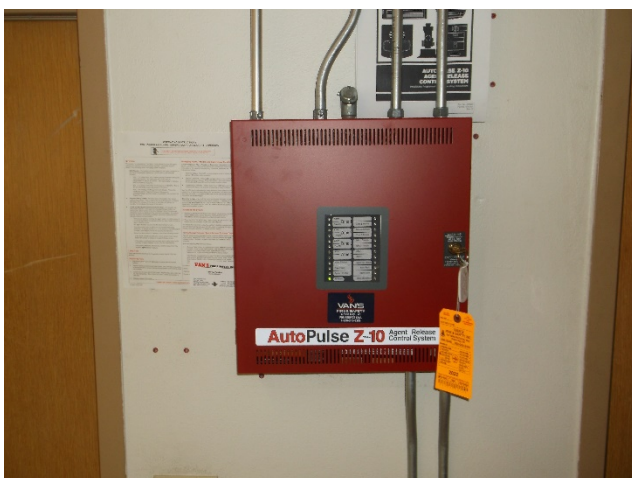
**Halon control panel – IT room**

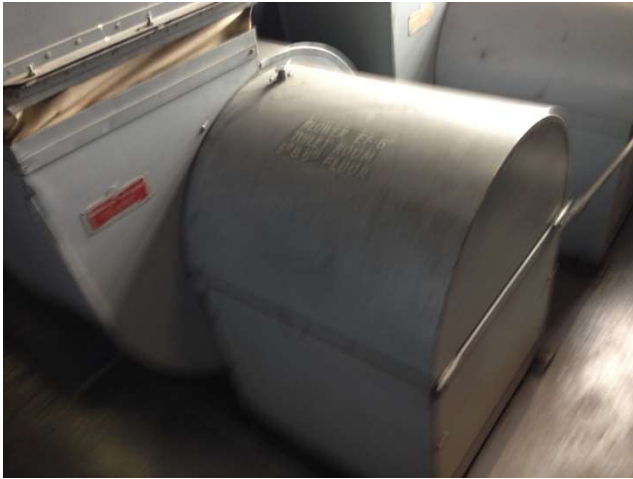
Four main exhaust fans serve the building's exhaust ventilation requirements. The fans are in poor condition, and the ducts, mostly original to the building, are dirty and leak. Exhaust ventilation is reduced significantly at the lower levels. A fan, that previously served a blueprint machine, is believed to still be abandoned in the areaway. The fan is powered with the manual on/off/auto switch located in a break room.

**Typical exhaust fan**

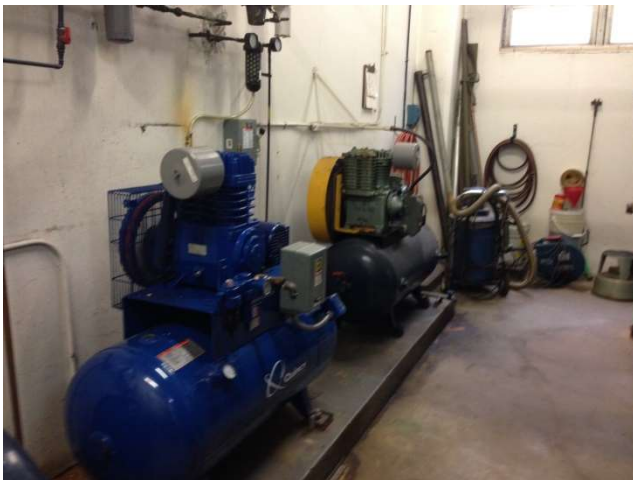
- H12.** The air compressor serving the buildings pneumatic controls appears to operate sufficiently. One of the units appears to be about 7 years old. As systems are replaced, low voltage DDC controls are recommended for installation as this will allow greater monitoring of the system. A DDC front end computer is located in an office in the basement. The DDC controls were installed in 2002 and will require an upgrade as the mechanical systems are replaced.

**Air compressors**

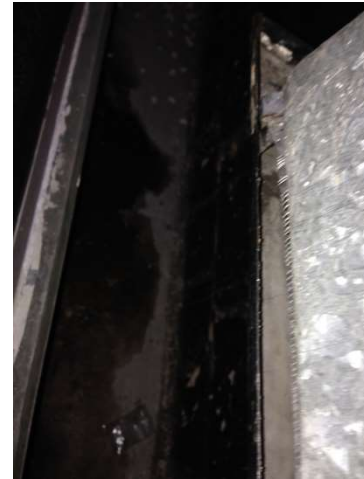
The chiller was replaced in 2008 and the cooling tower in 2011. The pumps have also been replaced. The piping, in general, is in fair condition. Pipe insulation is missing or has deteriorated around the air unit coils and is causing rust and deterioration of the piping. The lack of insulation at the induction unit coils allows condensation to form and drip into the building's envelope cavity.

**Condensation below induction unit (in wall)**

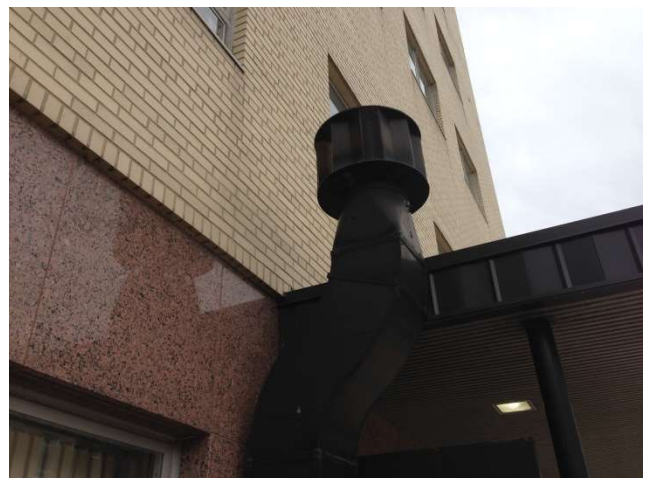
**Exhaust fan discharge (abandoned)**

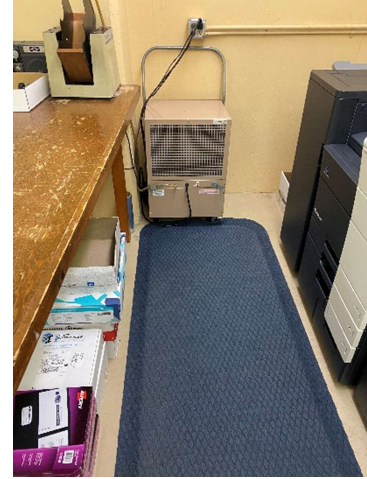
**Print room dehumidification  
(humidity issues)**

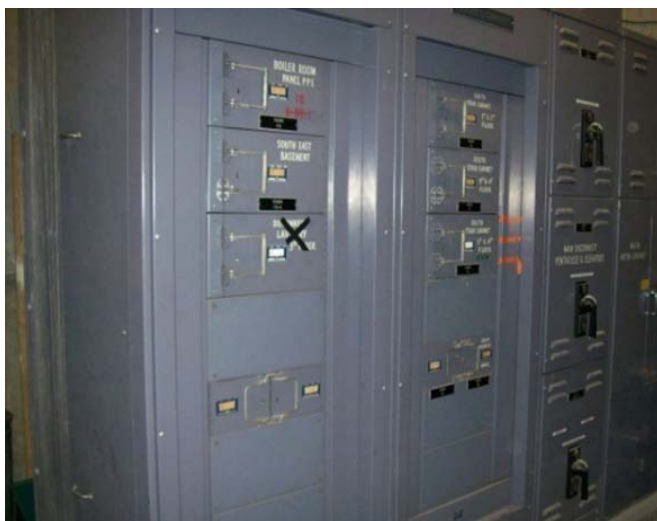
MSB main switchboard

City Hall is served by a 2000 Amp, 120/208 Volt, three phase electrical service. The Main Switchboard (MSB) is a Square D model Saflex fusible-switch type; it is in the basement. The MSB is original to the building (circa 1956). Although the equipment appears in fair condition, Square D no longer supports this style of switchboard. Often the mechanical component of a switch (the action of OPENING and CLOSING) becomes difficult to operate or simply fails to operate. Eventually replacement parts become difficult to find. The MSB consists of three service disconnect switches, and a distribution section. Each of the service disconnects is labeled – although more prominent labels and labels identifying each disconnect by number (e.g. – Service Disconnect No. 1, Service Disconnect No. 2, etc.) is recommended. The switch providing the normal power feed to the automatic transfer switch (ATS) is labeled “Emergency Circuits Disconnect”. Recommend changing this label to “Normal Power to ATS” since “emergency” circuits are fed from the generator and are not disconnected by this switch when utility power is lost. There is a project waiting for funding which replaces all the distribution equipment.

| electrical systems | grade | budget cost | notes | comments |
|---|---|---|---|---|
| Main switchboard MSB | F | See notes | E1 | Age lessens reliability of switches opening and closing; switches should be lubricated periodically. Plan for eventual replacement. |

- E1.** A Service Upgrade and Emergency and Normal Power Distribution project (approximately \$1.5 million) was bid but never constructed.
- E2.** A second ATS and branch panels dedicated to emergency egress lighting is the better option long term since the facility already has a standby generator. While unit equipment (battery operated emergency lighting) is the least expensive first-dollars solution, it has ongoing maintenance material and labor costs related to replacing batteries every 3 to 5 years.
- E3.** Continue to upgrade all light fixtures to LED when feasible. Approximately \$150K per floor.
- E4.** Consideration should be given to replacing older exterior HID fixtures with new LED ones.
- E5.** At a minimum, consider adding additional visual and audible devices to be code compliant. Approximate budget of \$25K.

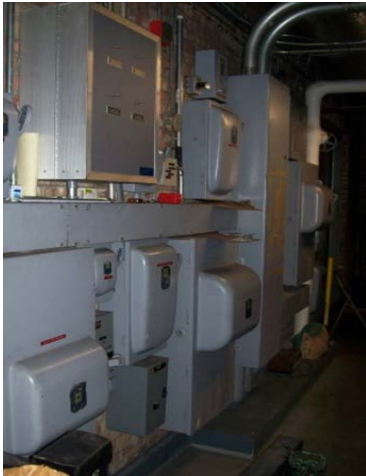
**Penthouse distribution**

Understanding how power is distributed in the penthouse could be improved by installing a motor control center. Currently the feeder serving the penthouse is tapped several times to serve numerous disconnect switches. There is a project waiting for funding which replaces all the distribution equipment.

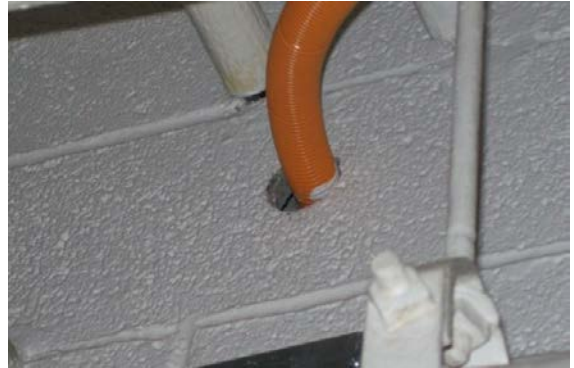
Various unsealed corridor wall penetrations were observed throughout the building. Most of these penetrations appear to be due to distribution of fiber optic cabling or other communications cabling.

**Unsealed penetration**

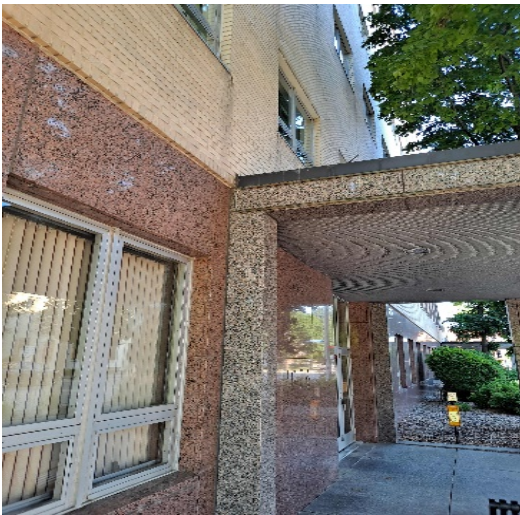
**Exterior lighting**

| electrical systems | grade | budget cost | notes | comments |
|---|---|---|---|---|
| Exterior | F | \$1000 | E4 | Replace HID with LED. |

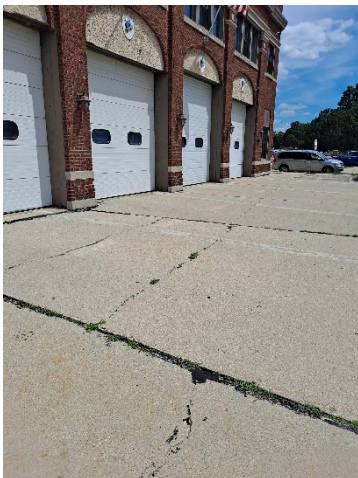
The driveway apron has significant cracking throughout.

**Cracked driveway apron**

- A1.** Tuck-point as needed on few wall locations. Tuck-point and repair masonry at chimney.
- A2.** Replace plywood transom in-fill panels. Paint doors and frames. Replace weatherstripping.
- A3.** Concrete at driveways is cracked and spalling. Recommend replacement.
- A4.** Plan to continue carpet replacement of worn areas.
- A5.** Re-paint wood door frames.
- A6.** Recommend replacing missing ceiling tiles to help maintain conditioned space.
- A7.** Refer to plumbing section for notes on replacing pipe insulation at women's room.

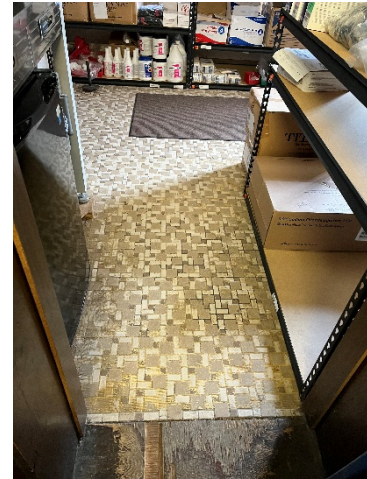
**Tile with adhesive on it**

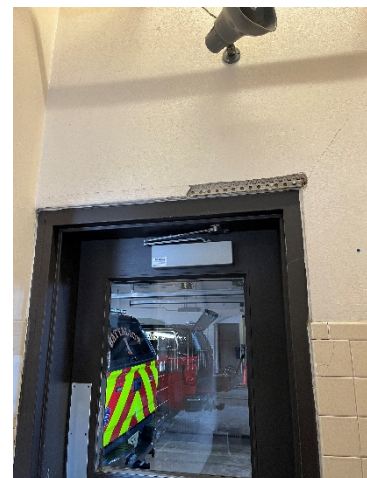
**Cracked/missing plaster over door**

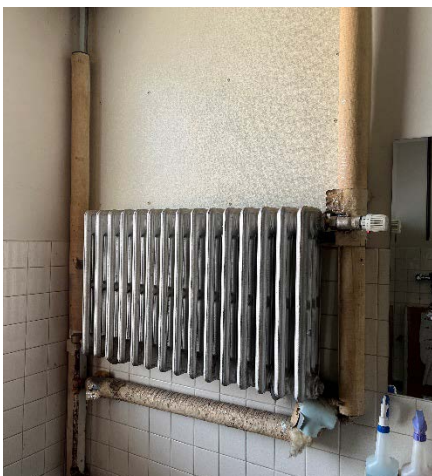
**Friable insulation on piping**

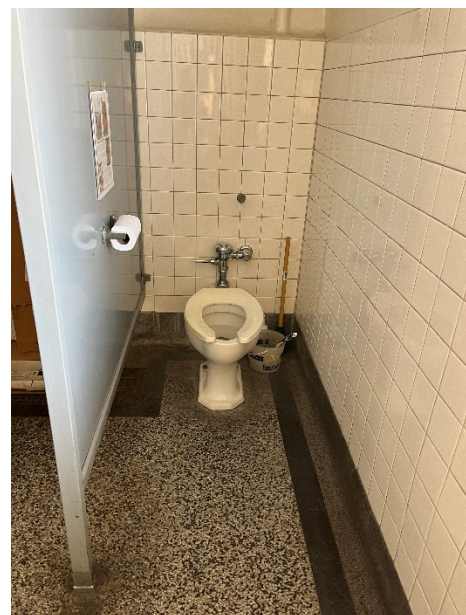
**Potential area for accessible toilet**

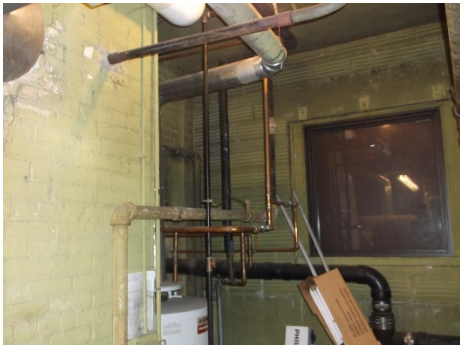
**Sanitary/water piping – boiler room**

- CA8.** The plumbing main is in the electrical room on the mid-level floor. This is a code violation. See Plumbing section of this report for cost estimate.

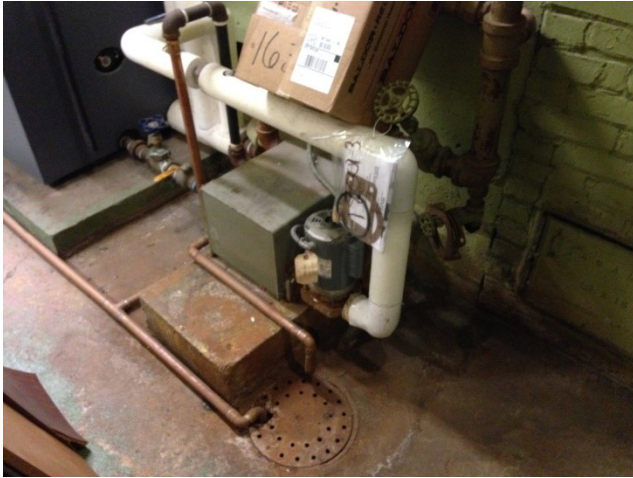
**H7.** The boiler system was replaced in 2007. The boiler is a low-pressure steam boiler. The boiler was inspected in 2020. A condensate pump is located behind the boiler. During the last evaluation walk-through the pump was leaking and spare seals were purchased. The pump appears to have been repaired.

**Condensate pump**

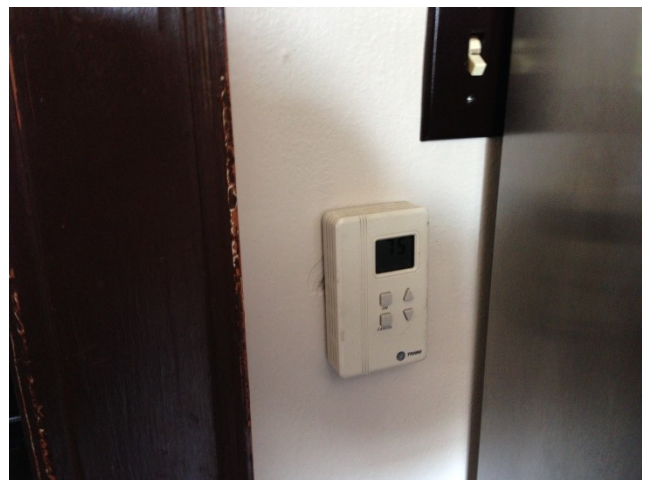
Typical thermostat (This one too close to fridge)

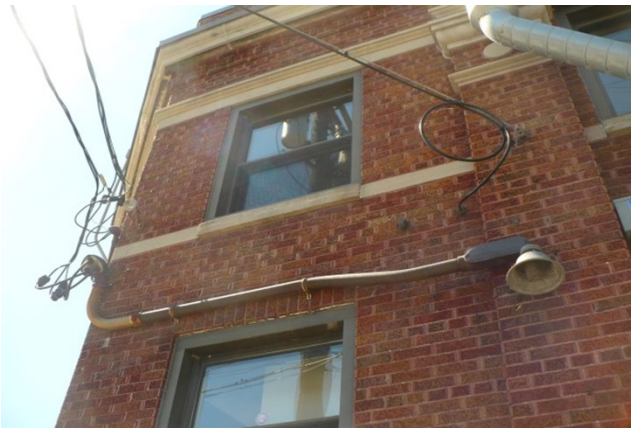
| electrical systems | grade | budget cost | notes | comments |
|---|---|---|---|---|
| Utility service entrance | C | | | Two overhead utility services, one 200 Amp, one 100 Amp enter the building on the north side into the 2 <sup>nd</sup> floor electrical closet. Water main over panels is a code violation. |

Electrical utility service entrance

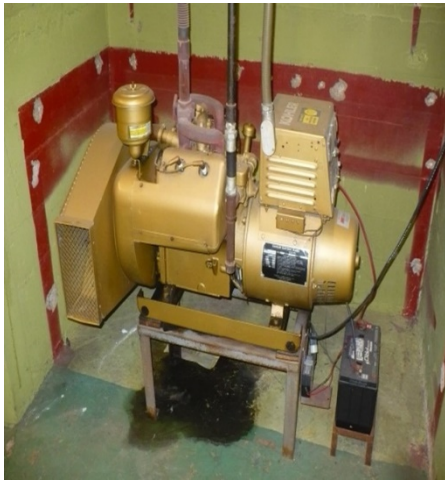
| electrical systems | grade | budget cost | notes | comments |
|---|---|---|---|---|
| Generator | F | | | 10 KW Kohler natural gas generator in fair condition. |

10kw generator

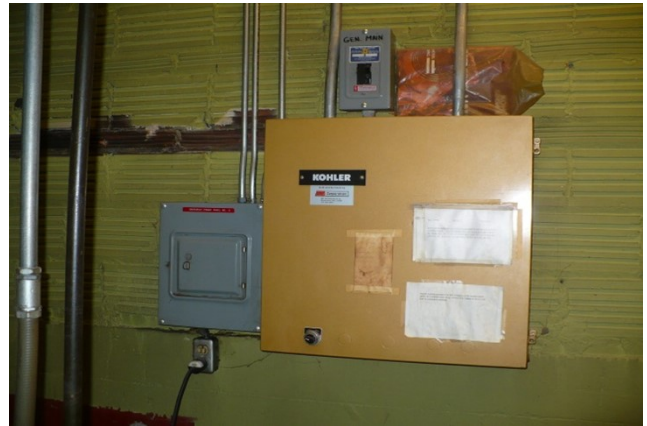
| electrical systems | grade | budget cost | notes | comments |
|---|---|---|---|---|
| Transfer switch | HP | \$6,000 | E2 | Kohler 50 Amp ATS in fair condition. |

50A transfer switch

- E1. Consideration should be given to replacing the existing Bulldog Electric panel (that is in poor condition and will have limited parts available) with a new panel.
- E2. Recommend providing an additional automatic transfer switch and panel board to separate the critical and equipment branch loads from the life safety loads. The existing panels have several circuits listed as "unknown". These circuits should be traced and identified to get a better idea of available capacity.

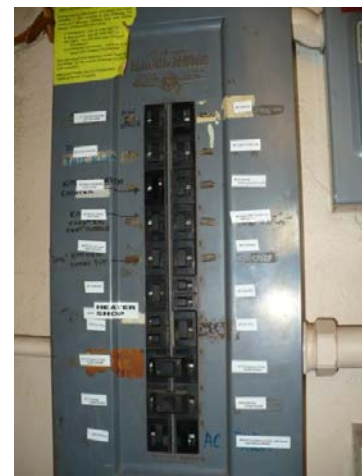
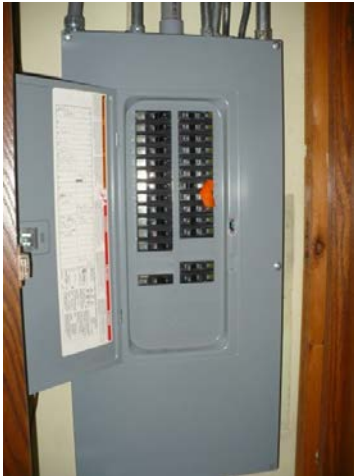
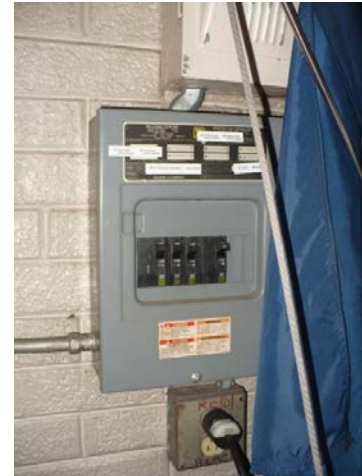
| electrical systems | grade | budget cost | notes | comments |
|---|---|---|---|---|
| Branch panels | HP | \$6000 | E1 | Two panels on 2nd floor, two panels on 1 <sup>st</sup> floor. Bulldog Electric panel on 2 <sup>nd</sup> floor in poor condition, Square D load centers in good condition. |

Existing panel

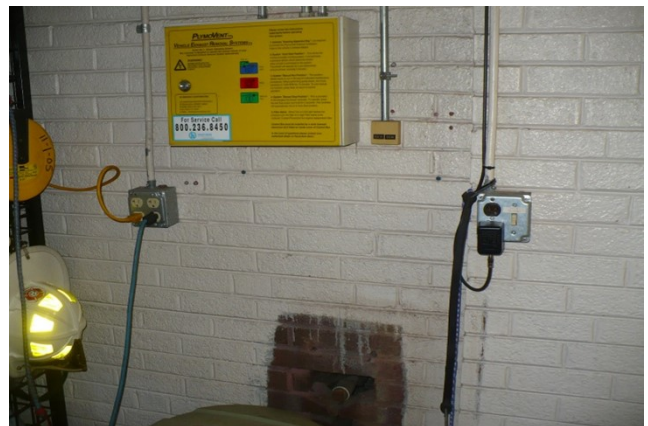
The outlets within the garage are not GFCI protected. Lighting fixtures are in good to fair condition and utilize T8 lamps and ballasts and compact fluorescent lamps. There are occupancy sensors located in the toilet rooms and in the conference room, but the facility should install occupancy sensors in offices, storage rooms and janitor's closets. Decorative compact fluorescent building mounted fixtures are in good condition; consideration should be given to replacing with more efficient and lower maintenance LED fixtures in the future.

Garage receptacles

- E3.** Replace all outlets located in the garage area with GFCI type device. Replace existing kitchen outlets with GFCI type device unless they are currently protected from the adjacent GFCI outlet. If this is the case, the outlet should be labeled per NEC requirements.
- E4.** Consideration should be given to replacing older non-LED fixtures with new LED ones.
- E5.** Occupancy sensors should be installed in the offices, storage rooms, and janitor's closets to provide additional energy savings. If areas are renovated, controls will be required to be updated to meet current energy code.

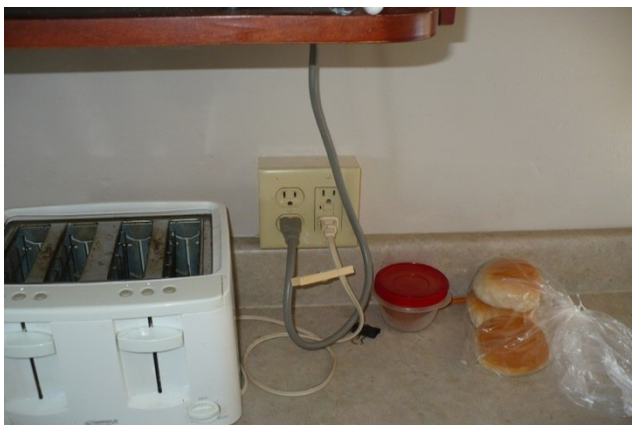
Kitchen receptacles

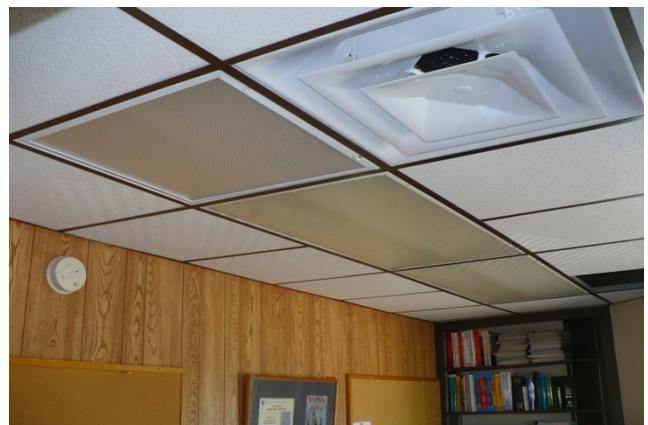
| electrical systems | grade | budget cost | notes | comments |
|---|---|---|---|---|
| Office spaces, conference rooms, and corridors | F | \$2,000 | E4 | Recessed acrylic lens troffers with T-8 lamps in good to fair condition. |

Office lighting

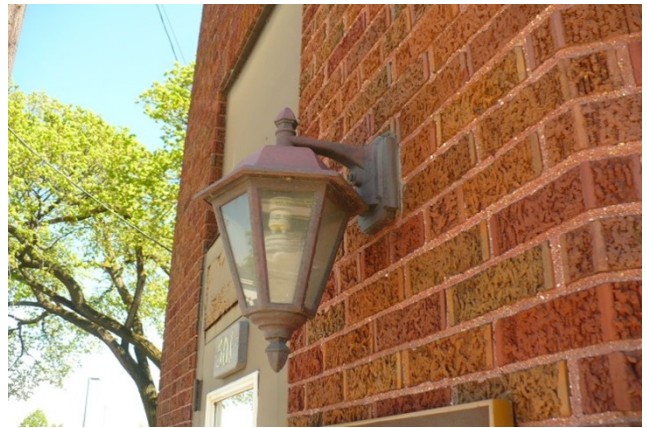
| electrical systems | grade | budget cost | notes | comments |
|---|---|---|---|---|
| Exterior | F | \$6,000 | E4 | Decorative wall mounted fixtures are in fair condition. Fixtures are utilizing screw-in compact fluorescent lamps. |

**Exterior fixture**

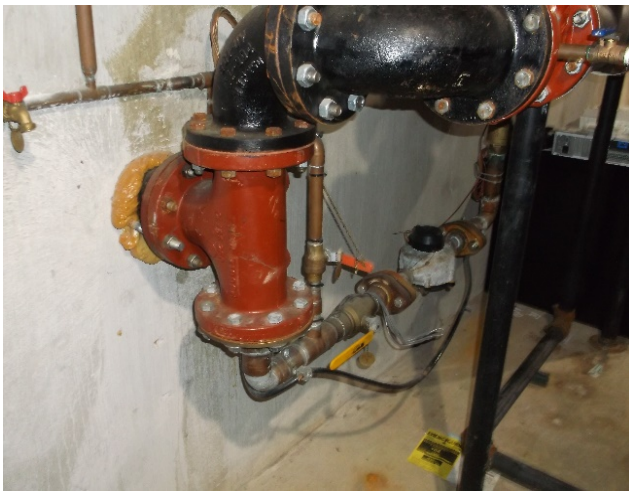
- P17.** Utilities are fed from Jefferson Street. 4" water main to the building serves the domestic water and fire protection systems combined. 4" sanitary sewer. 4" and 6" storm sewers combined, route to a 6" storm main to the street. Parking lot has internal storm drainage with catch basin(s).

4" water service

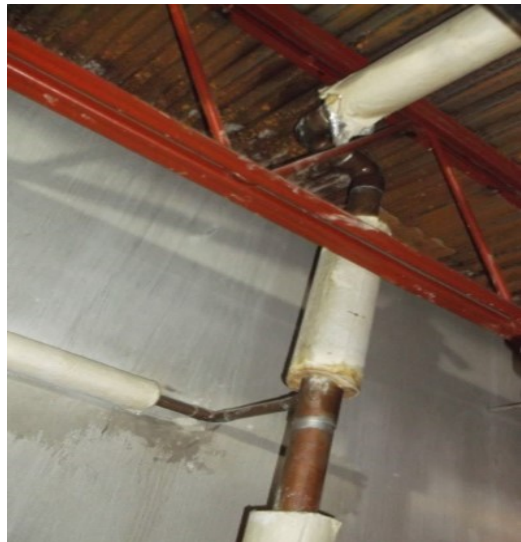
- P1.** Water piping is mainly copper, soldered joints in fair condition. There are some pre-press connections at the water heater. Some sections of piping are missing insulation. Repair as required.

Water piping

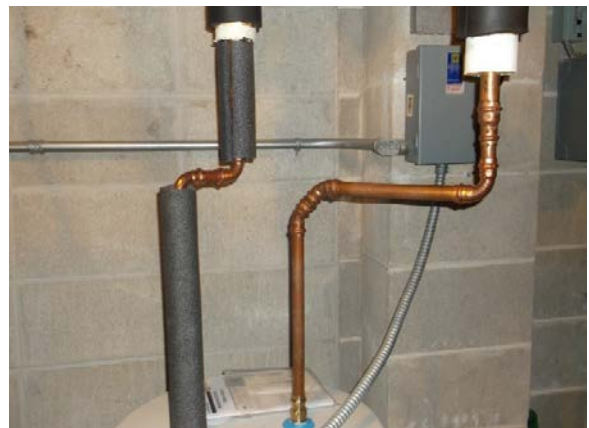
- P8.** Water heater is electric, AO Smith model #ECS 40 200, 208/240Volt, 40-gallon unit. Piping has pro-press connections, also missing insulation. Repair as required. 1" HCW connections.

**Water piping at water heater, pro-press piping**

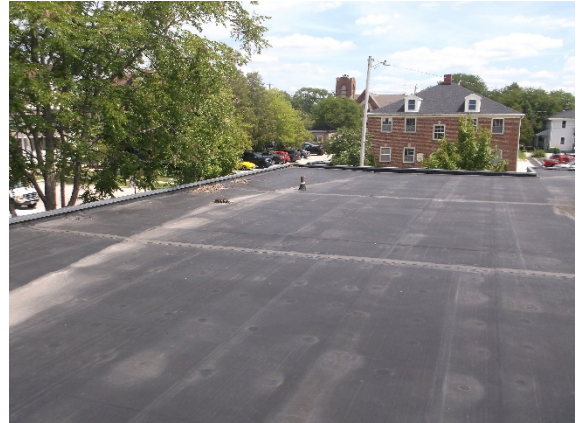
- P15.** Sanitary ejector pumps are duplex top-mount. Pumps are 1 ½ hp, 208Volt, 3-phase.
- P16.** Building is served by four 3" roof drains with 4" roof leaders to below grade. Piping is insulated with glass fiber. There is no secondary roof drainage installed, which is a code issue. (International Plumbing Code 1108.1) Secondary drainage could have been added during the last re-roofing project.

**Sanitary vent & roof drain**

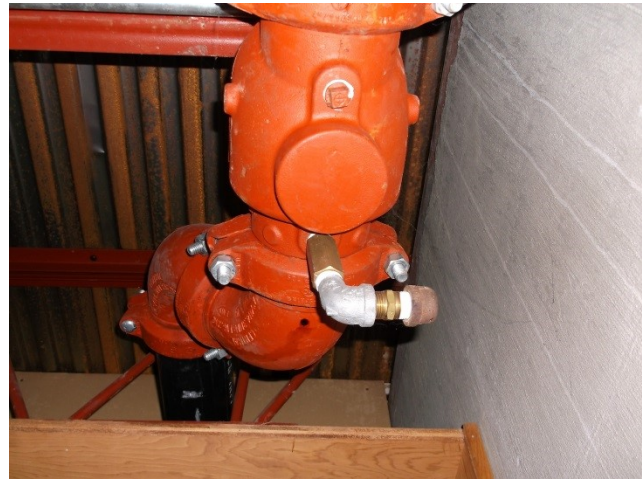
**Automatic ball drip capped**

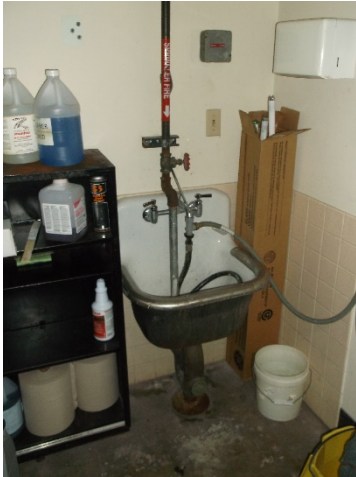
Inspector's test drain discharging in sink

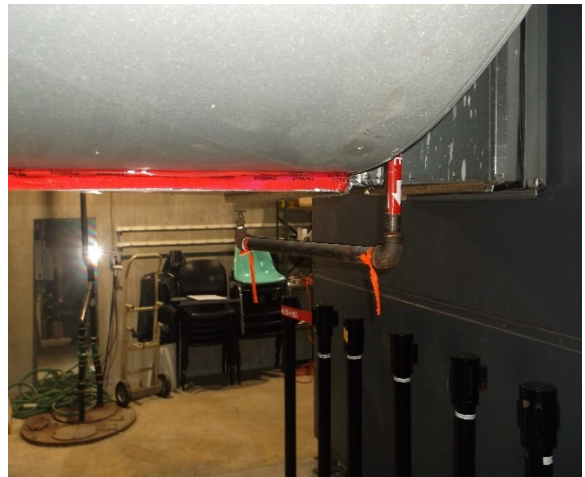
Sprinkler head under duct

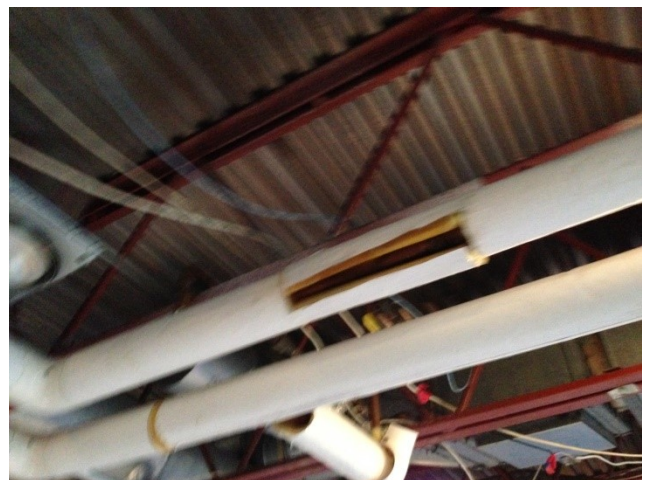
| HVAC systems | grade | budget cost | notes | Comments |
|---|---|---|---|---|
| Pipe insulation | HP | \$7,000 | H3 | Insulation missing at a variety of locations. Poor condition around unit coils. |

**Poor insulation (typical)**

- H3.** The boiler system has been replaced since the last evaluation. No operational issues were noted during the building walk-through.
- Pipe insulation is missing or in disrepair in a variety of locations around the building. The insulation is especially poor around the air unit and boiler, where maintenance work has required the removal of the insulation and it was not repaired or replaced. It is recommended to insulate this piping and repair insulation during an air unit and/or boiler replacement project.

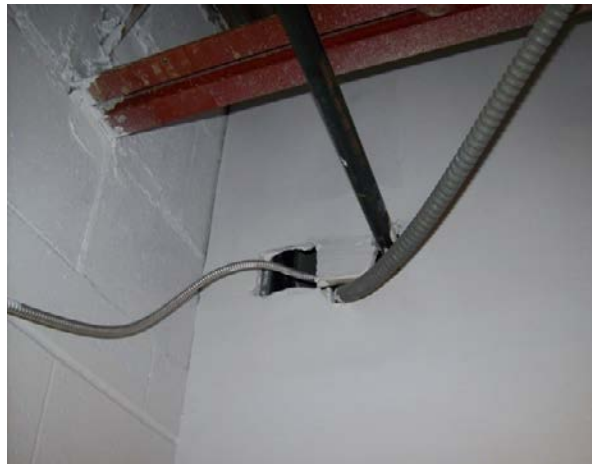
Opening through wall common with stairway

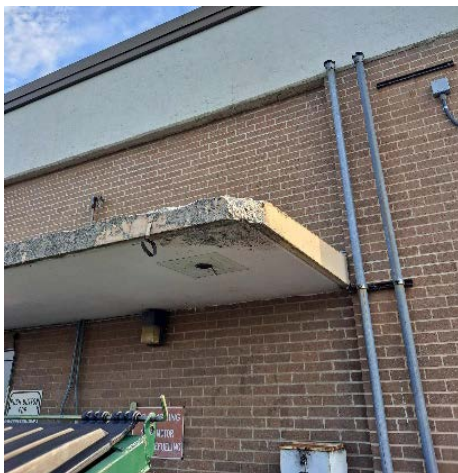
The concrete canopy along the south side of the building has spalled and cracked concrete. This is allowing water to penetrate the canopy and could cause additional damage to the soffit if not addressed.

**Damaged canopy**

| architectural elements | grade | budget cost | notes | comments |
|---|---|---|---|---|
| Precast canopy | <b>CP</b> | \$8,000 – \$12,000 | A4 | Cost will depend on selected repair solution. |

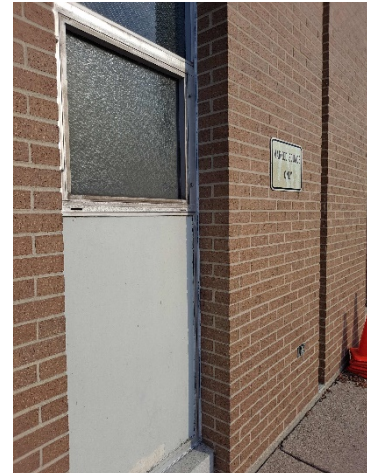
**Faded window infill panels**

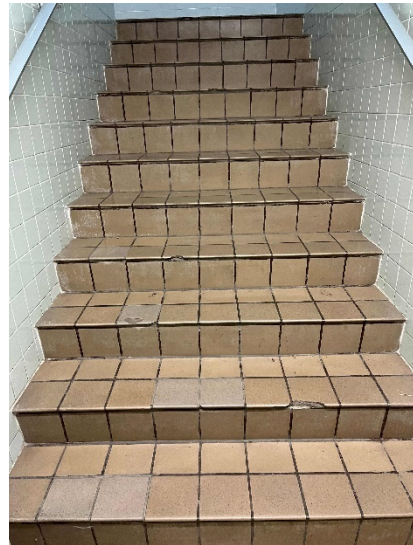
**Chipped tiles at south stair**

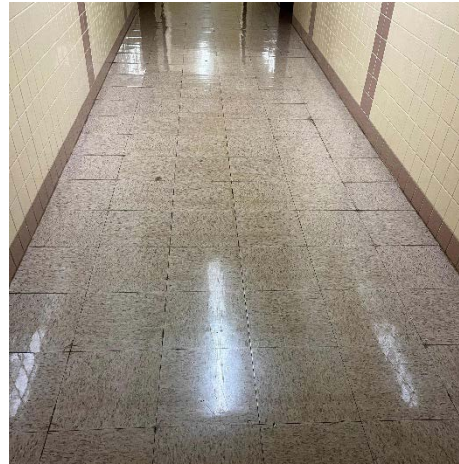
**Dirt at center of corridor and edges of tiles**

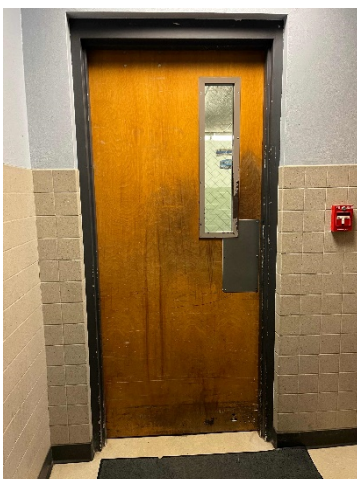
**Chipped paint at lite and damaged wood finish  
Missing kick plate**

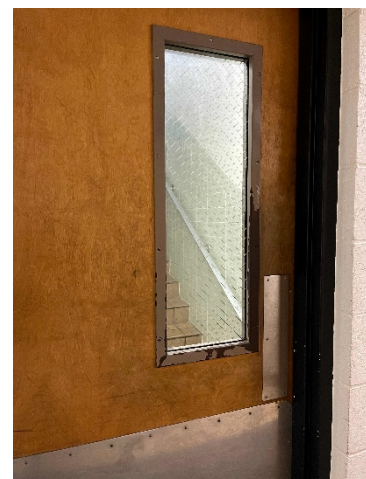
**Chipped paint at lite and damaged wood finish**

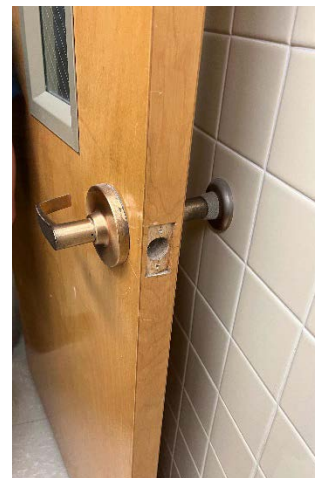
**Missing latch at north stair door**

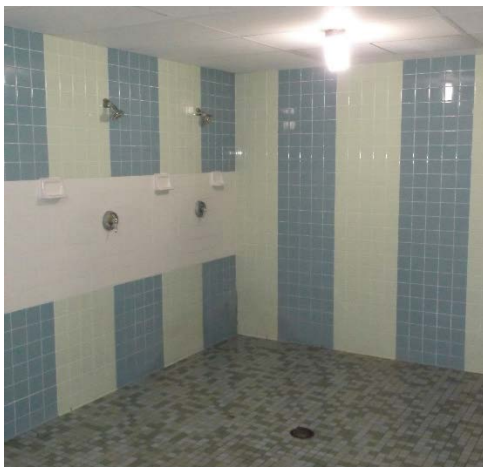
**No accessible shower – men's**

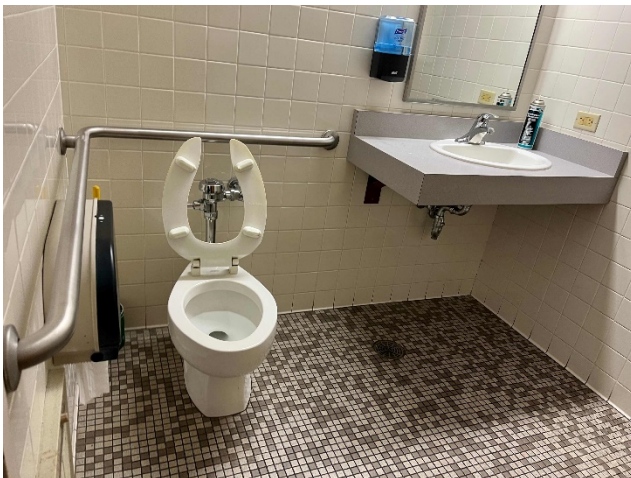
**Toilet with grab bars, but lacking clear floor space**

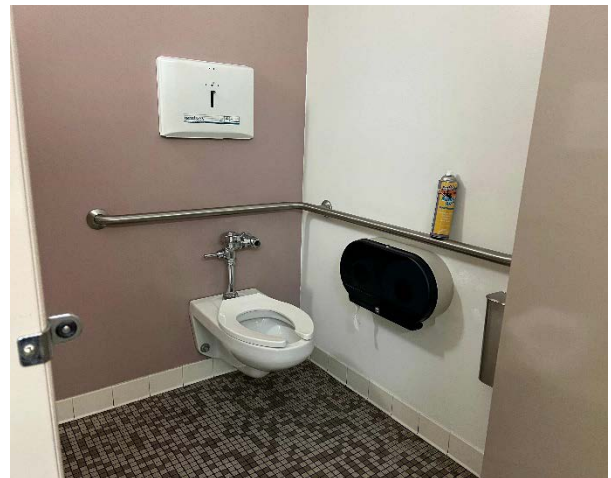
**Toilet stall accessible, but room is not  
(See photo above)**

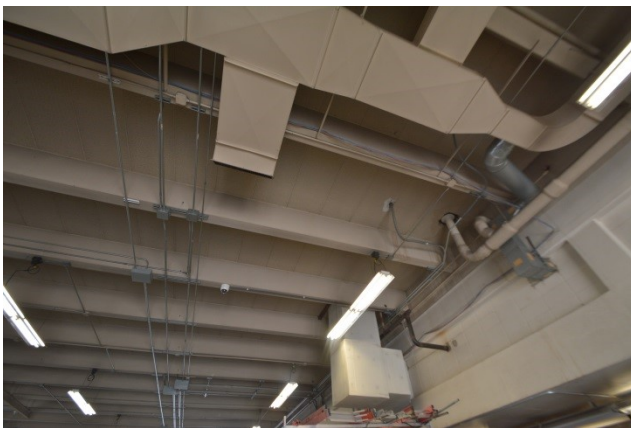
Roof structure at garage bay
