# **AGENDA OF THE FINANCE COMMITTEE**

**TUESDAY, NOVEMBER 29, 2022, 4:30 PM**

**F. Report of the Ad Hoc Facilities Committee (November 15, 2022).**

1. To direct Finance Staff to work with BSA on the total cost of the deficient and critical needs listed in the report in response to the review of the Facilities Assessment Updates for City Hall, Municipal Court, Police Station, and Fire Station #1.

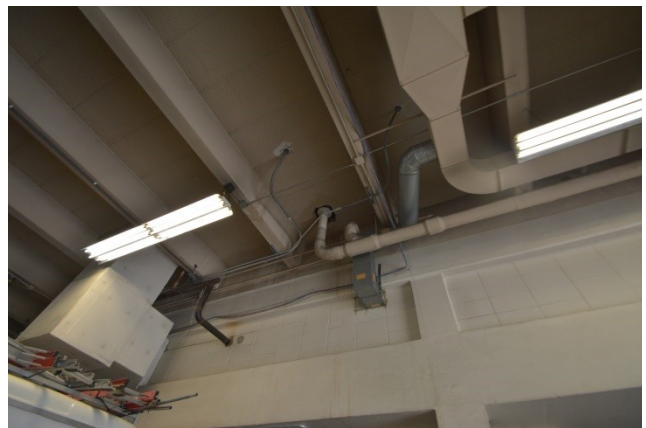
Roof bearing at office/garage supporting wall

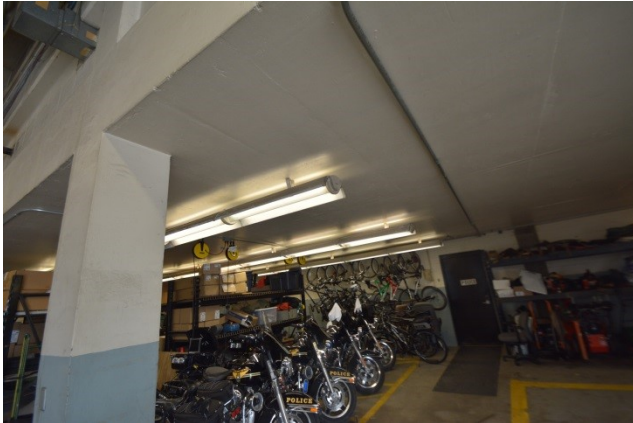
2<sup>nd</sup> floor plan structure as seen from garage

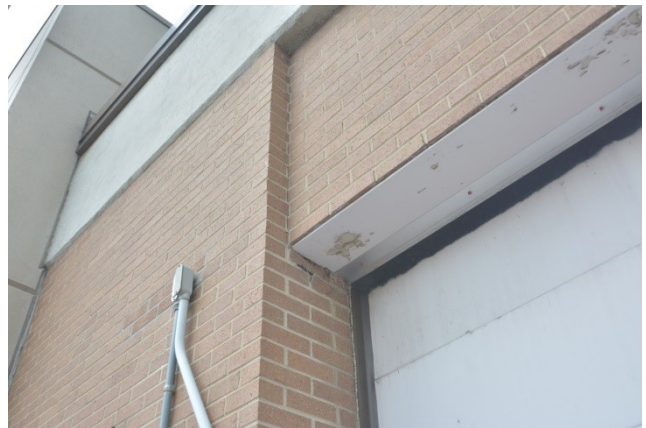
Lintels at garage door openings

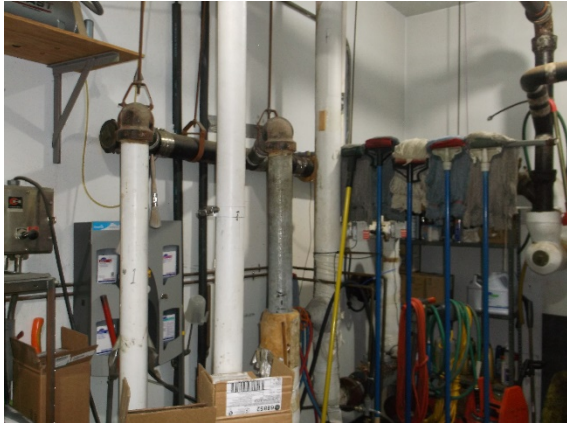
- P2.** Original sanitary waste/vent is cast iron hub & spigot. 1992 piping is cast iron, no-hub connections. Pump discharge is cast iron. Piping is in fair condition.

**Pump discharge – sanitary piping**

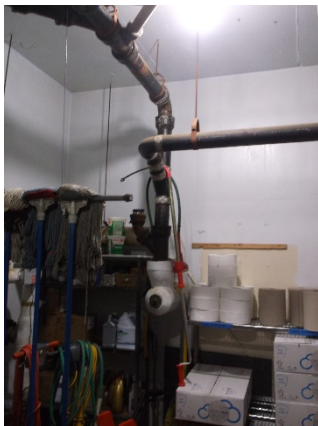
**Sanitary piping**

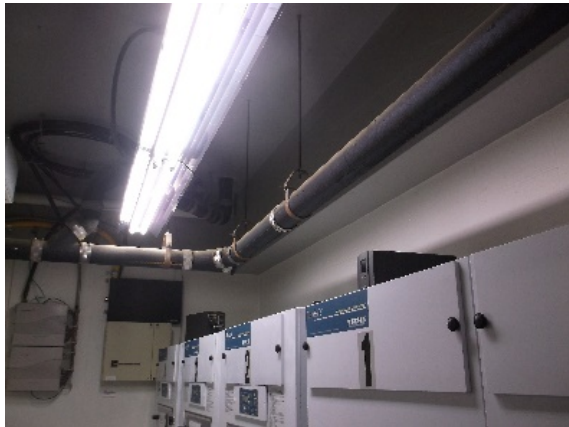
**Sanitary piping over evidence dryers**

There is a sanitary pipe installed over the evidence dryers in the basement. It would be advisable to install a drain trough below the piping to protect the equipment from potential leaks.

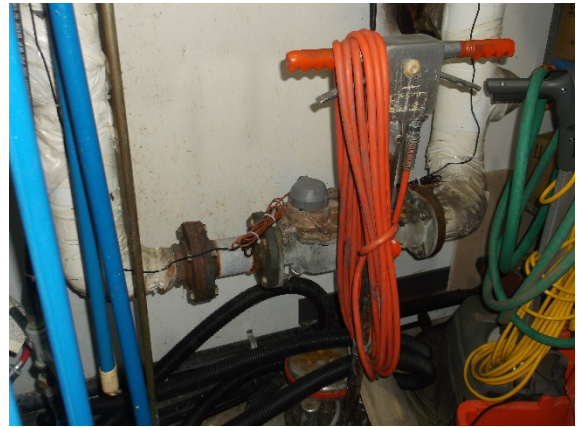
- P1.** Water piping is mainly copper, soldered joints. Fair condition. Some galvanized piping at the water meter. Some PEX piping also installed. Most of the piping is insulated.

**Water meter**

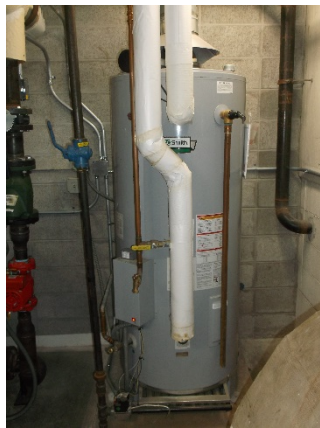
- P8.** Water heater is a single gas fired, AO Smith model BTR-365 series 118, 365,000 BTU/HR, 85 gallon with atmospheric gas venting. No expansion tank installed.  
*Recommendation: add expansion tank at the water heater.*

**Water heater**

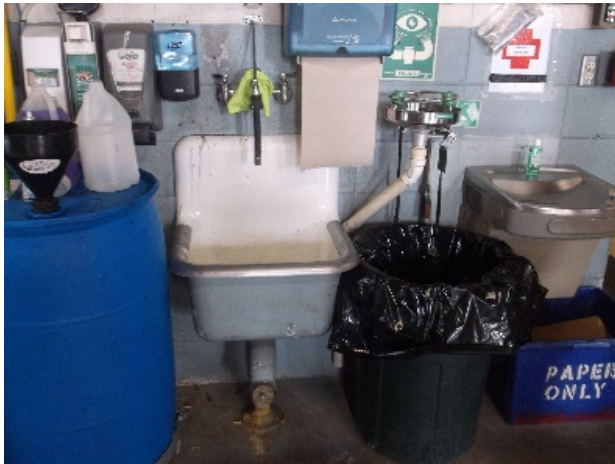
Sink, EWC & eyewash in garage

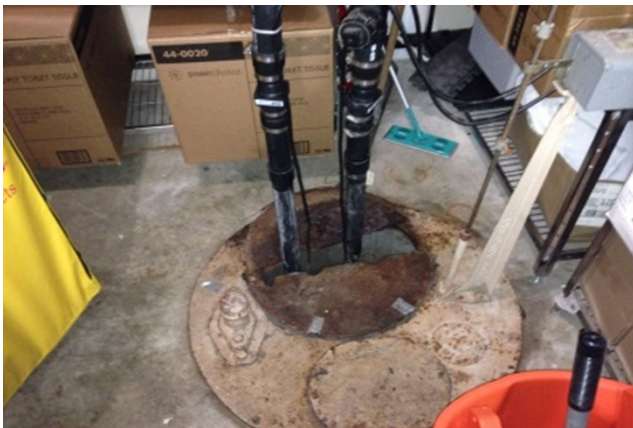
Sump, duplex pumps

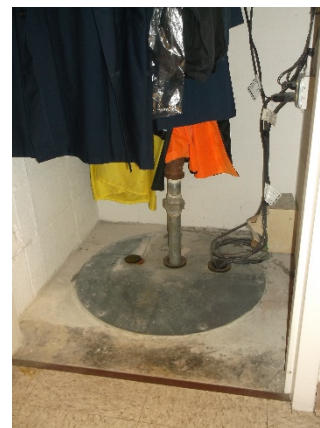
Elevator sump/pump

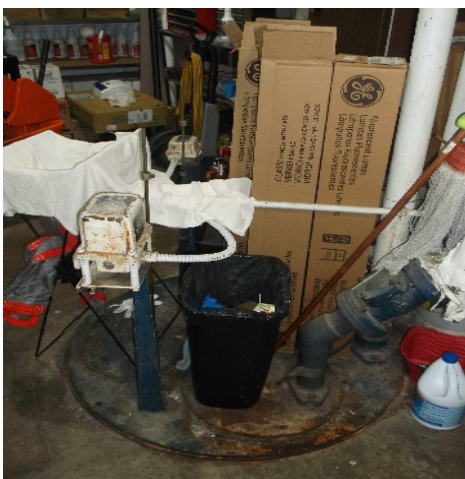
Sanitary sump/pump

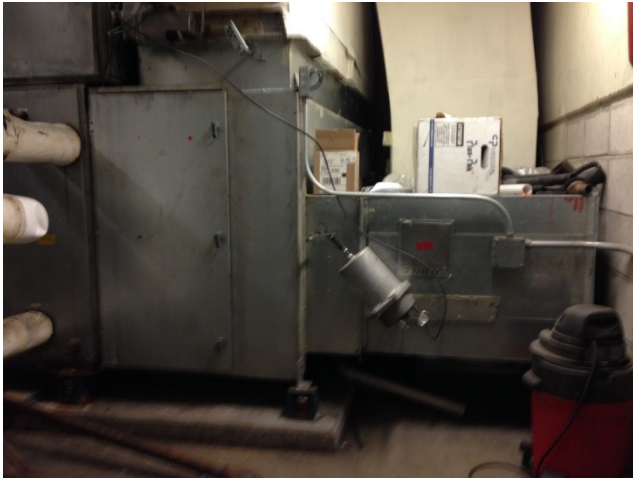
| hvac systems | grade | budget cost | notes | comments |
|---|---|---|---|---|
| Housing | CP | \$435,000 | H1 | Showing signs of 30 years of operation. Minor rust. |

**H1.** These units are original to the 1992 project. Units are 30 years old with an expected useful life of 25 years depending on maintenance and operation of the unit. Overall, the units have been maintained well but are showing signs of age and continuing to rust. The coils appear to be in fair condition, however most deterioration occurs from the inside out and won't be visible until leaks occur. The unit grade is mainly based on the unit's age and expected useful life. The estimated replacement cost assumes many factors, including ability for extended unit outage during construction, and combining of multiple units into one. The actual cost could widely vary depending on the project specifics.

**Air unit (typical)**

The units are indoor modular units with hot water heating coil, chilled water-cooling coil and VAV control. The supply ducts are lined. Duct liner erodes over time, and this will lead to system inefficiency and condensation which will damage building material. It is recommended to seal the ductwork and install duct wrap insulation during renovation projects.

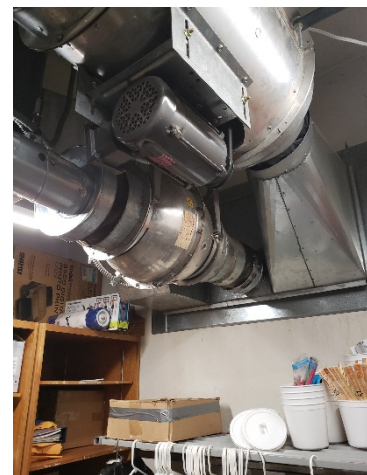
**Interior exhaust fans (noisy)**

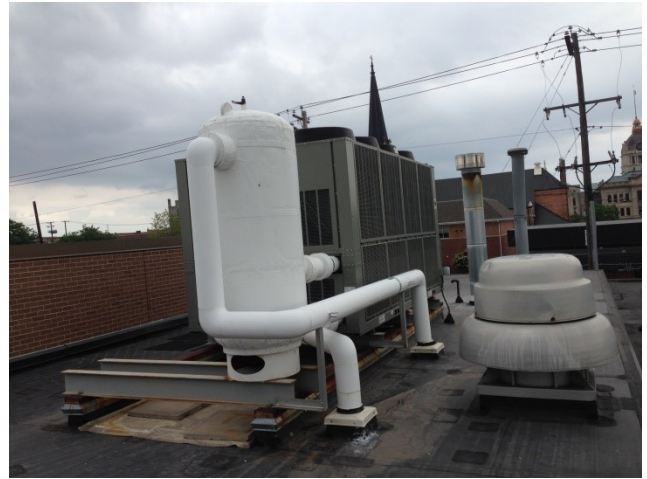
**H2.** The chiller was replaced in 2010. No system complaints relayed by staff. Insulation is damaged at the chilled water pump. Recommend repair to the insulation to prevent condensation and further deterioration of the insulation and piping. The insulation prevented inspection of the pump seals to determine if the water was condensation from the damaged insulation or if the pump itself was starting to leak and causing the insulation damage.

**Chiller**

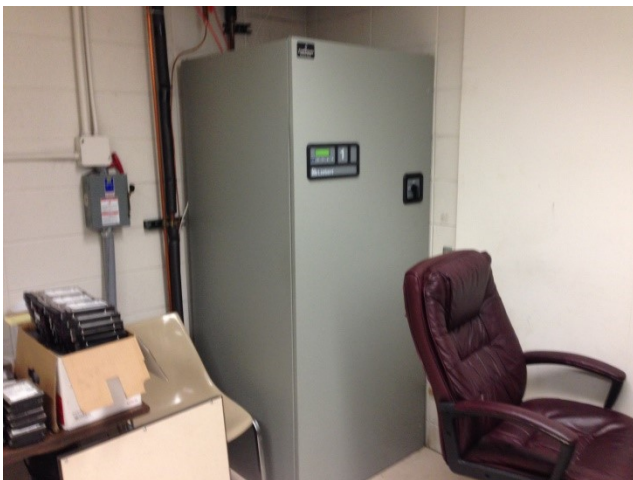
| hvac systems | grade | budget cost | notes | comments |
|---|---|---|---|---|
| Housing | HP | \$30,000 | | Leibert units-DX and water cooled. Humidifier on basement unit. Ages vary. Budget is a single unit starting point. |

**Leibert unit (floor mounted example)**

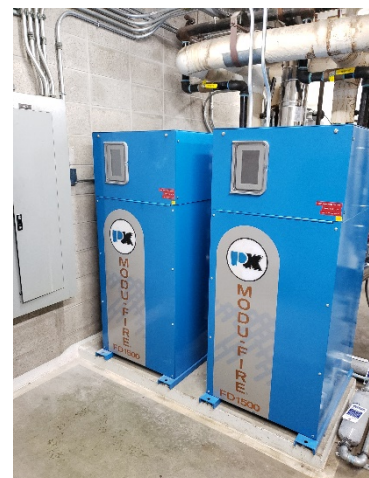
| hvac systems | grade | budget cost | notes | comments |
|---|---|---|---|---|
| Boilers | N | | H7 | Replaced 2022 |

**Boilers**

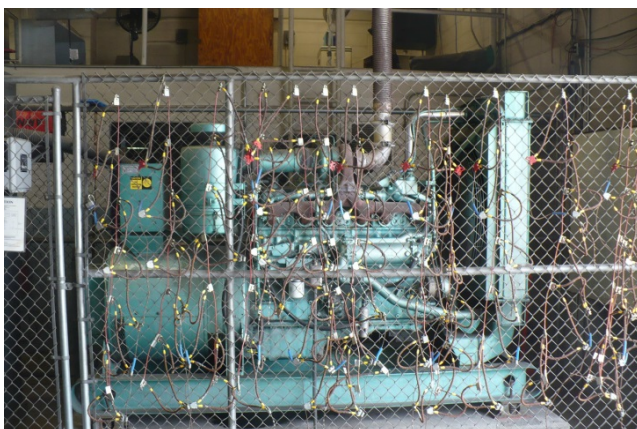
| electrical systems | grade | budget cost | notes | comments |
|---|---|---|---|---|
| Generator | F | | E2 | 200 KW Onan natural gas generator located in the vehicle garage, in fair condition. |

**Generator**

- E1.** Code required 3-feet for electrical clearance and clear space above the equipment is not being maintained in server room.
- E2.** When the generator is replaced in the future, it will need to be located within a dedicated electrical room with appropriate floor, ceiling, and wall fire-rated construction.

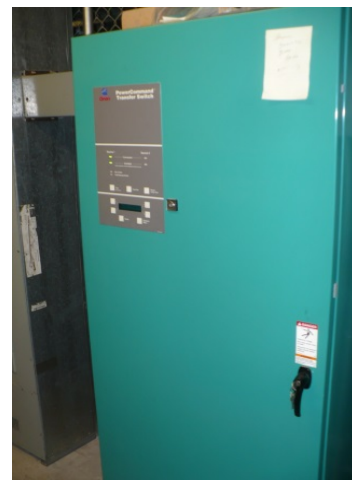
| electrical systems | grade | budget cost | notes | comments |
|---|---|---|---|---|
| Transfer switch | HP | \$25,000 | E3 | Onan 800 Amp ATS in fair condition. |

**Automatic transfer switch**

- E3.** Recommend providing an additional automatic transfer switch and a new distribution panel to separate the non-life safety loads from the life safety loads. Additional branch panels would be needed to transfer circuits from existing panels that have mixed loads.

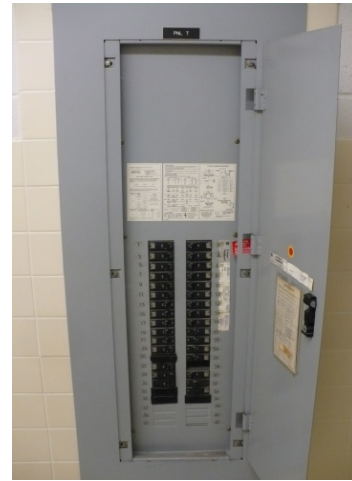
| electrical systems | grade | budget cost | notes | comments |
|---|---|---|---|---|
| Branch panels | F | | E1 | Original GE NLTG panels in fair condition and 1992 renovation GE A-Series panels in good condition. Panels have future capacity. |

**1992 renovation panel**
