AGENDA OF THE AD HOC FACILITIES COMMITTEE

Report to the
Ad Hoc Facilities Committee
of the City of Green Bay

■ Existing Flow Analysis - City Hall | Green Bay, WI

Existing Flow Analysis - Police Department | Green Bay, WI

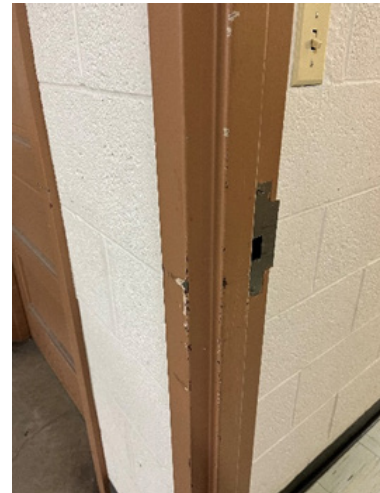
Chipped paint

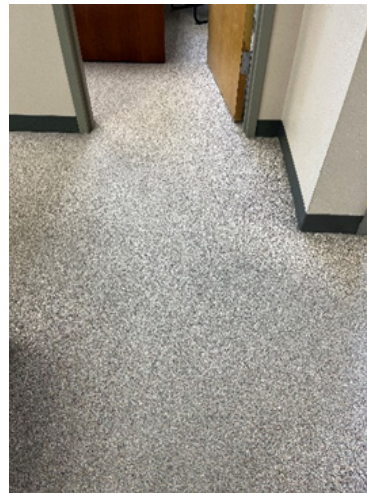
•Carpet at high traffic areas (legal suite, reception areas) is showing wear.

Worn carpet – legal area

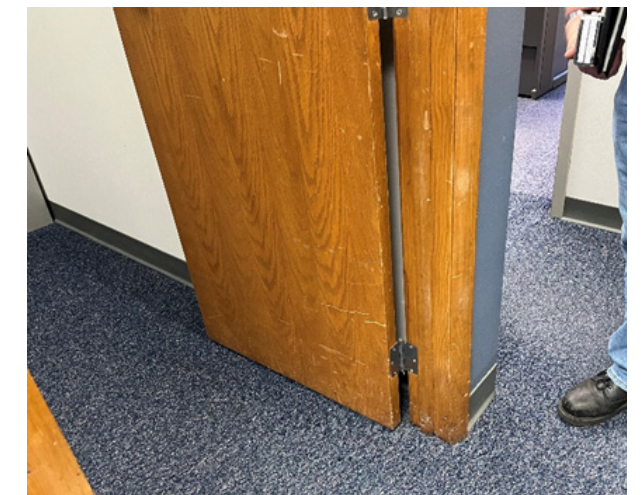
Scratched wood finish

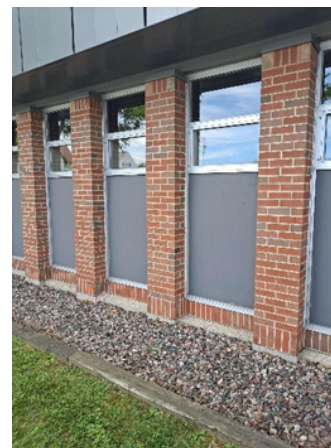
Transom panels at windows
