# AGENDA OF THE FINANCE COMMITTEE

**TUESDAY, NOVEMBER 28, 2023, 4:30 PM**

An assessment of City Hall was conducted in 2015 by Berners Schober with an update in 2022, which reviewed the condition of the building’s architectural, structural, mechanical, plumbing, and electrical elements. This report is a flow analysis, studying and noting the observed deficiencies.

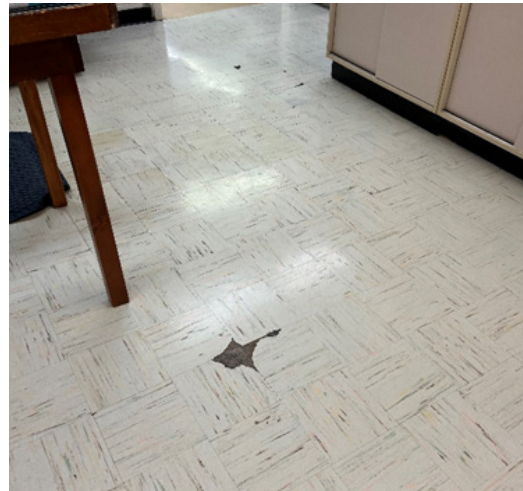
•9” composite tile in print shop area has cracked and missing tile at multiple locations throughout the space. Staff reports that a previous asbestos survey found asbestos in the adhesive for the tiles, but not the tiles themselves. Areas of missing or damaged tile should be addressed in order to prevent old adhesive from becoming airborne.

Chipped floor tile

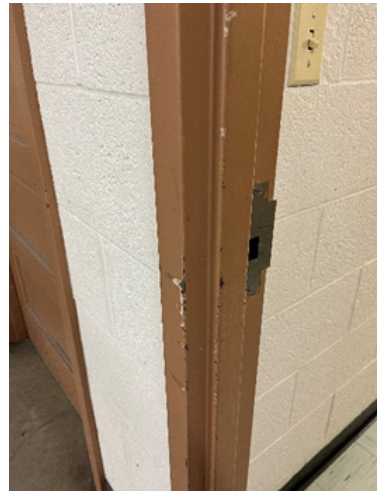
Chipped paint

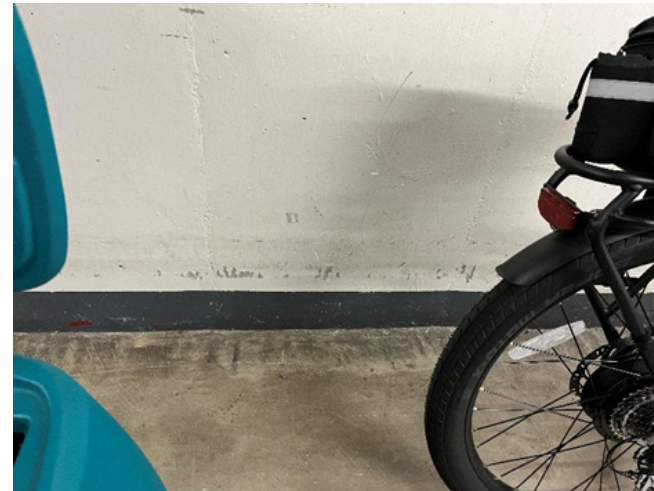
Chipped paint at wall

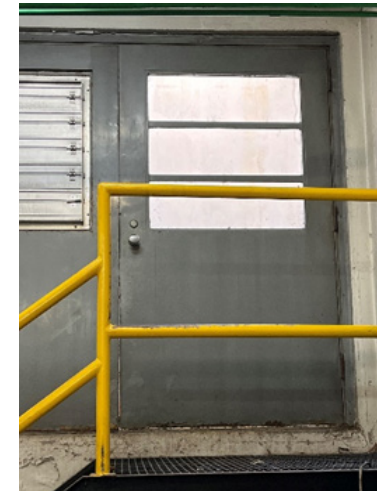
•Paint at frames is worn and chipped in multiple locations.  
•Metal door from boiler room to exterior is rusted at sill. Weatherstripping is missing at door. Daylight visible at door perimeter.

Missing weatherstripping  
at rusted door

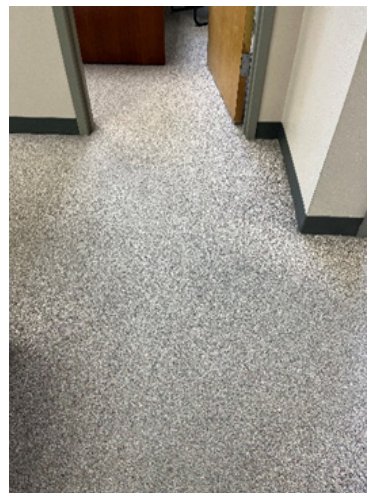
•Carpet at high traffic areas (legal suite, reception areas) is showing wear.

Worn carpet – legal area

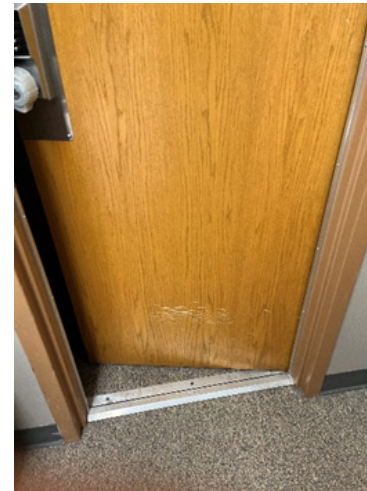
Scratched wood door

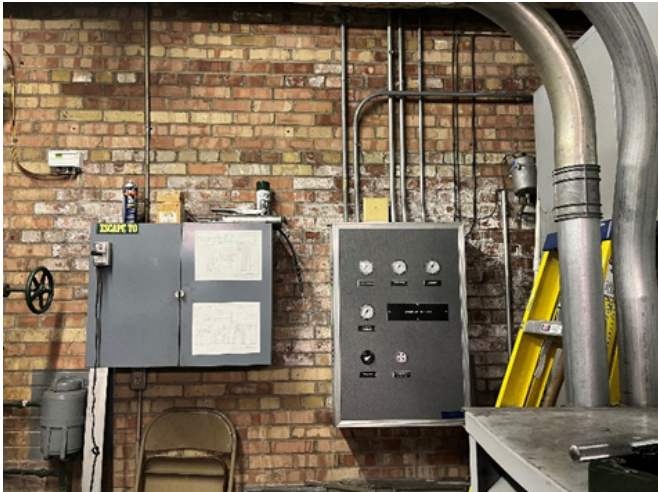
Penthouse

Efflorescence on west wall

**Efflorescence of Brick** - The presence of efflorescence on the brickwork indicates moisture-related issues that need to be addressed promptly to prevent further damage.

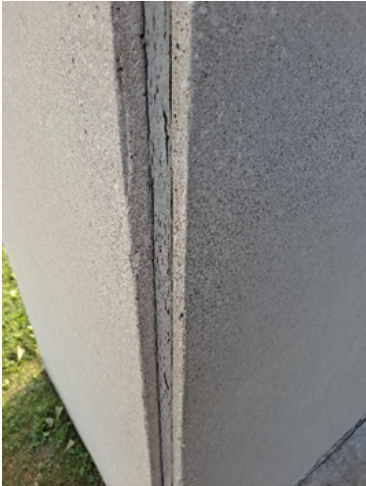
**Caulking Deterioration** - The dried-out and brittle caulking around the building's exterior poses a risk of water infiltration, potentially leading to structural damage and decreased energy efficiency.

The remainder of the exterior walls are precast concrete panels. At the panel joints, there is dried and brittle caulking which should be replaced. There are also several locations where the panels are stained from the window frames or other wall-mounted equipment. Large gaps are present in the soffit areas of the precast panels. There is also some damage to the upper portion of the precast concrete wall panel at the southeast corner where a previous patch was made. There are some settlement cracks in the vertical concrete elements between the large west-facing windows.

Caulking dried and brittle

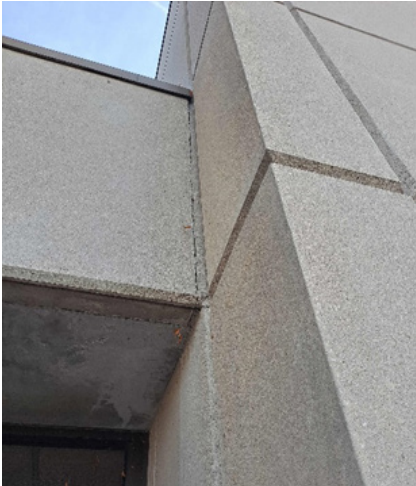
Caulking dried and brittle

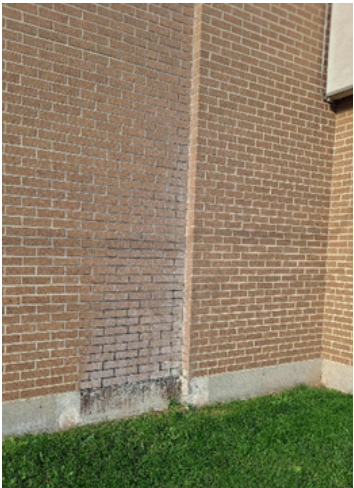
**exterior walls**  
Portions of the exterior walls are brick, which is in fair condition. There are a few spots where tuck-pointing would be recommended as part of a typical maintenance program. One area near an inside corner shows effervescence that starts approximately 6’ up on an inside corner and extends diagonally down. The mortar is compromised, and the exposed portion of foundation wall is stained.

Efflorescence on brick

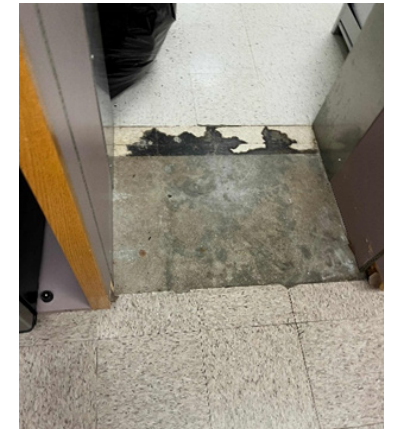
Duct tape at transition from carpet to VCT

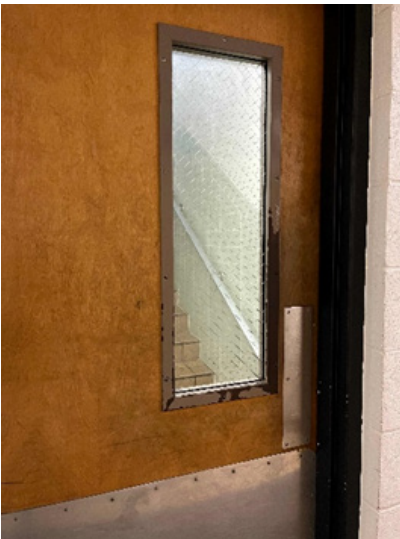
Chipped paint at lite and  
damaged wood finish  
Missing kick plate

High-use doors show wear at locations of door push. This may be able to be cleaned and re-protected with clear finish. Paint is missing from many metal door light frames. Some wood doors have scratched veneers at lower portion (no kick-plate). Door hardware missing includes latches in door, latch plate in frame and kickplates. Doors in the basement are generally in the worst condition.

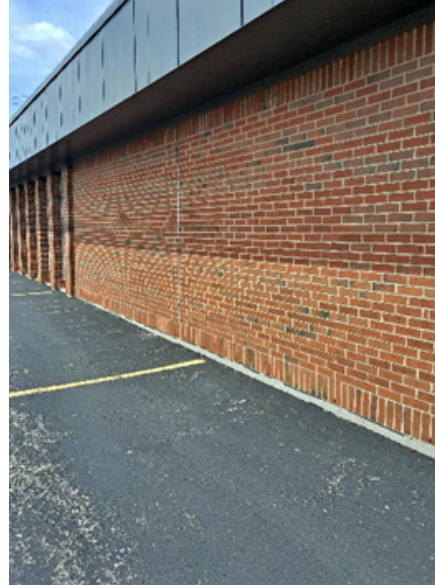
Exterior brick in good condition

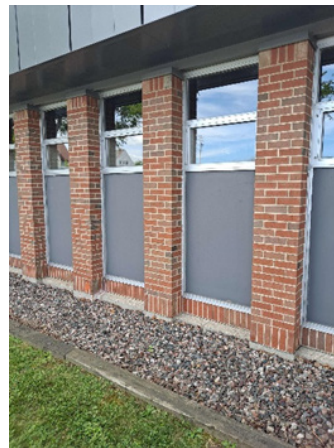
The composite panel portion of the windows has faded but is in otherwise serviceable condition.

Transom panels at windows
